33 The Crescent, Brimington, S43 1AZ

Elemental Structural Report

CHESTERFIELD
BOROUGH COUNCIL

Contract Title	33 The Crescent, Brimington, Chesterfield
Report Title	Elemental Structural Report on Cracking
Revision	Rev.C
Status	Revised
Control Date	05 th October 2018

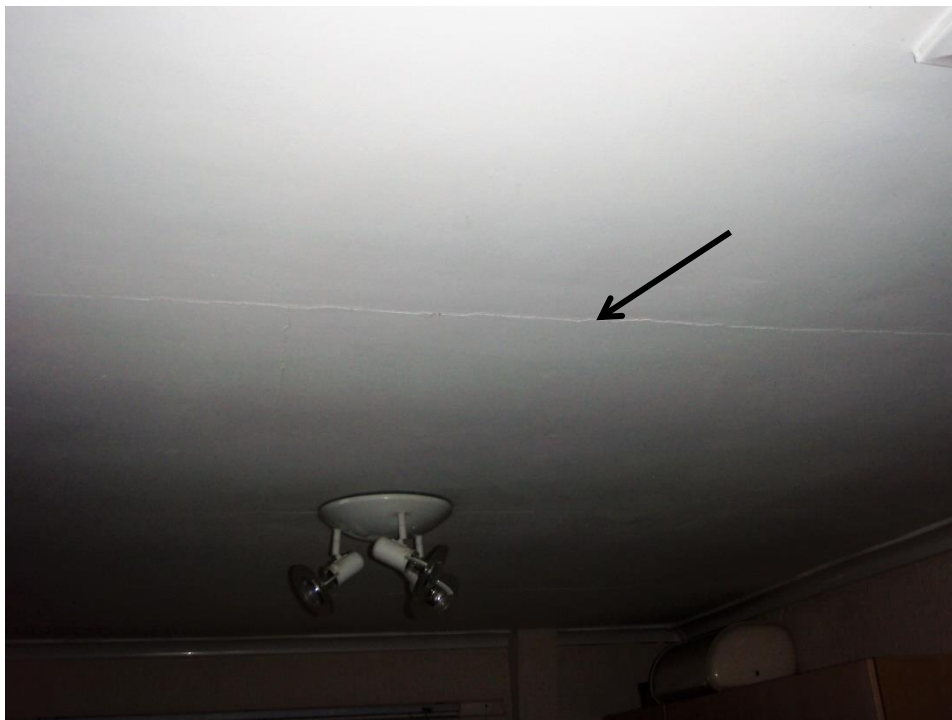
- 2.1 There are three lines of cracking in the ceiling to the kitchen. These were measured at 0.9mm wide.

CRACKS IN KITCHEN CEILING

- 5.4 The cracking on the end, north-east wall should be repaired in accordance with Helifix Crack Stitch repair detail CS01 as attached.
- 5.6 Internal cracks to the walls and ceilings should be V-cut out and filled with a non-shrink remedial plaster filler

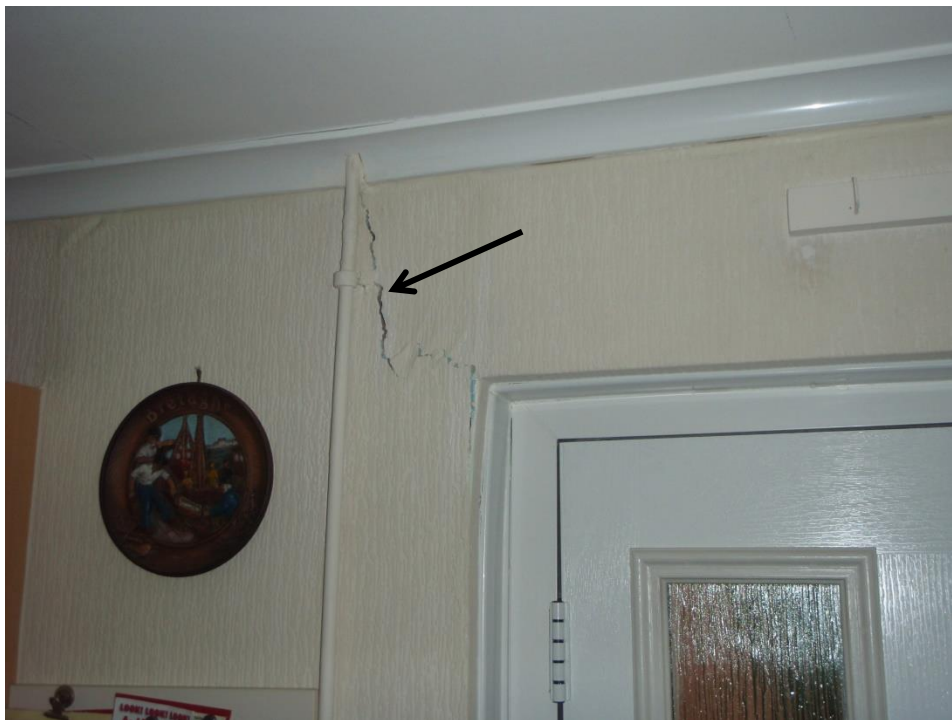
- 2.2 There is a 4mm wide crack in the wall to the top left of the rear door in the kitchen and a 0.4mm wide crack in the wall over the internal hatch to the lounge.

CRACKS OVER REAR KITCHEN DOOR

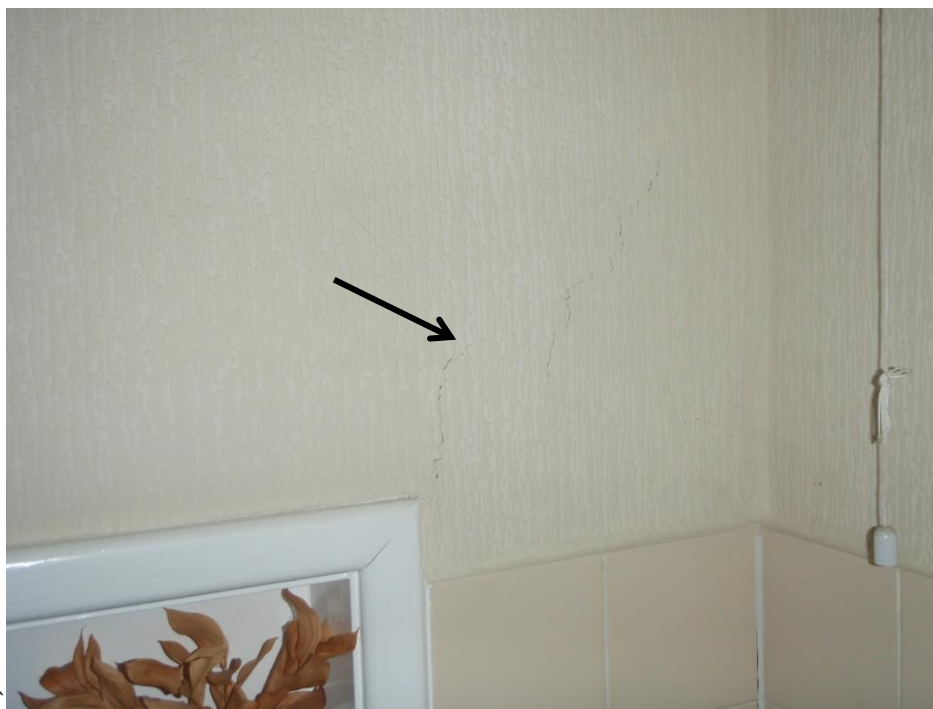
CRACKING OVER KITCHEN SERVING HATCH

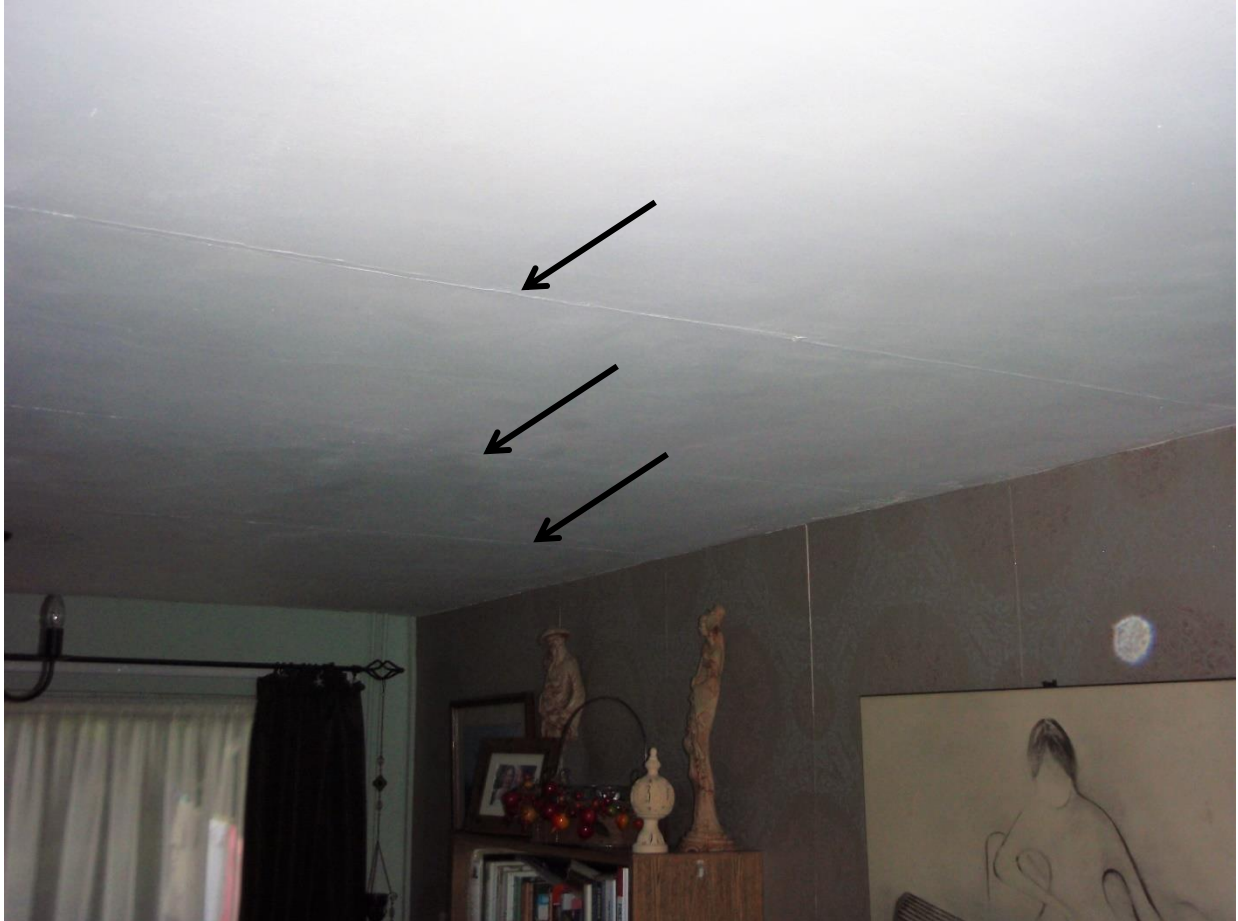
2.3 There are 3 lines of cracks across the lounge ceiling travelling southwest to northeast.

CRACKS IN LOUNGE CEILING

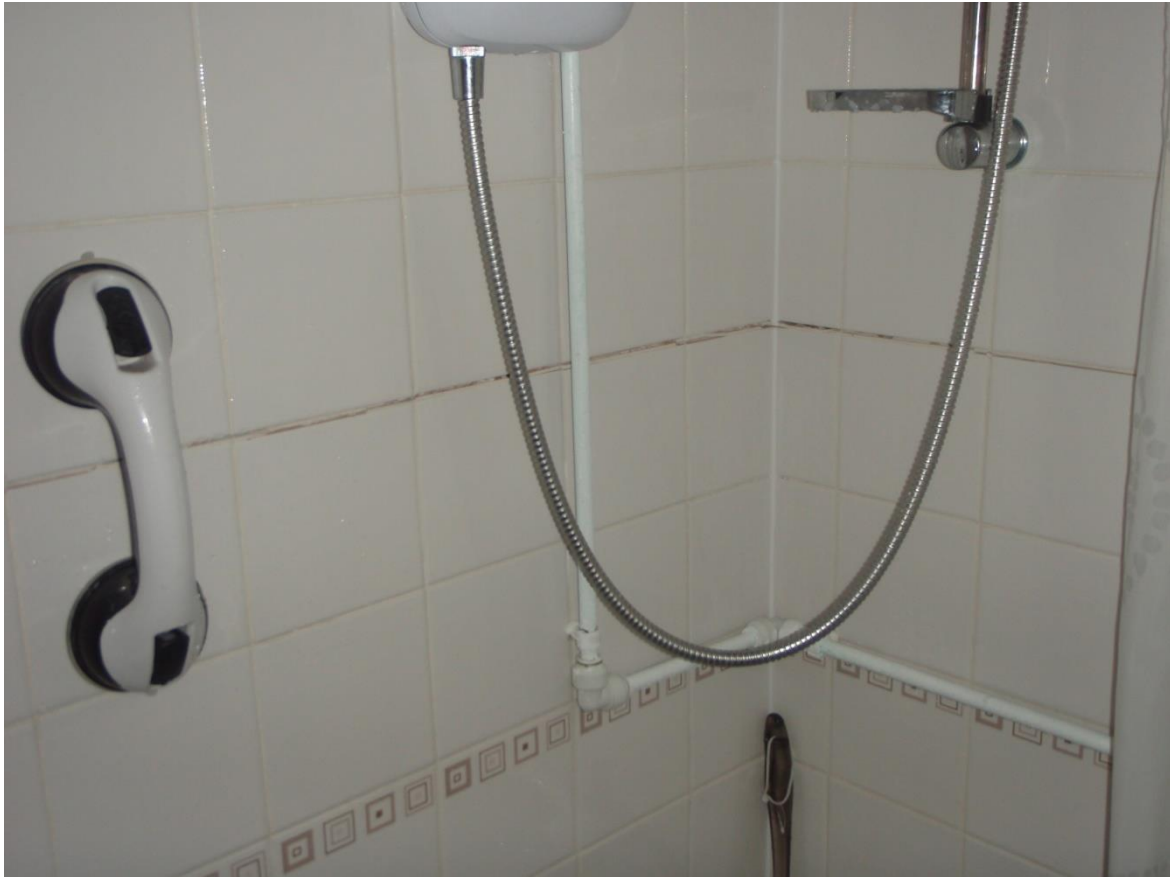
- 2.4 The external northeast wall of the bathroom has horizontal cracks measured at 2.5mm that continues into the adjacent northwest wall. There is a diagonal crack under the bathroom window, which was measured as 7mm at the window sill reducing to 2.5mm towards the bottom of the crack. There is a horizontal crack of 4mm to the wall top left of the window. The window is distorted and does not operate correctly.

HORIZONTAL CRACK IN BATHROOM WALL

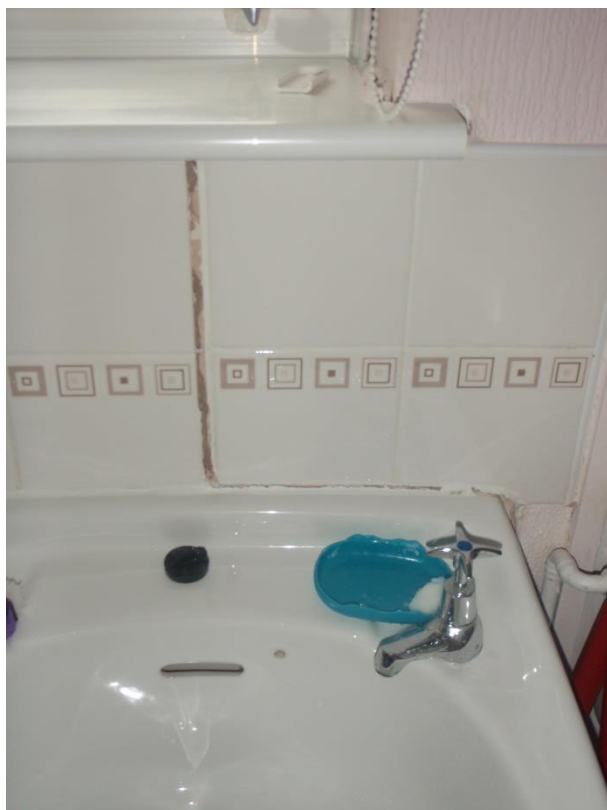
VERTICAL SECTION OF CRACK UNDER BATHROOM WINDOW

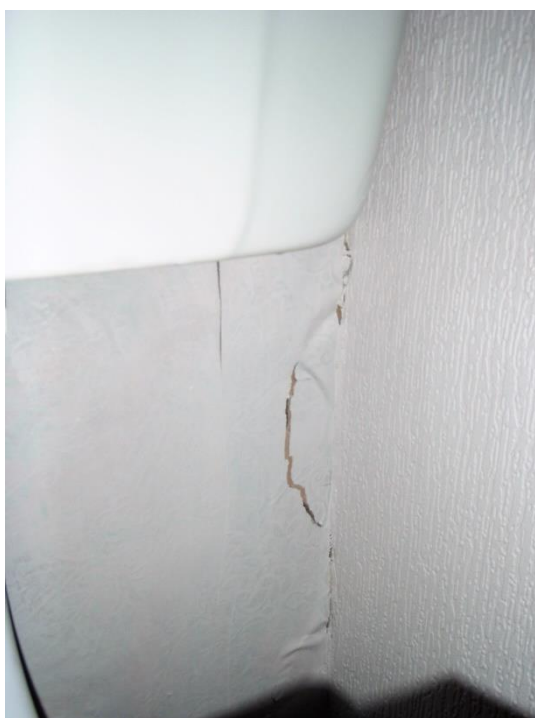
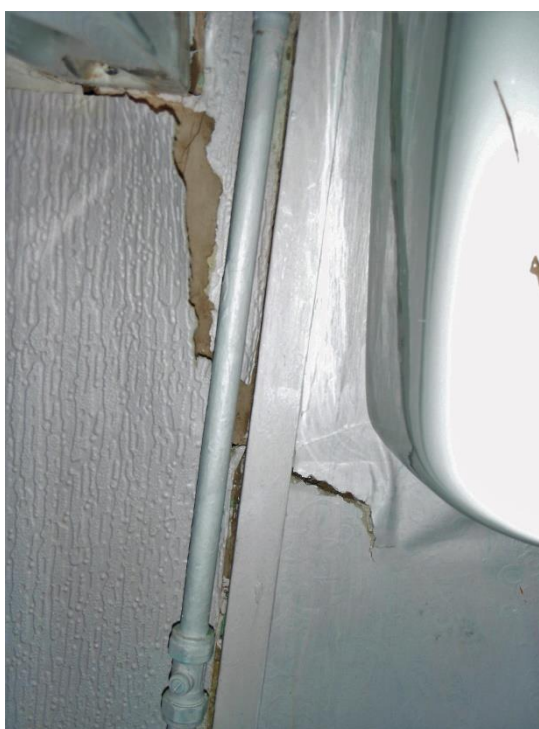
DIAGONAL CRACK BELOW BATHROOM WINDOW BEHIND WC

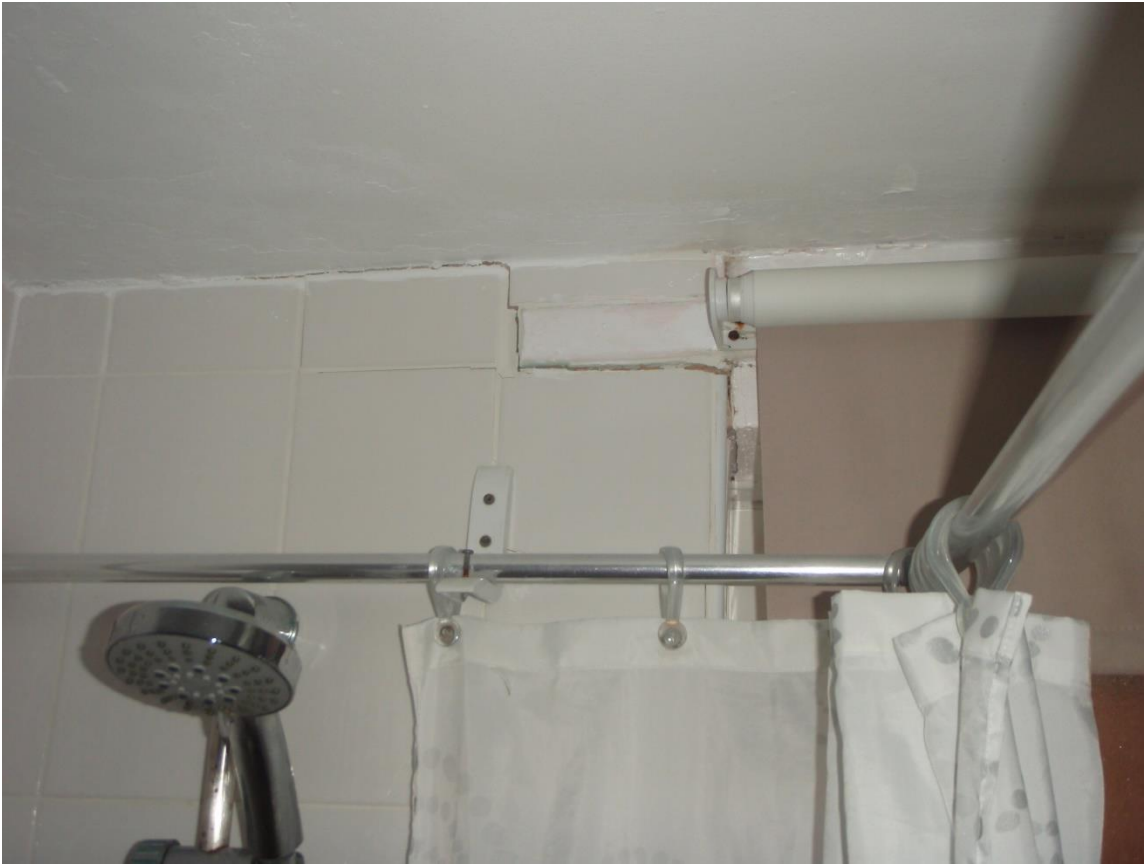
CRACK IN EXTERNAL BATHROOM WALL AT TOP OF WINDOW

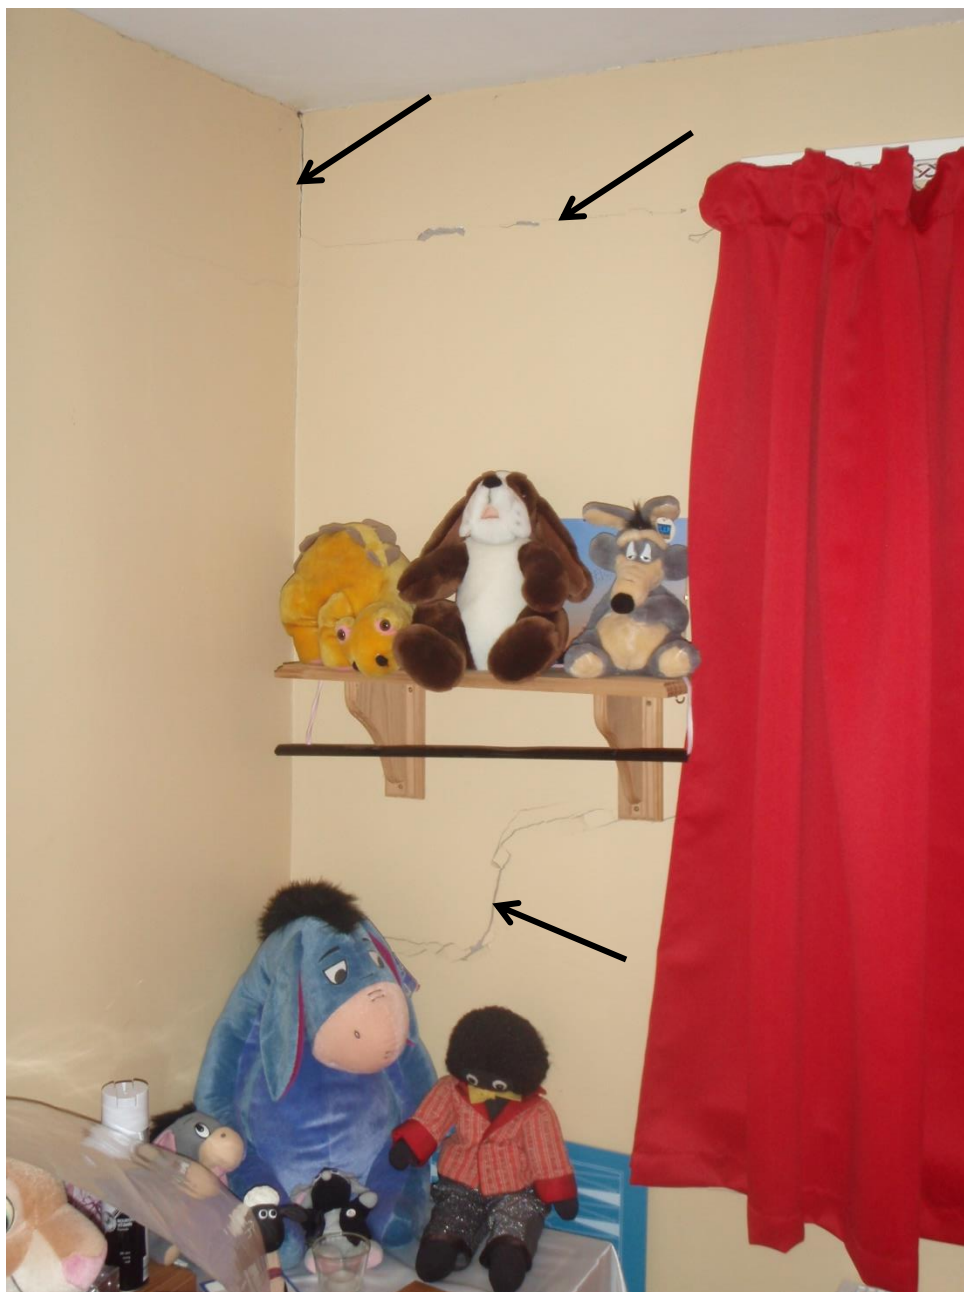
- 2.5 There are a number of vertical and horizontal cracks to the rear wall of the rear bedroom with widths ranging from 0.1mm to 3mm.

HORIZONTAL AND DIAGONAL CRACKS TO REAR WALL SMALL BEDROOM

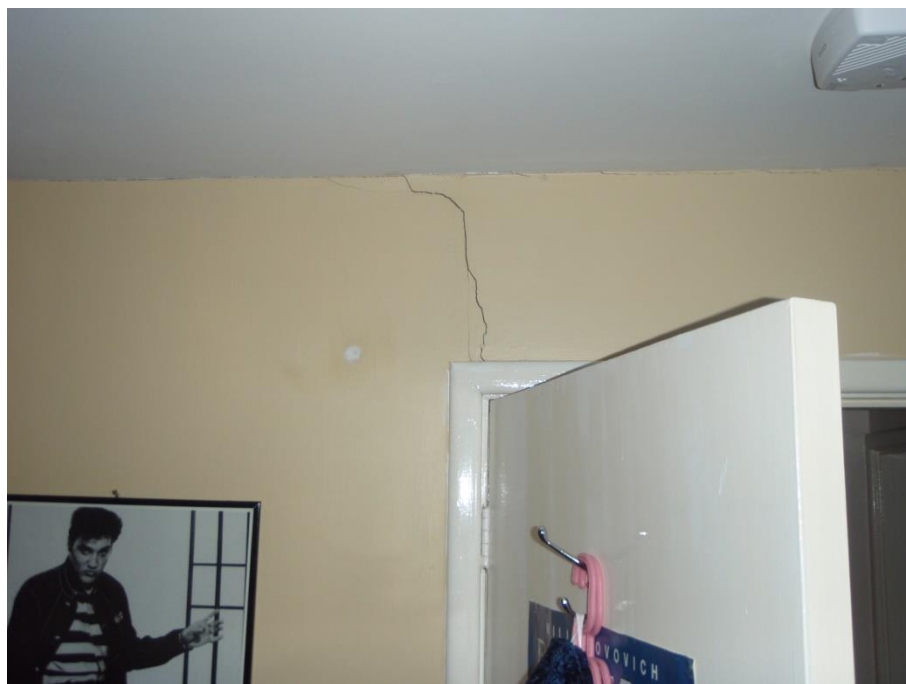
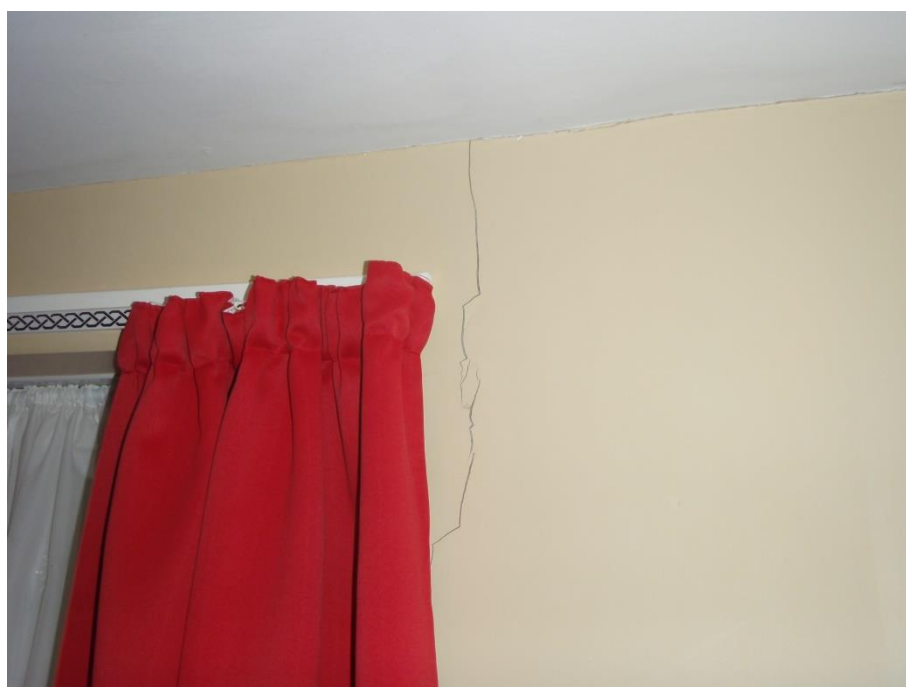
CRACKS TO REAR BEDROOM

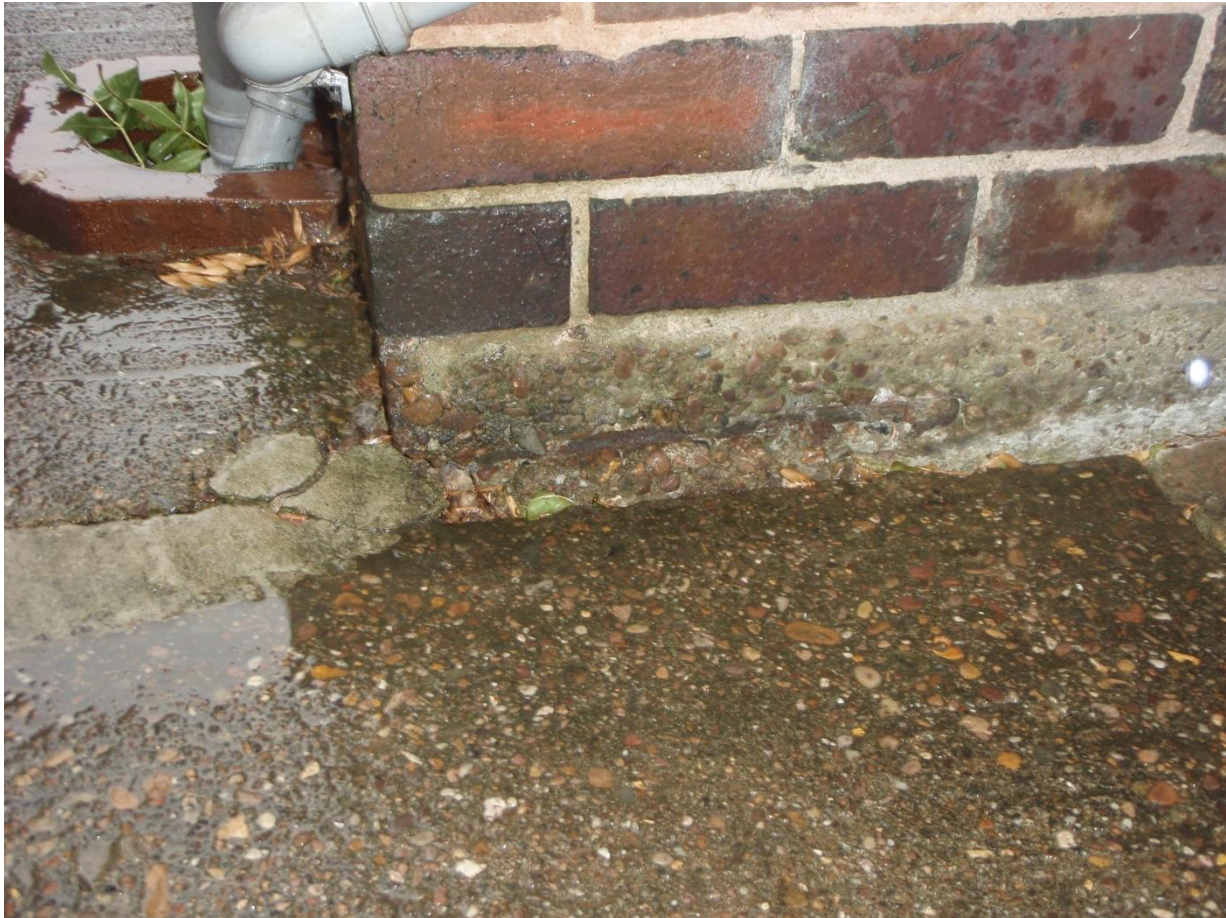
- 2.6 The building appears to be on a reinforced concrete raft foundation, the top of which was visible at ground level, although trial pits would be required to confirm this. This is likely to be due to the property being built in an area known to be affected by mining. The exposed section of raft foundation on the northeast corner is spalling and the reinforcement is exposed and corroding.

EXPOSED CORRODING REINFORCEMENT IN RAFT FOUNDATION

- 5.3 The spalling concrete and exposed reinforcement to the raft foundation should be repaired in accordance with the attached concrete repair specification.

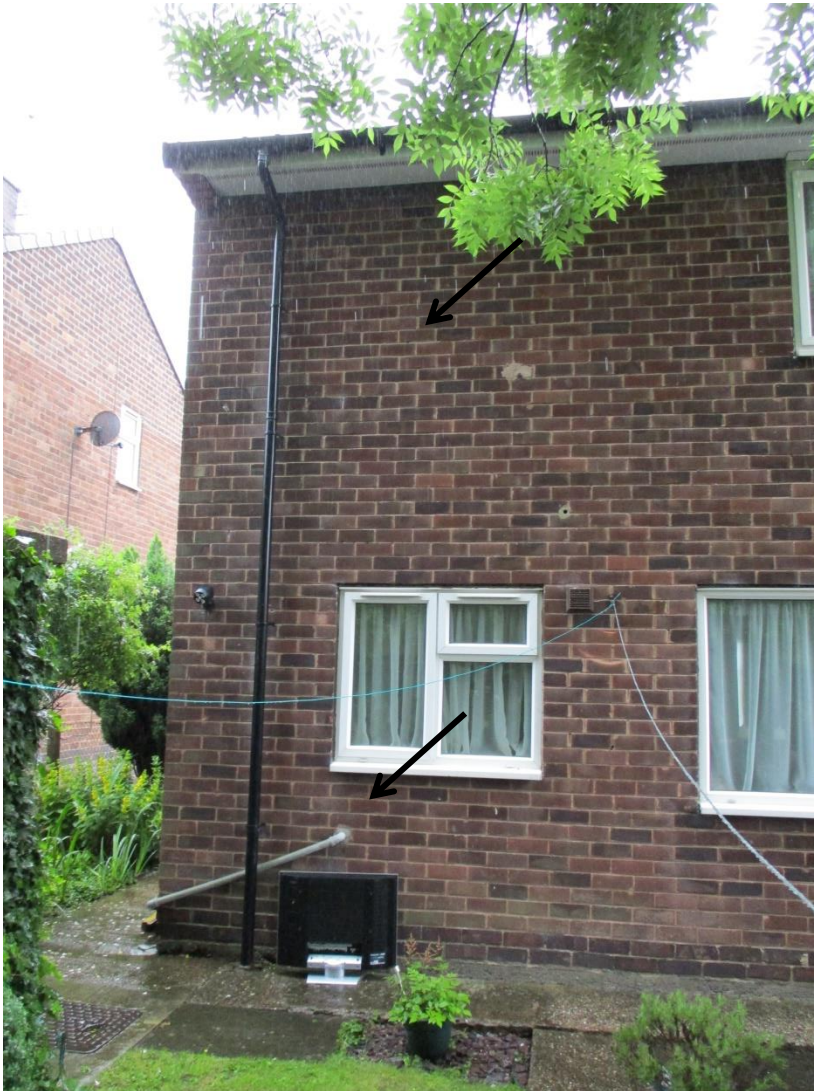
- 2.7 The rear elevation has diagonal cracking above and below the kitchen window. This was measured at 0.85mm below the window and estimated to be 1.0mm above the window. Cracks were travelling from top left to bottom right. However a second visit on 25/06/19 the cracks had closed up.

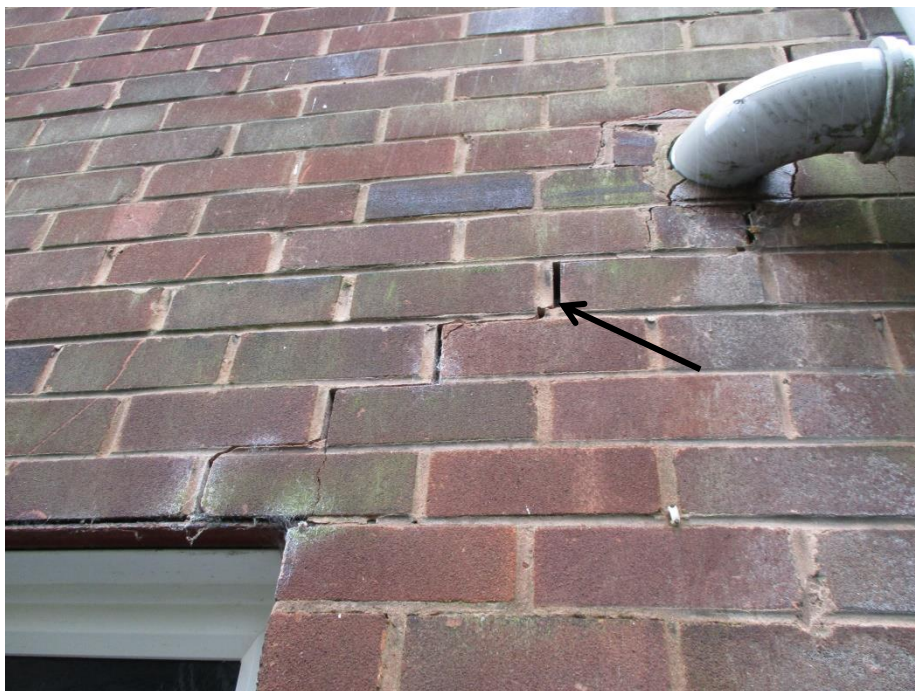
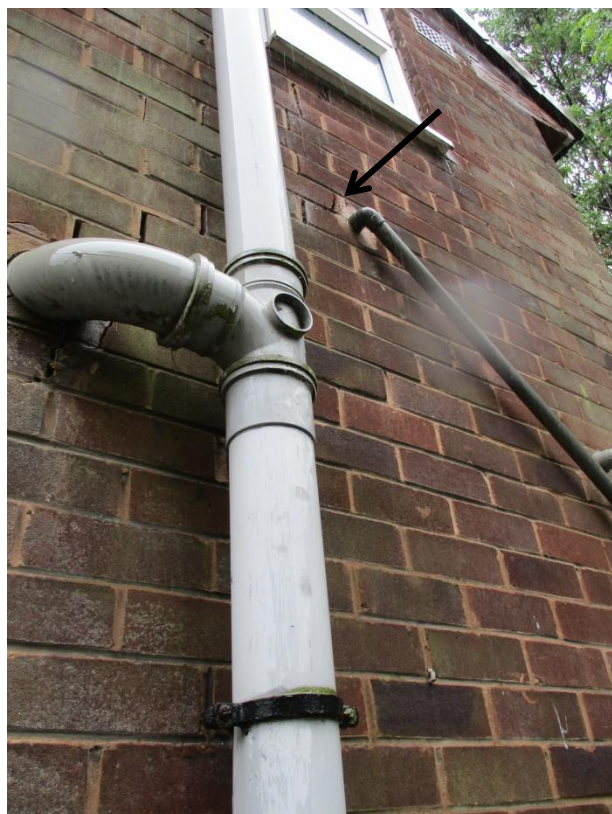
- 2.8 On the end northeast wall there is a diagonal crack corresponding to the crack in the bathroom travelling from the kitchen door to the bathroom window. This crack was estimated to be 5mm wide suggesting that the northeast corner of the property is settling.

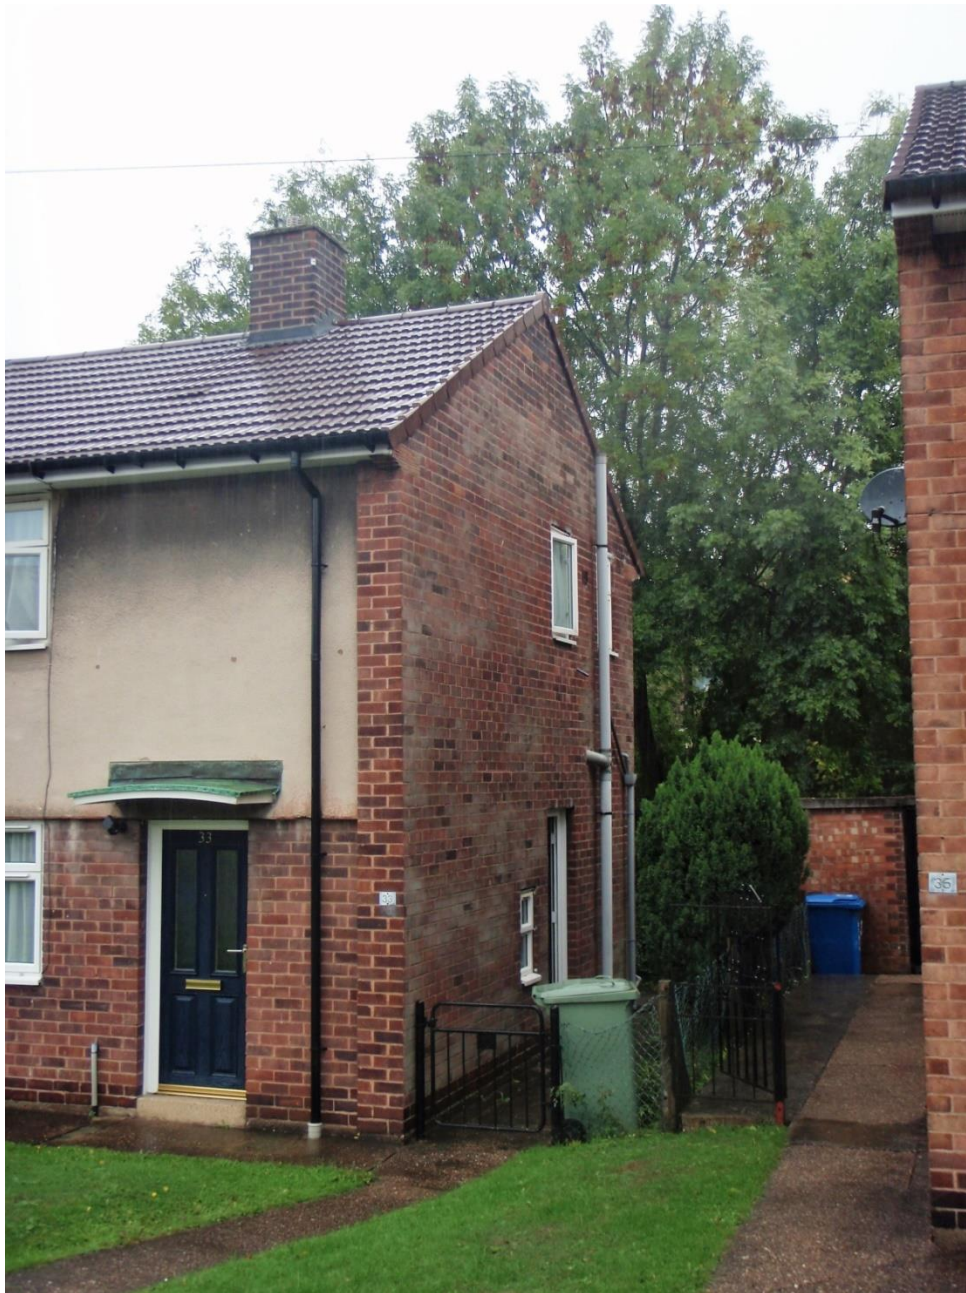
- 2.8 There are trees to the rear of the property, approximately 10m from the house, and a small conifer hedge between this property and the adjacent No.35. Analysis of the anticipated effects of the Ash and Sycamore trees are provided in appendix B. Height of the tree was estimated at 10m and the ground conditions assumed to be of 'Medium' shrinkability. Soils testing would be required to confirm the assumptions made in the analysis.

TREES CLOSE TO REAR OF PROPERTY

- 4.3 The building is within the influencing distance of two trees in the back garden. Root action on the underlying clays is a potential cause of settlement. Tree roots were found in the trial pit undertaken on the rear corner.

- 5.1 It is understood that CBC have re-lined the leaking shallow surface water drainage that is within their area of responsibility.
- 5.2 It is recommended that the rear Ash and Sycamore trees are reduced in height to a maximum 5.0m and a tree management plan is instigated to keep them at this height. Alternatively, if there is no TPO on the trees, it is recommended that they are removed.

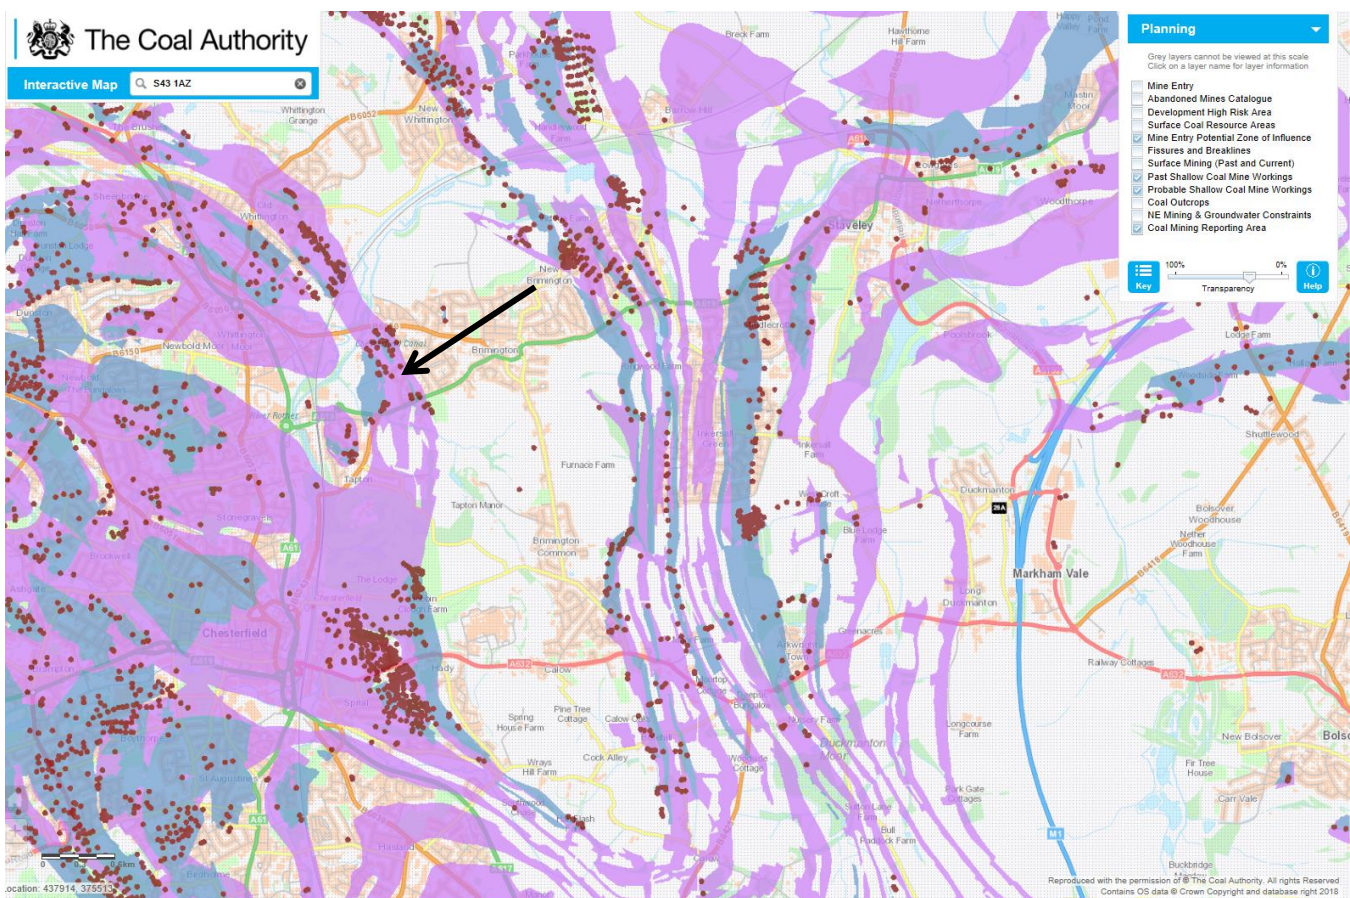
- 3.1 The site lies over Sandstones of the Lower Coal Measures from the Carboniferous Period. There are a number of coal seams conjectured as outcropping both east and west of the property, dipping under the site. Below the site there are four coal seams at shallow depth, the Cockleshell, Low Tupton, Threequarters and Silkstone coal seams. The estimated depth of the Coal seams is conjectured on the Geological Map, but could be from the surface. The Coal Authority interactive map indicates the site as lying within an area that has probable coal workings below it, although it is not clear which seams may have been worked under this site. Shallow workings are a potential cause of the observed movement. There are several known shafts within the vicinity of the site as well as several adits.

COAL MAP FOR SITE INDICATING POSSIBLE WORKINGS (Magenta)

- 5.8 If following the underpinning movement continues, then the coal mining situation will have to be investigated further. Underpinning will be required regardless of any further works due to the depth of Made Ground found on the site.

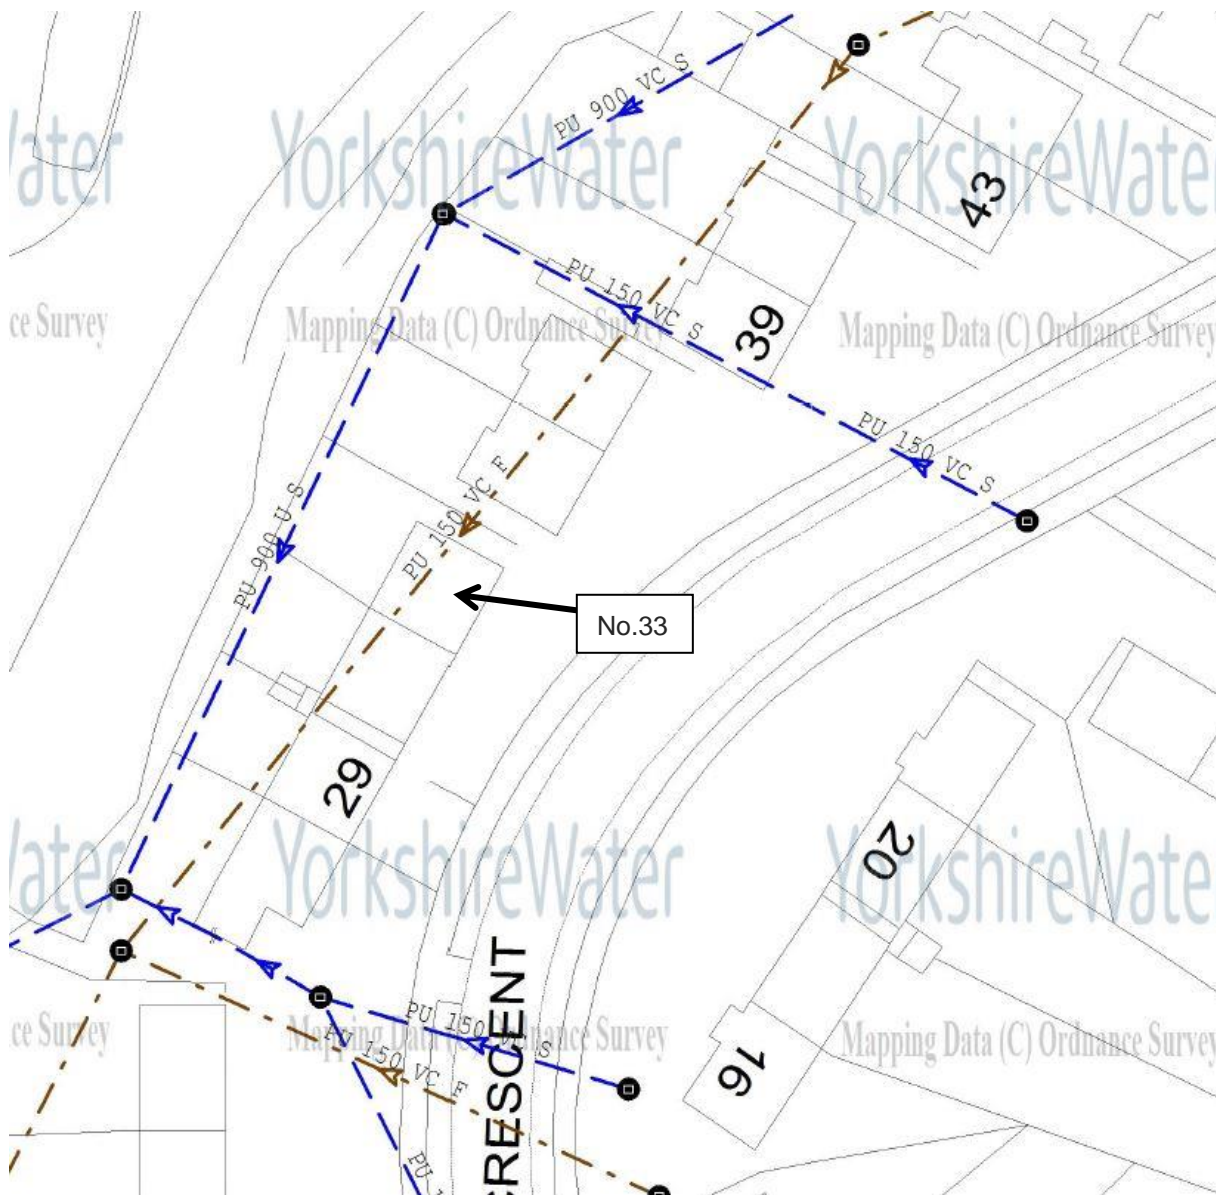
- 3.2 Analysis of the required foundation depth to offset the effects of trees indicates a depth of 0.45m would be required for a raft foundation. It is anticipated that the foundations are at or are very close to surface level. Therefore, the foundations would be considered to be within influencing distance of the trees, which is calculated at 17.25m.
- 3.3 Underground services have been considered. Plans from Yorkshire Water indicate that the property lies over the route of a foul drain that coincides with the corner of the property that is exhibiting signs of settlement. It is therefore considered likely that the property has been constructed over the line of the trench to this service.

ORIGINAL ROUTE OF DRAIN SHOWN RUNNING UNDER PROPERTY

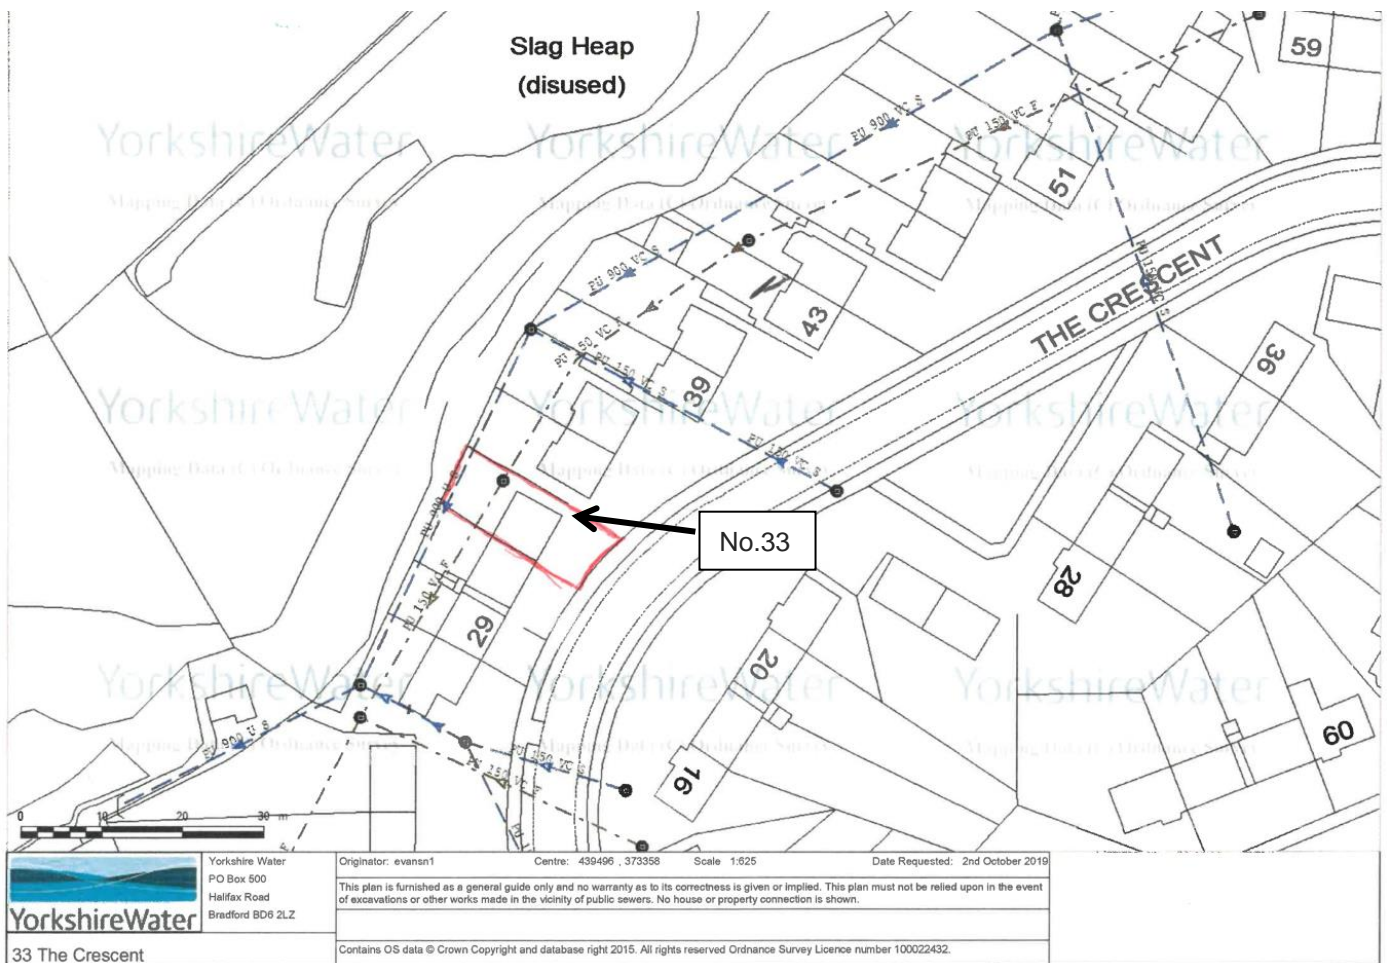
REVISED ROUTE OF DRAIN SHOWN RUNNING TO THE REAR OF PROPERTY

- 3.5 The revised line of the sewer shows that it does not run under the property, but across the rear garden.
- 3.6 The trial pit confirms that the ground under the foundation, at least in the corner of the building is settling, has been constructed on clay fill and there is evidence that roots from the adjacent tree have reached the foundations.

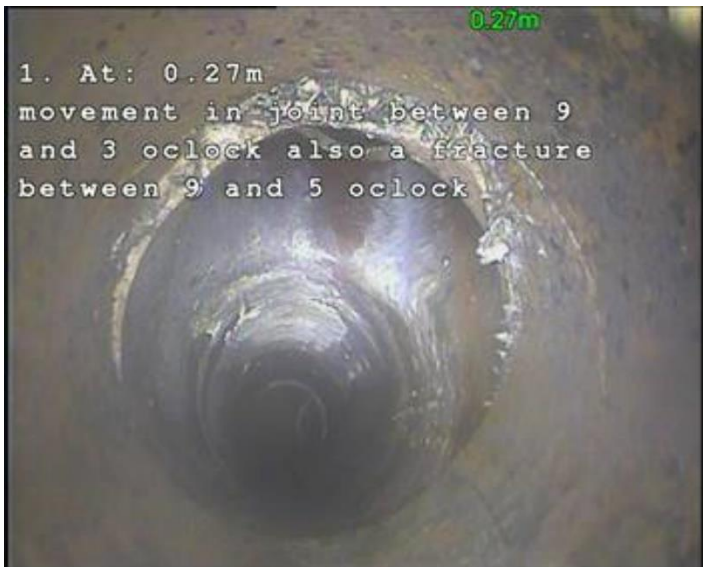
0. 0.27m Displaced joint between 9 and 3 o'clock also a fracture between 9 and 5 o'clock

RECOMMENDATION: Several displaced joints and fractures – CBC to dig up and replace defective pipework as soon as possible.

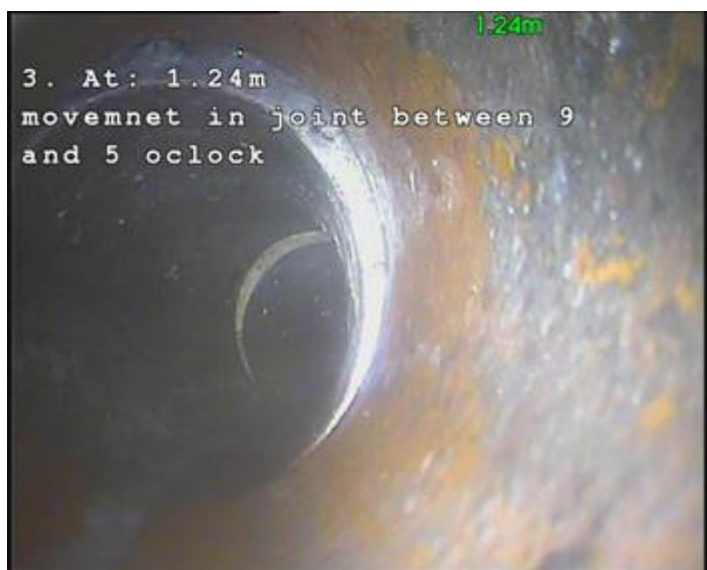
3. 1.24m Displaced joint between 9 and 5 o'clock

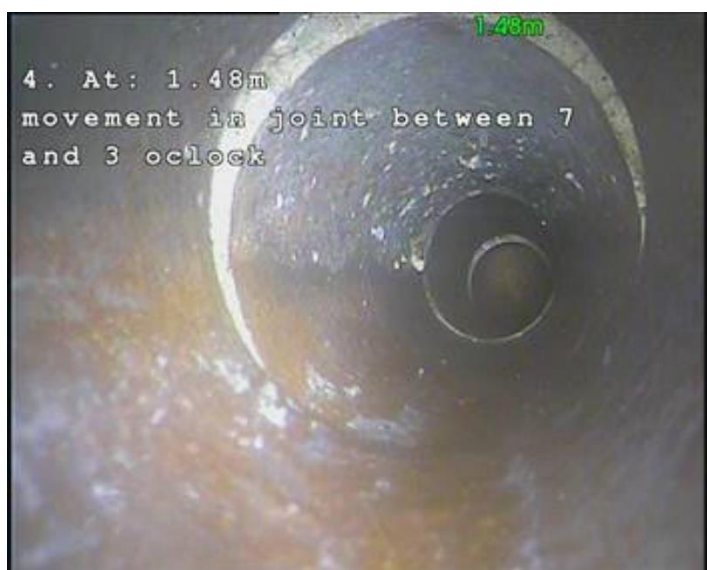
4. 1.48m Displaced joint between 7 and 3 o'clock

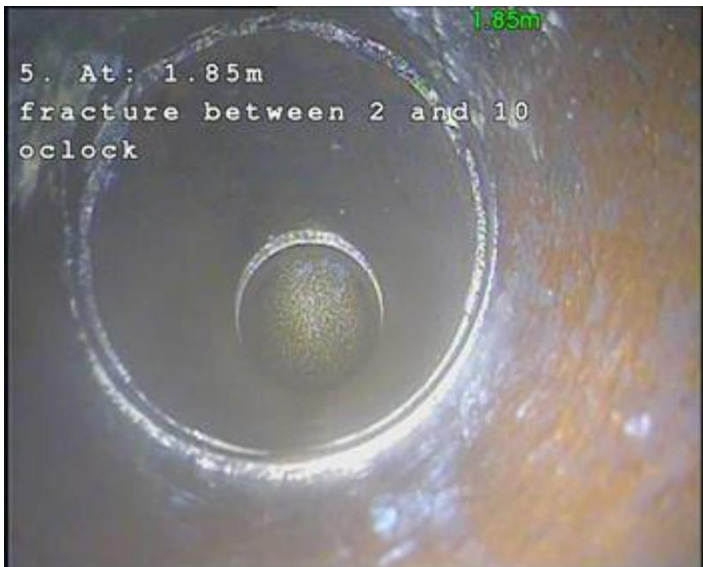
5. 1.85m Fracture between 2 and 10 o'clock

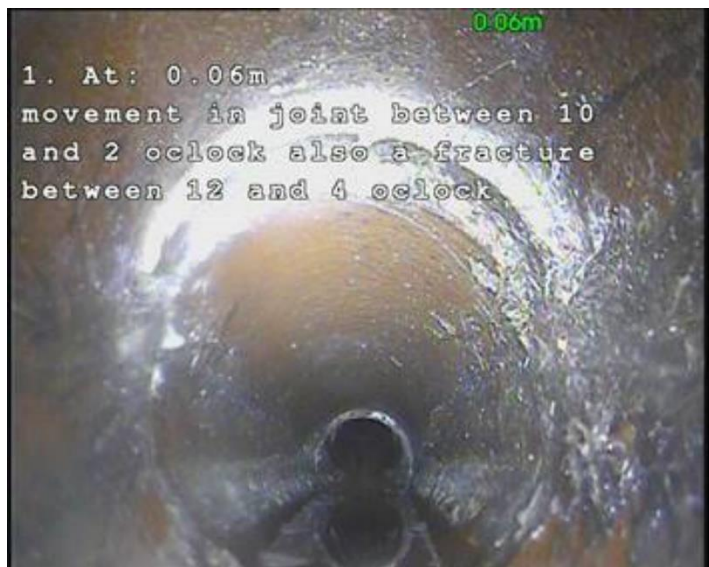
0. 0.06m Displaced joint between 10 and 2 o'clock,
also a fracture between 12 and 4 o'clock

RECOMMENDATION: Several Fractures and displaced joints and holding 50% water – would recommend dig up or reline the defective pipework
C. Lowe to pass to Yorkshire Water for their information and action

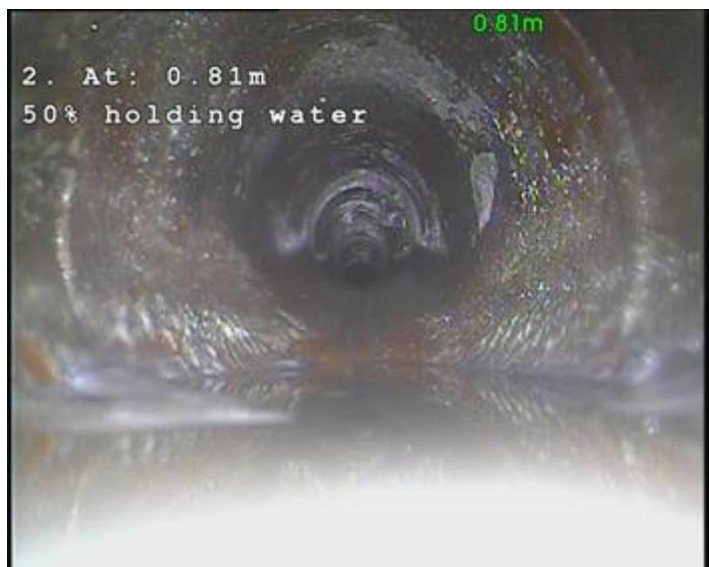
2. 0.81m 50% Holding Water

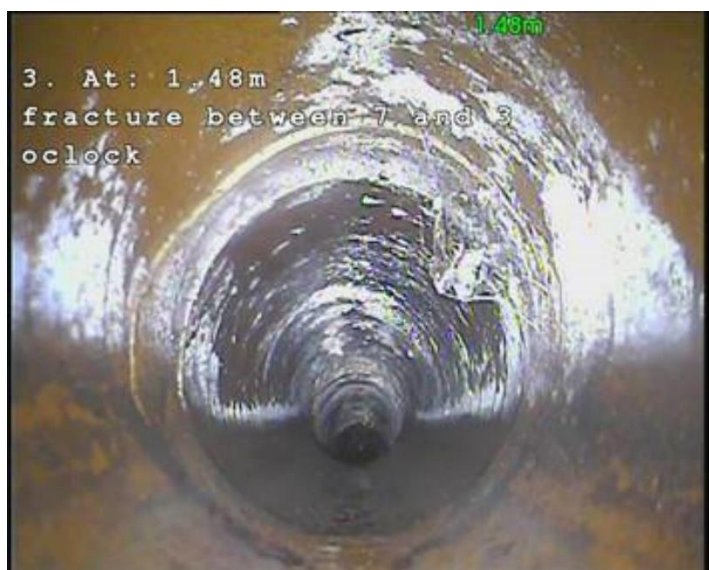
3. 1.48m Fracture between 7 and 3 o'clock

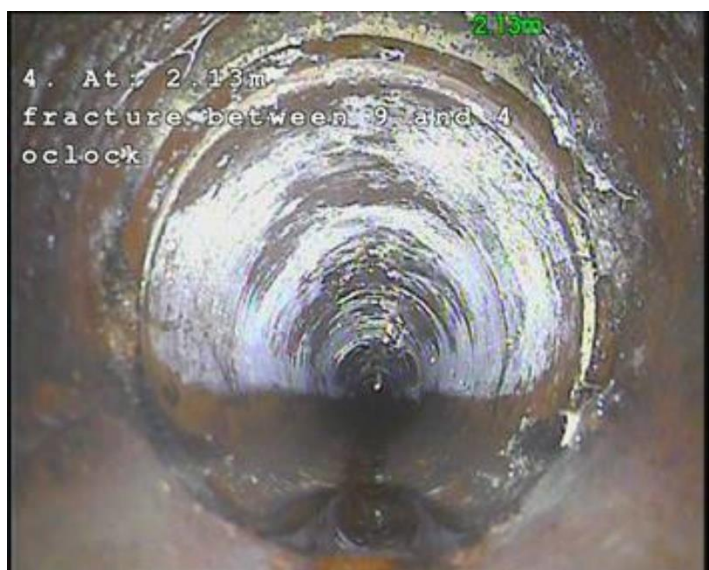
4. 2.13m Fracture between 9 and 4 o'clock

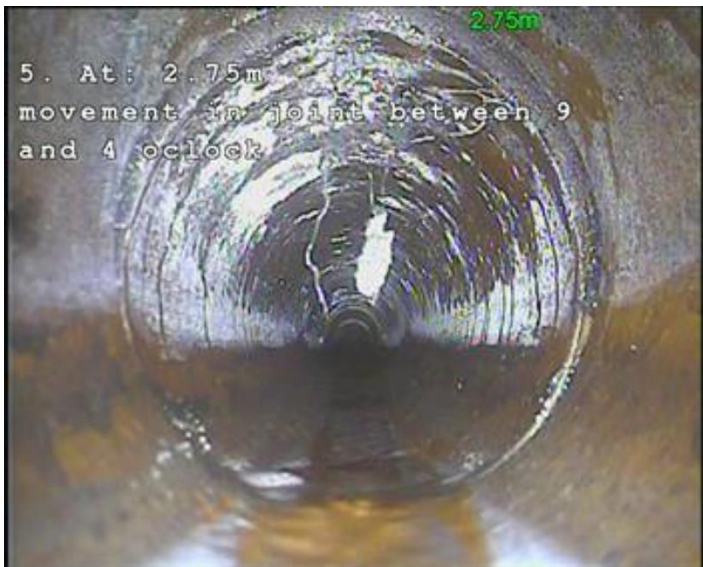
5. 2.75m Displaced joint between 9 and 4 o'clock
