33 The Crescent, Brimington, S43 1AZ

Elemental Structural Report

CHESTERFIELD
BOROUGH COUNCIL

Contract Title	33 The Crescent, Brimington, Chesterfield
Report Title	Elemental Structural Report on Cracking
Revision	Rev.C
Status	Revised
Control Date	05 th October 2018

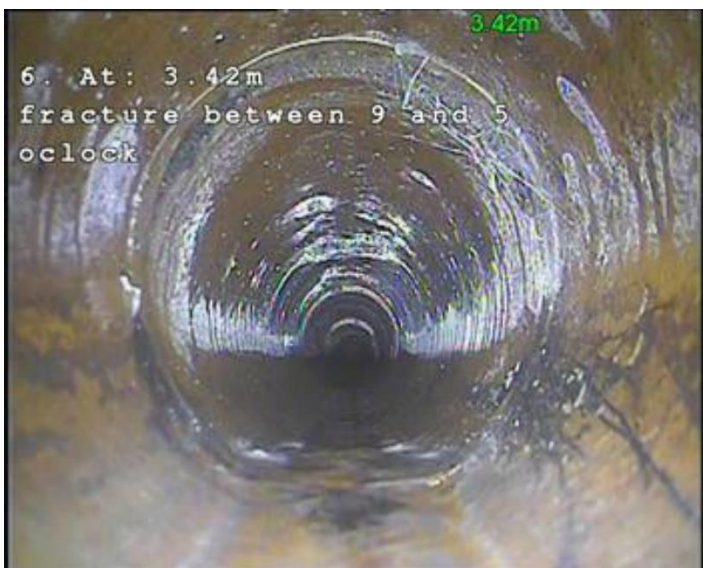
6. 3.42m Fracture between 9 and 5 o'clock

RECOMMENDATION: Several Fractures and displaced joints and holding 50% water – would recommend dig up or reline the defective pipework
C. Lowe to pass to Yorkshire Water for their information and action

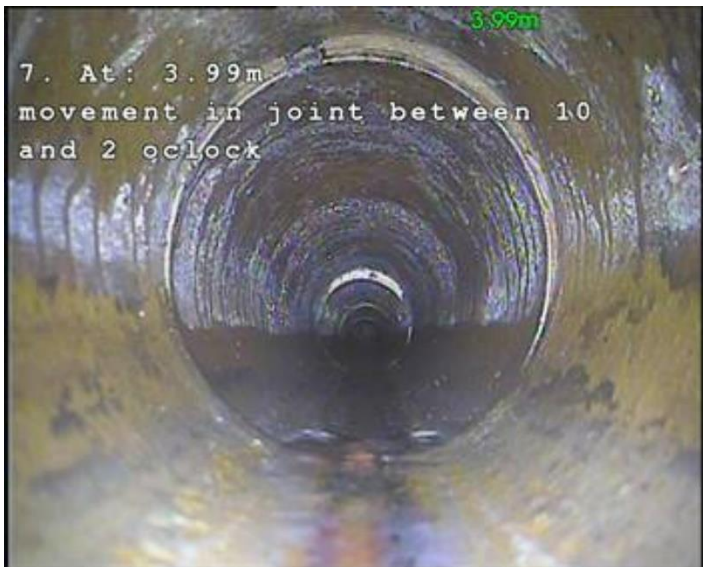
o. 3.99m Displaced joint between 10 and 2 o'clock

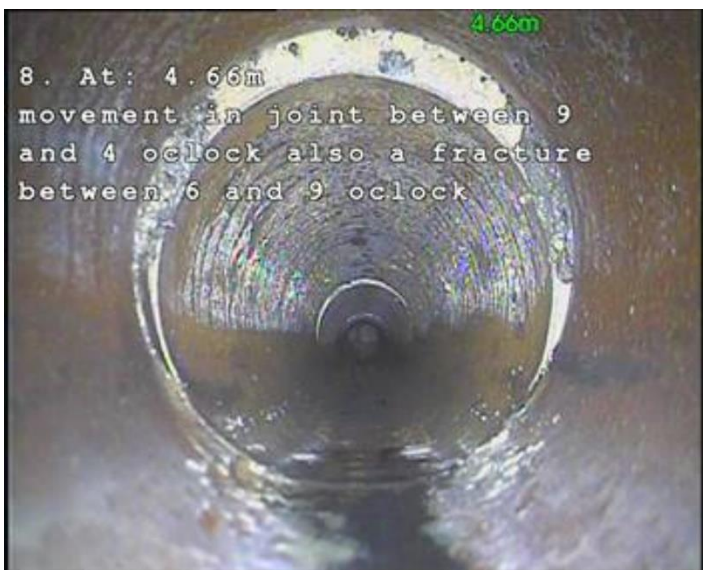
o. 4.66m Displaced joint between 9 and 4 o'clock also a fracture between 6 and 9 o'clock

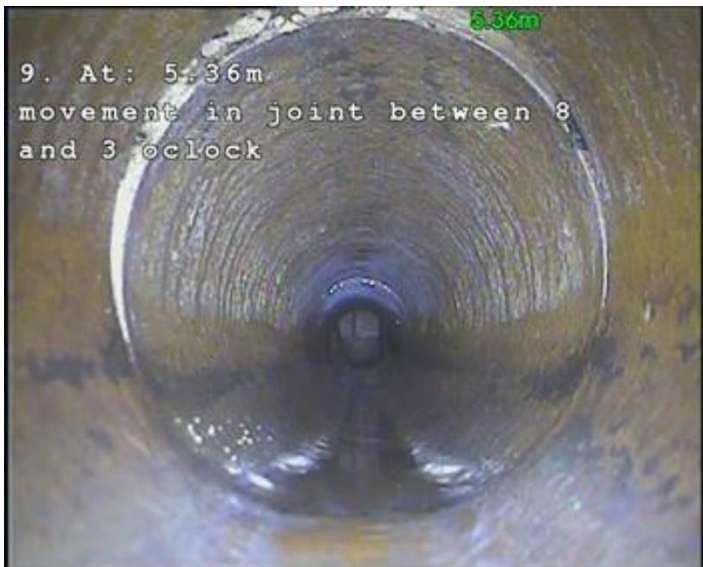
9. 5.36m Displaced joint between 8 and 3 o'clock

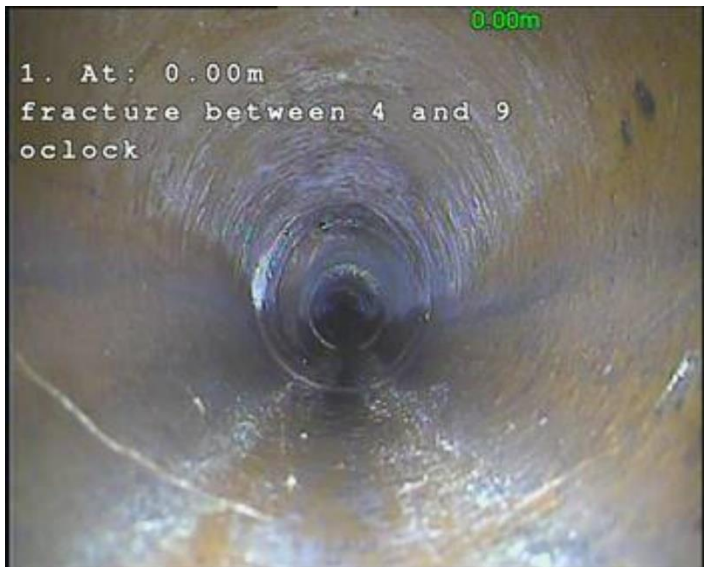
0. 0.00m Fracture between 4 and 9 o'clock

RECOMMENDATION – Several fractures and displaced joints – C. Lowe to pass to YW for their information and action

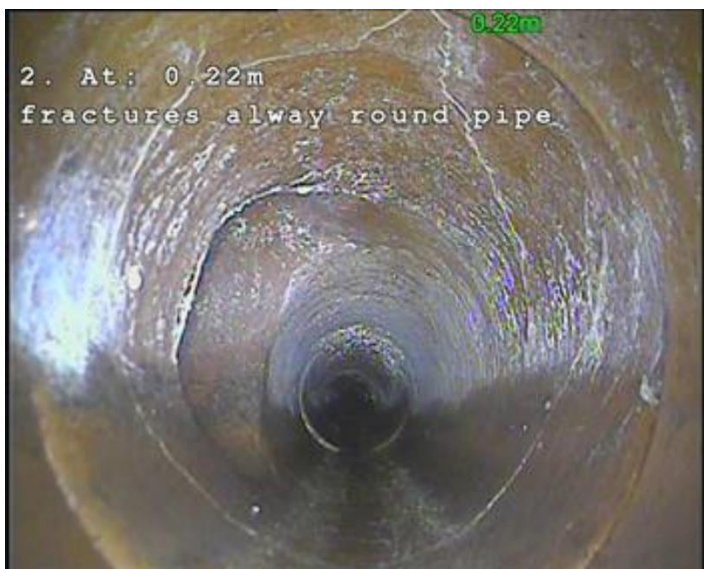
2. 0.22m Circumferential fractures

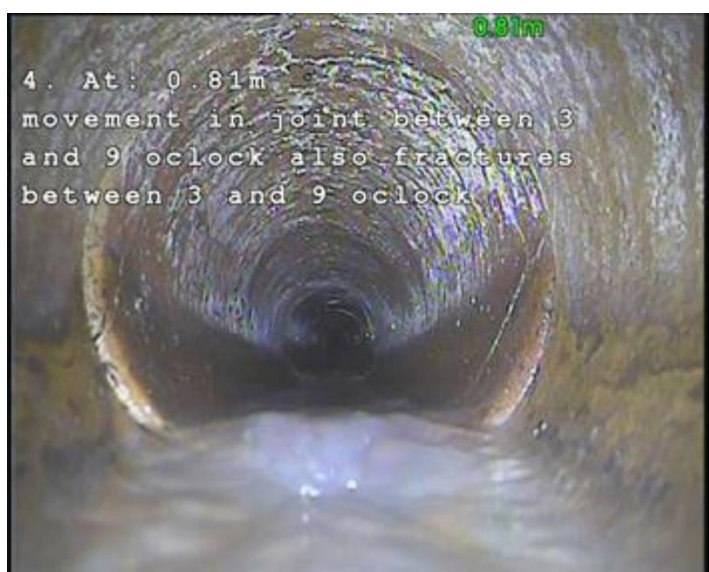
4. 0.81m Displaced joint between 3 and 9 o'clock also fractures between 3 and 9 o'clock

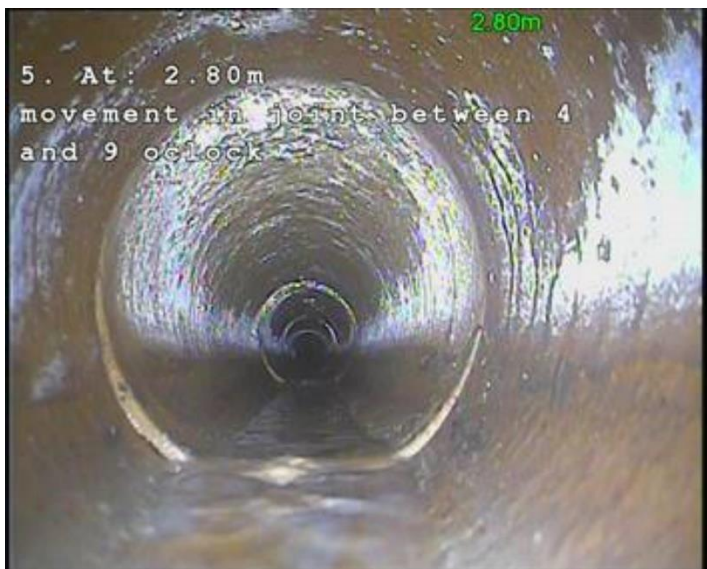
5. 2.80m Displaced joint between 4 and 9 o'clock

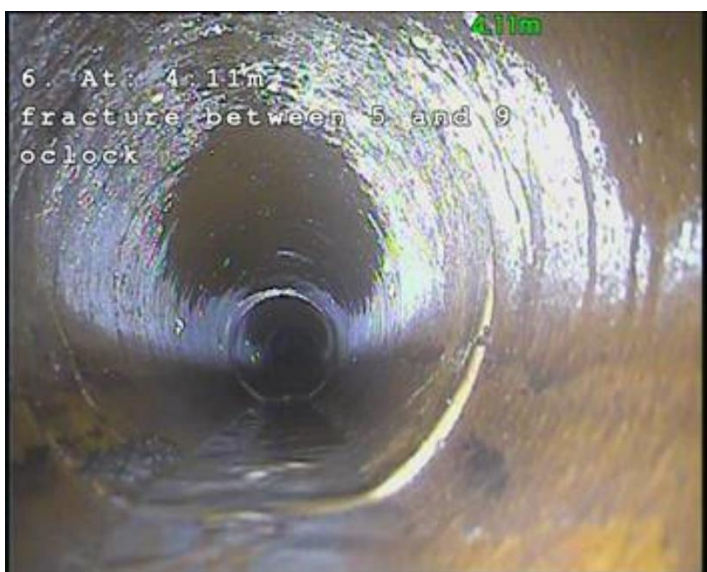
6. 4.11m Fracture between 5 and 9 o'clock

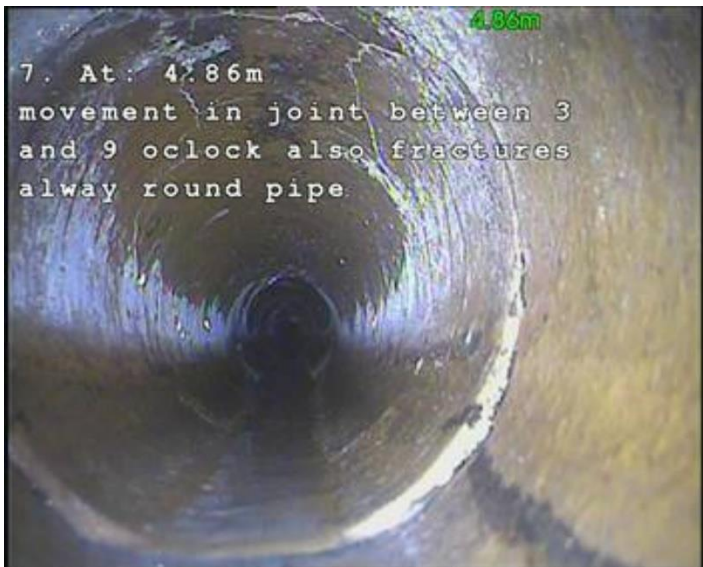
- o. 4.86m Displaced joint between 3 and 9 o'clock also circumferential fractures

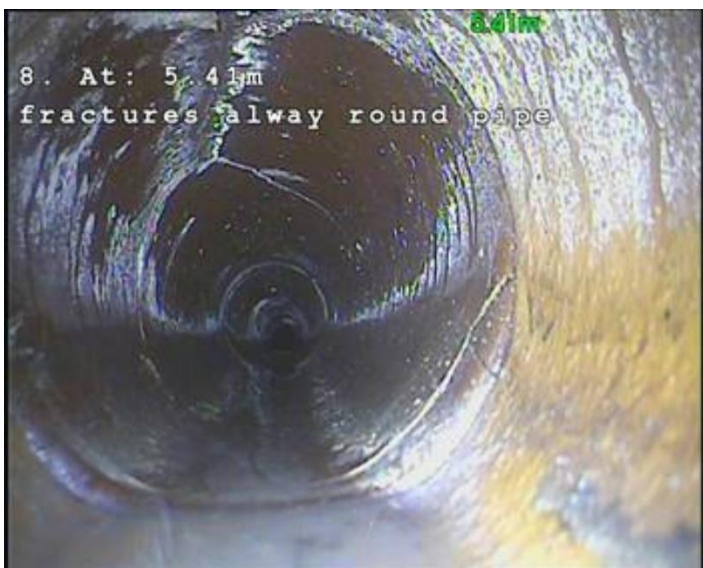
- o. 5.41m Circumferential fractures
