2013 Air Quality Progress Report for Chesterfield Borough Council

In fulfillment of Part IV of the
Environment Act 1995
Local Air Quality Management

August, 2013

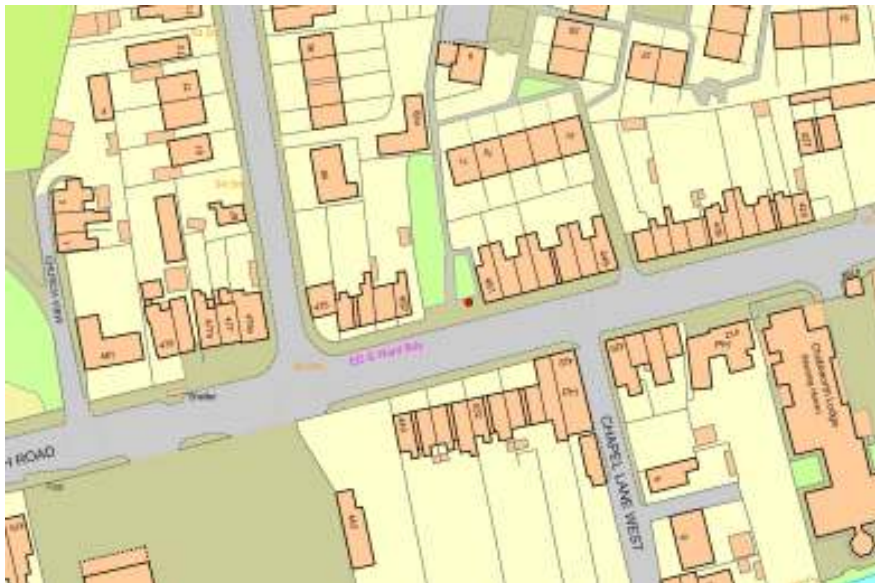
Figure 2.1 Location of Chatsworth Road Automatic Monitoring Site

Note: For data handling and data download purposes, this site is referred to as Chesterfield Roadside, by both Bureau Veritas and DEFRA

This site, formerly classified as a Roadside site, has been reclassified as an Urban Traffic site. This site is indicative of public exposure for dwellings in urban locations.

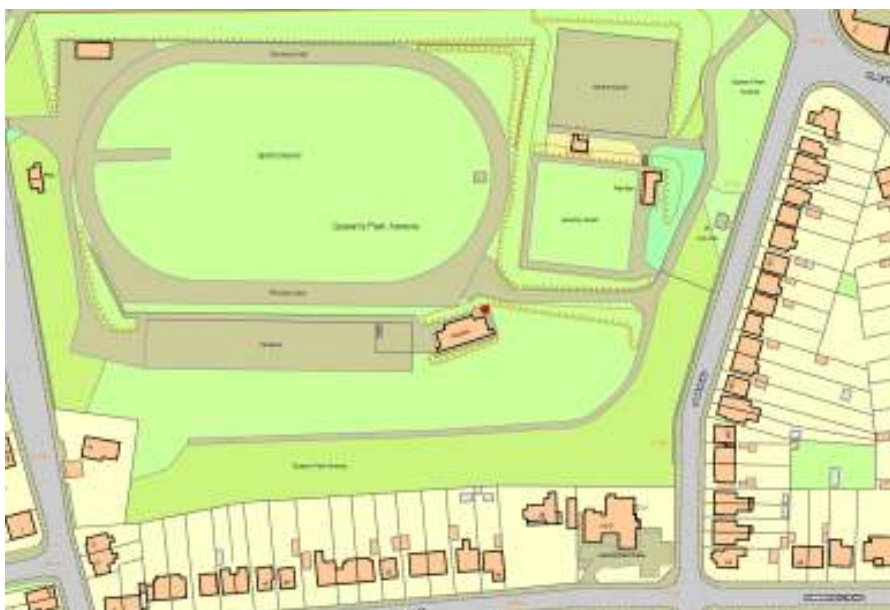
Figure 2.2: Location of Queens Park Annex Automatic Monitoring Site

Note: For data handling and data download purposes, this site is referred to as Chesterfield, by both Bureau Veritas and DEFRA.

This site is classified as an Urban Background site, and is indicative of the diffusion tubes in locations set away from main roads (Note: Please see the section 2.1.2 below and Appendix B regarding the relocation of some tubes to facilitate the ongoing Detailed Assessments).

There is a firm plan to develop the immediate vicinity of the Queens Park Annex site, to provide a new sports centre replacing the existing facility on an adjacent site. The result of this is that the monitoring location will cease to be used, due to the impact of development leading to the site no longer being able to be classified as an Urban Background site. The long term use of this equipment is in question. The unit will either be relocated (ideally, continuing to provide data to AURN at an alternative Urban Background location) or may be decommissioned. Work is currently being carried out to identify possible sites for the unit to be moved into.

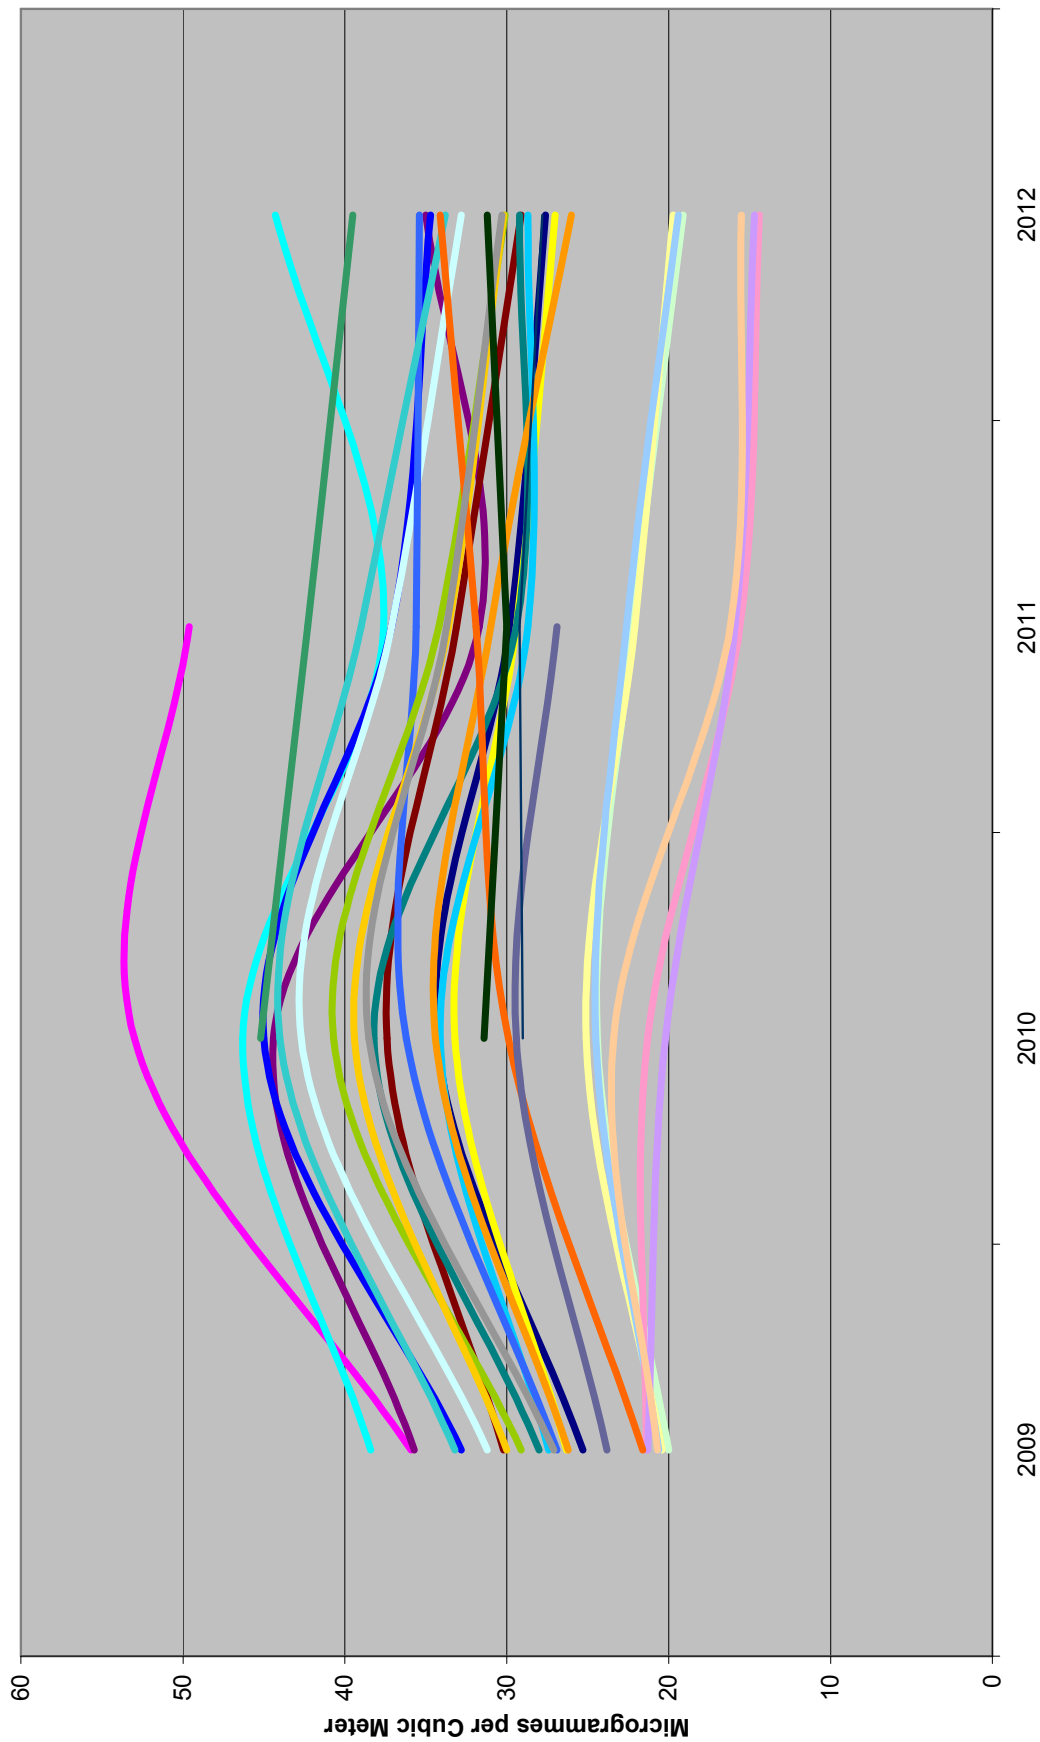
Figure 2.3 Trends in Annual Mean Nitrogen Dioxide Concentrations Measured at Diffusion Tube Monitoring Sites

Table 2.5 and Figure 2.3 (overleaf and following) shows longer term trend data, based upon the monitoring locations which have been unchanged over the past four years. The gradual reduction in overall levels of nitrogen dioxide from the peak in 2010 is continuing.

Tube 2 (Markham Road in the following table), and the elevated pink line in the associated figure) has been removed. This location reflected a historical exposure. A small row of terraced housing abutted a very busy road skirting the town centre. The houses became vacant, and have now been demolished. The site (a lamp-post) remained in use as it gathered trend data, but was ultimately removed by the local highways authority.

Tube 32 (Hasland By-pass) is showing a gradual increase in nitrogen dioxide, but is located on an isolated lamp-post at the end of a cul-de-sac. There is no adjacent housing. Once again trend data is being gathered.

Tube 6 (Church Street, Brimington) shows a fluctuation around the Air Quality Objective. This area has been subject to a Detailed Assessment. The results of this and associated monitoring will be discussed further in this report.
