**CHESTERFIELD**  
BOROUGH COUNCIL

# 2015 Updating and Screening Assessment for Chesterfield Borough Council

In fulfillment of Part IV of the  
Environment Act 1995  
Local Air Quality Management

May, 2015

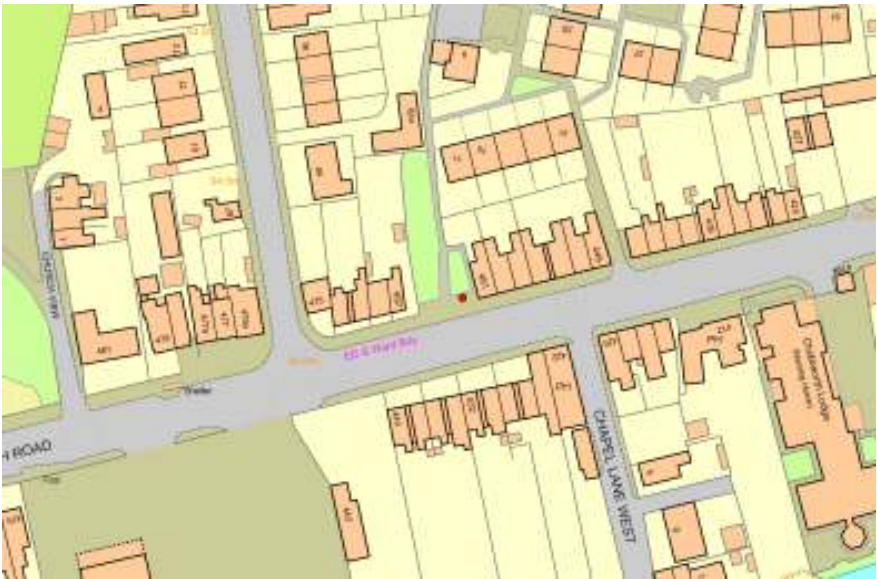
**Figure 2.1 Location of Chatsworth Road Automatic Monitoring Site**

Note: For data handling and data download purposes, this site is referred to as Chesterfield Roadside, by both BureauVeritas and DEFRA

This site, formerly classified as a Roadside site, has been reclassified as an Urban Traffic site. This site is indicative of public exposure for dwellings in urban locations.

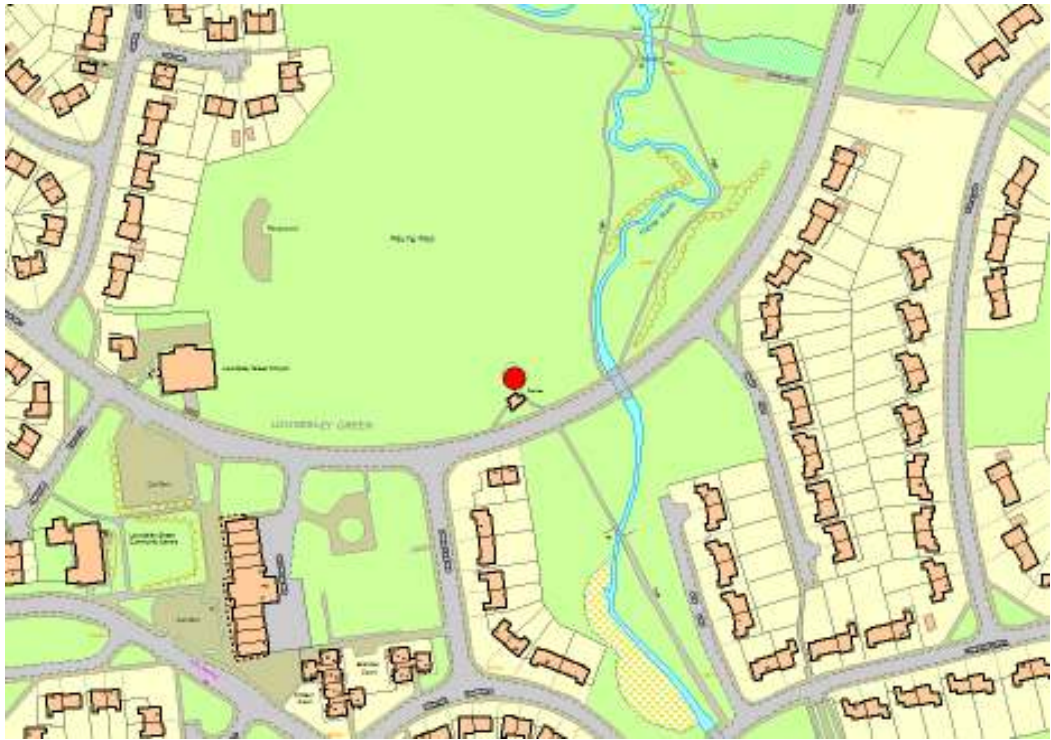
**Figure 2.2: New AURN Monitoring Location**

The AURN monitoring unit, formerly located at Queens Park has been moved, as a

result of the redevelopment of the sports field

Note: For data handling and data download purposes, this site is referred to as Chesterfield Loundsley Green, by both BureauVeritas and DEFRA.

This site is classified as an Urban Background site, and is indicative of the diffusion tubes in locations set away from main roads. The immediate surroundings are playing fields, with residential development further afield. The adjacent road is used for access within the residential area, and does not carry through traffic. Relocating and recommissioning this unit proved problematic, and as a result no data is available for this report. However, this site is now in use and will provide data for subsequent reports.

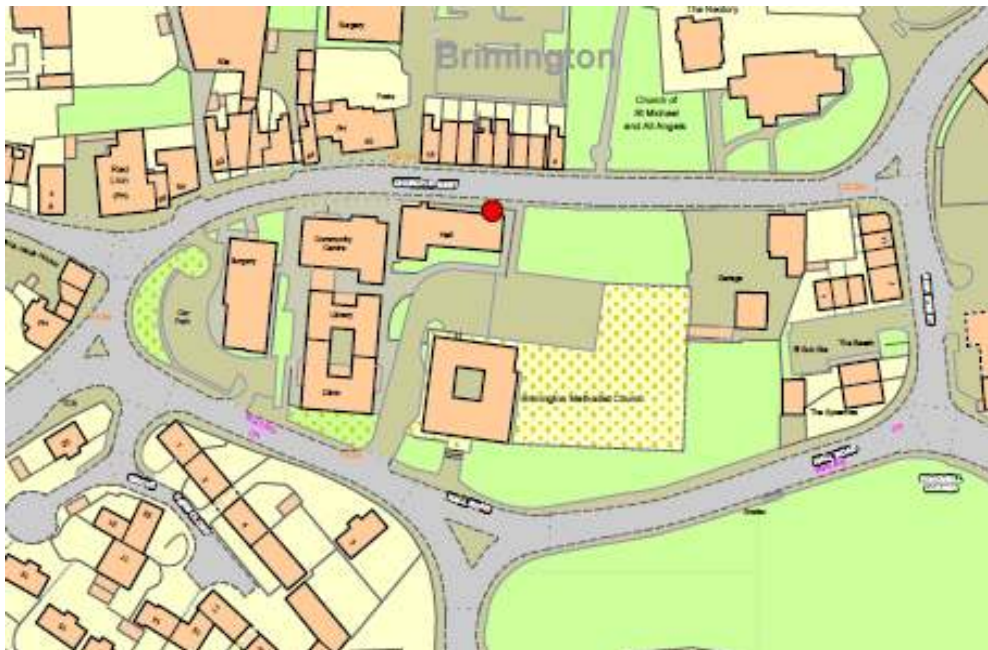
**Figure 2.3: Location of Temporary Automatic Monitoring Site**

Site Name	Site Type	OS Grid Ref		Pollutants Monitored	Monitoring Technique
Brimington Church Street	Urban Traffic	440428 E	373503 N	NOx	Chemi-luminescent

This site is operated, on contract, by TRL Ltd, who are responsible for running the site and validating the data retrieved, which is then made available to this Authority.

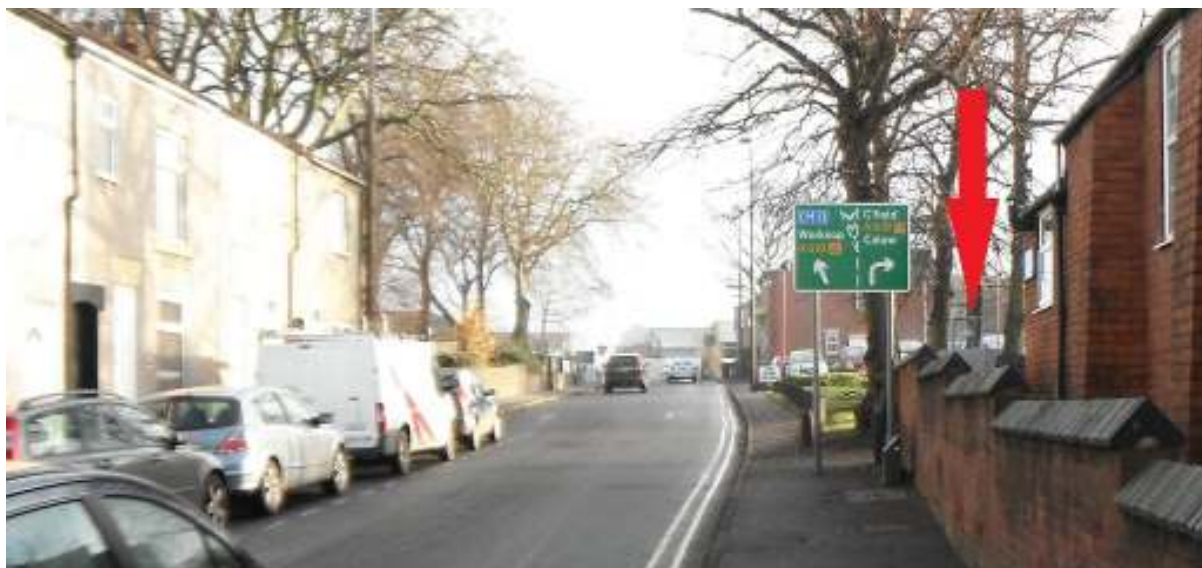
**Figure 2.4: Location of Sampling Head in Relation of the Affected Row of Terraced Housing on the Opposite Side of Church St**

The sample head (arrowed) is placed between the road sign and the window of the building façade, and projects above the adjacent wall. One of the diffusion tubes on the terrace façade is directly opposite, but is obscured by the van near the centre of the picture. Note how, due to the row of parked vehicles, the useable carriageway is displaced away from the terrace façade. The practical result of this is that the sample head is located an equivalent distance from the traffic as the diffusion tubes on the housing façade.

The co-location tubes which had been used on the Chesterfield Site (at Queens Park Annex, and due to be relocated due to impending redevelopment) are currently being used at this site.

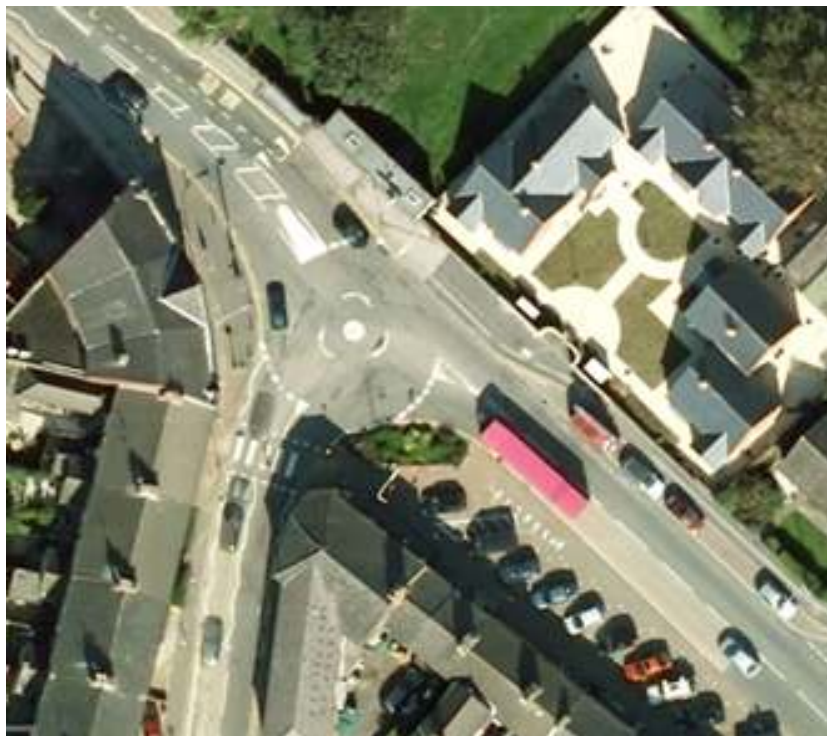
**Figure 2.5: Original Road Layout (now reinstated)**

The locations of the NO<sub>2</sub> diffusion tubes across the Borough as a whole has remained unchanged since the previous report. As mentioned the increased monitoring in Hasland has remained, reflecting the change in a road junction, and the concerns regarding increased traffic congestion. Public disquiet regarding this led to the previous mini roundabout being reinstated and the traffic lights being removed. The following figures show the changes in the affected road junction and the location of the diffusion tubes placed to assess the possible adverse impact of the changes

The green space at the top of both pictures is Eastwood Park. This has been the subject of investment to bring it back into general use. Concern had been raised that the previously uncontrolled junction may have given rise to an increased risk of accidents to crossing pedestrians, prompting the alterations which were carried out by the County Council (in their role as the local highways authority). The new monitoring locations are spaced along the main road and on the junction road which makes up the leg of the “T” junction, with an additional tube on a further adjacent road junction, due to the proximity of houses at that location, and the locations are shown in Figure 2.7, overleaf. There are no plans, at present, to relocate any diffusion tubes across the borough.

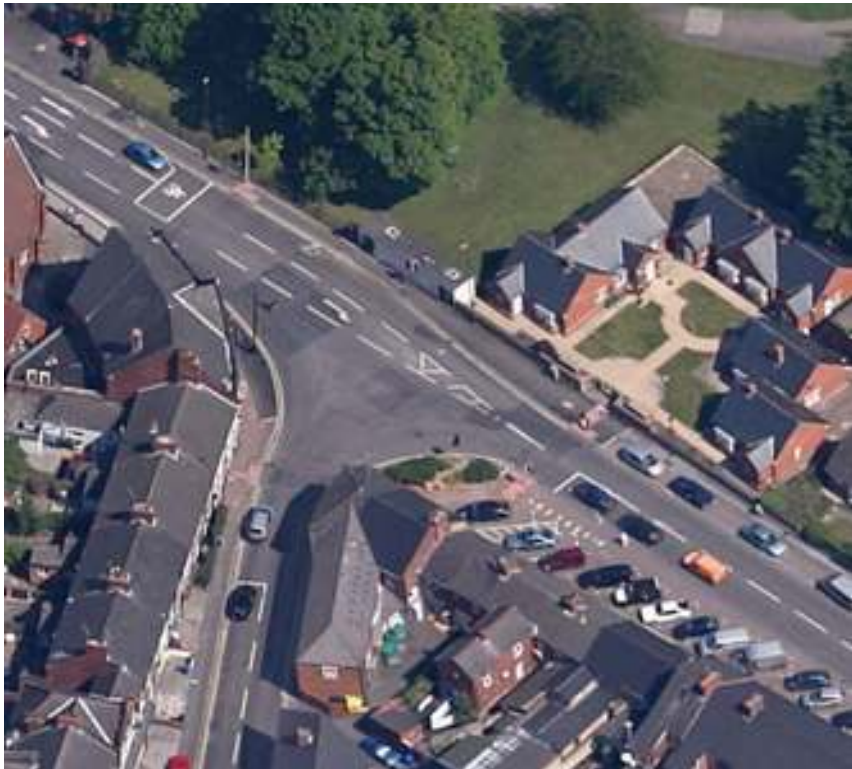
**Figure 2.6: Revised Road Layout (now removed)**

This was replaced by a traffic light controlled junction (shown in Figure 2.6, overleaf).

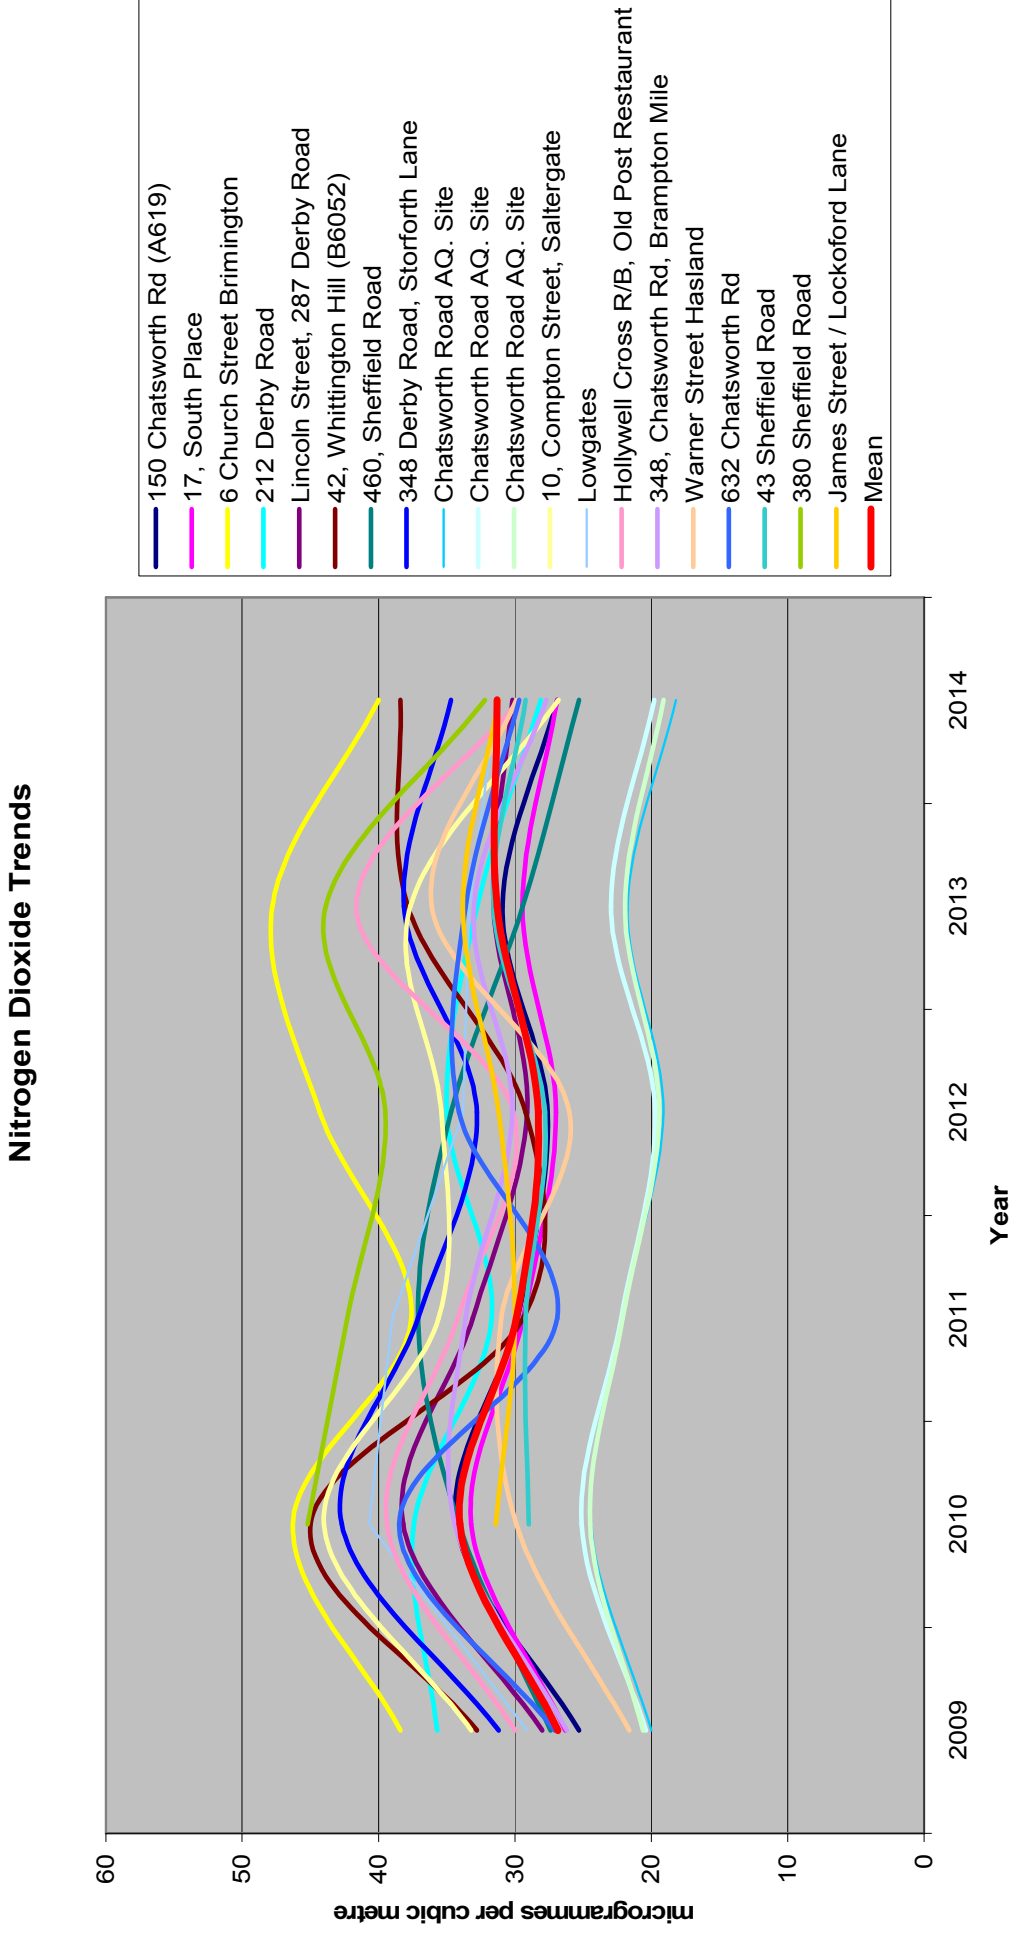
Figure 2.8: Trends in Annual Mean Nitrogen Dioxide Concentrations measured at Diffusion Tube Monitoring Sites

Figure 2.8, below, shows the trends in nitrogen dioxide concentrations between 2009 and 2014 (only showing the diffusion tubes which were continuously exposed throughout this period). The general underlying trend is a gradual fall in the levels, with a fluctuation in general levels which appear to be affected by regional influences (as they appear to have a similar effect on all tube locations) – a linear regression assessment of each of the lines of data shows either a reduction (in most data series) or a steady trend (this analysis has not been included in the figure, as it obscured the real world data)

These results are plotted below, clearly showing the trends over time. As can be seen from the full dataset (in Figure 2.8) the most recent data shows a reduction in levels. Most noticeable is the reduction at the monitoring locations on Church Street, which is affected by “stop/start” traffic flows due to a lights controlled junction. The levels on High Street show a very slight reduction in levels and this appears to reflect the fact that the traffic passing this location is free flowing.

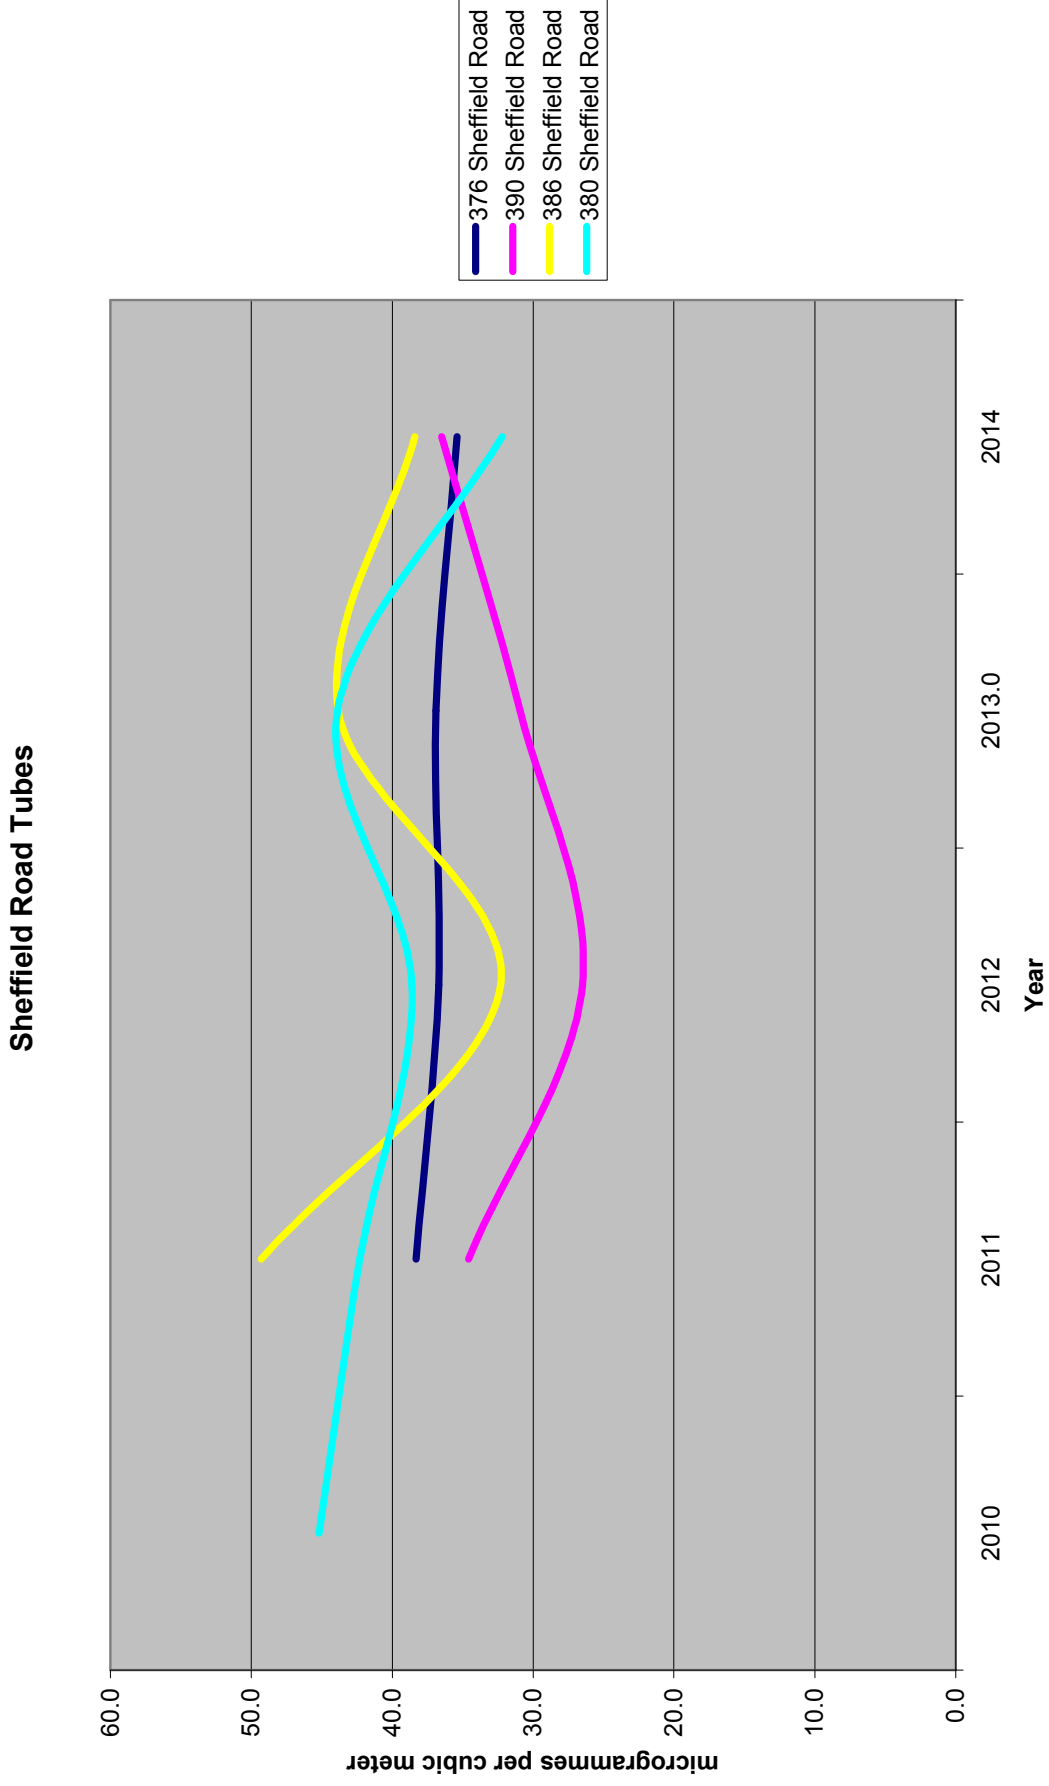
**Figure 2.9: Nitrogen Dioxide Trends at Sheffield Road**

These results are plotted below, showing trends over time

As can clearly be seen, the levels of traffic pollution have dropped below the Air Quality Objective. However, it is troubling to note that a single diffusion tube (390 Sheffield Rd) is showing a steady increase. This also appears to be counter-intuitive, as this site is the farthest away from the traffic light controlled junction and traffic should have finished accelerating away from the junction by this point. We still intend to undertake a more detailed assessment in this area, by relocating the temporary automatic monitor which has been situated at Church Street, Brimington. Work is progressing on this and we expect to be able to report preliminary results in the next annual report.
