Detailed Assessment for Chesterfield Borough Council

In fulfillment of Part IV of the Environment Act 1995
Local Air Quality Management

March, 2013

Chesterfield Borough Council - England

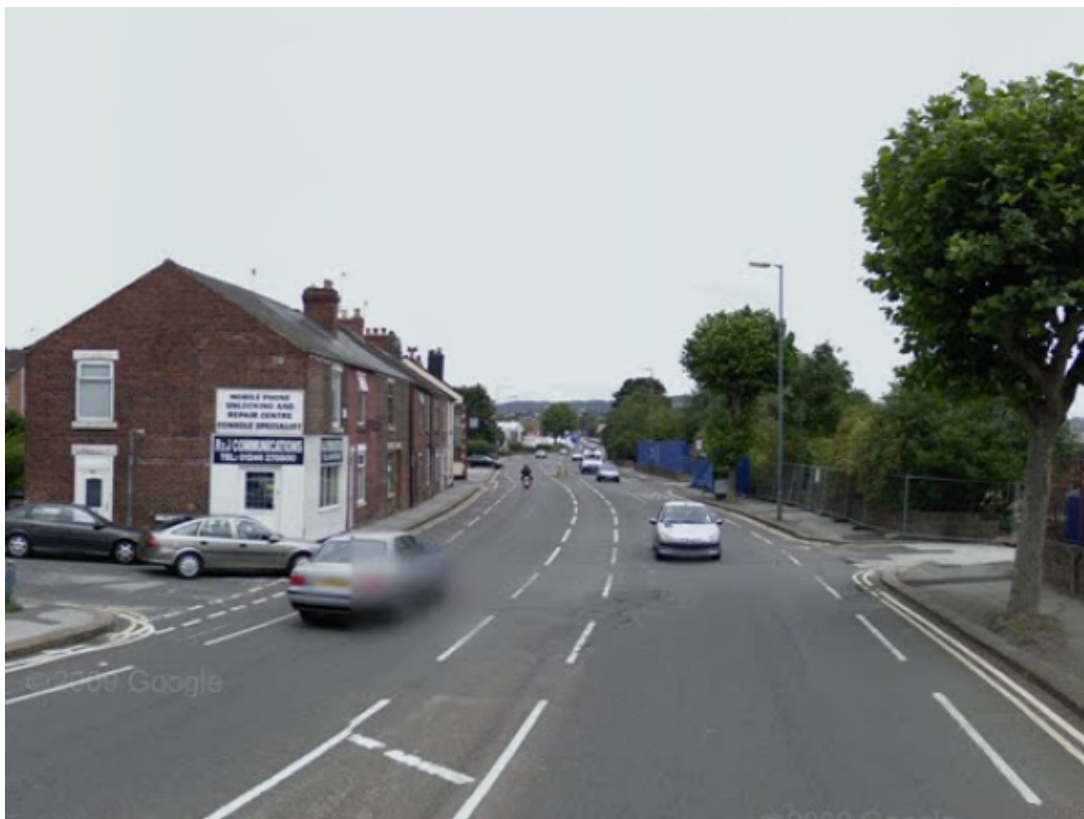
Figure 4.1.1 Original Road Layout on Sheffield Road

The photograph, below, shows the previous road setup and the affected terraced row of shops and houses. The existing gate to the right of the picture has now been widened and is one of the access roads to the Tesco supermarket on the former DemaGlass glassworks site. The blue awnings which can be seen near the middle of the frame are adjacent to a second gate (located at the far end of the awnings) which has also been widened and this is now a vehicle access to the new Proact football stadium.

The first mosaic approximates the view shown in Figure 4.1.1

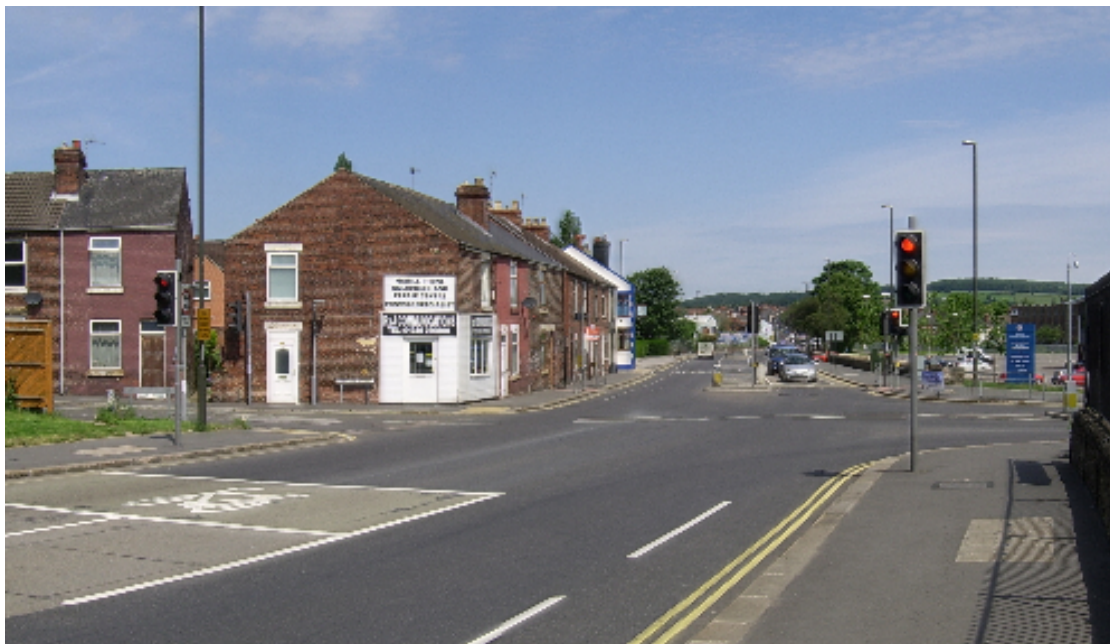
Figure 4.1.3 Revised Road on Sheffield Road

The following pictures show the now traffic light controlled junction, and the widened access road to the right, and the close proximity to the row of houses shown above. Note: the pictures used to assemble the mosaics were taken when vehicles were not in shot to avoid “ghosting” of vehicle images in the final panorama.

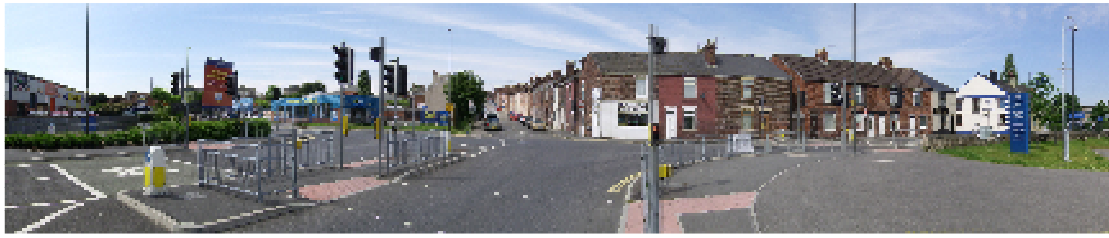
Figure 4.1.4 Revised Road Layout Facing Affected Facade

The second mosaic picture faces the affected row of houses, and approximates the view from the gate shown to the right of the Figure 4.1.1.

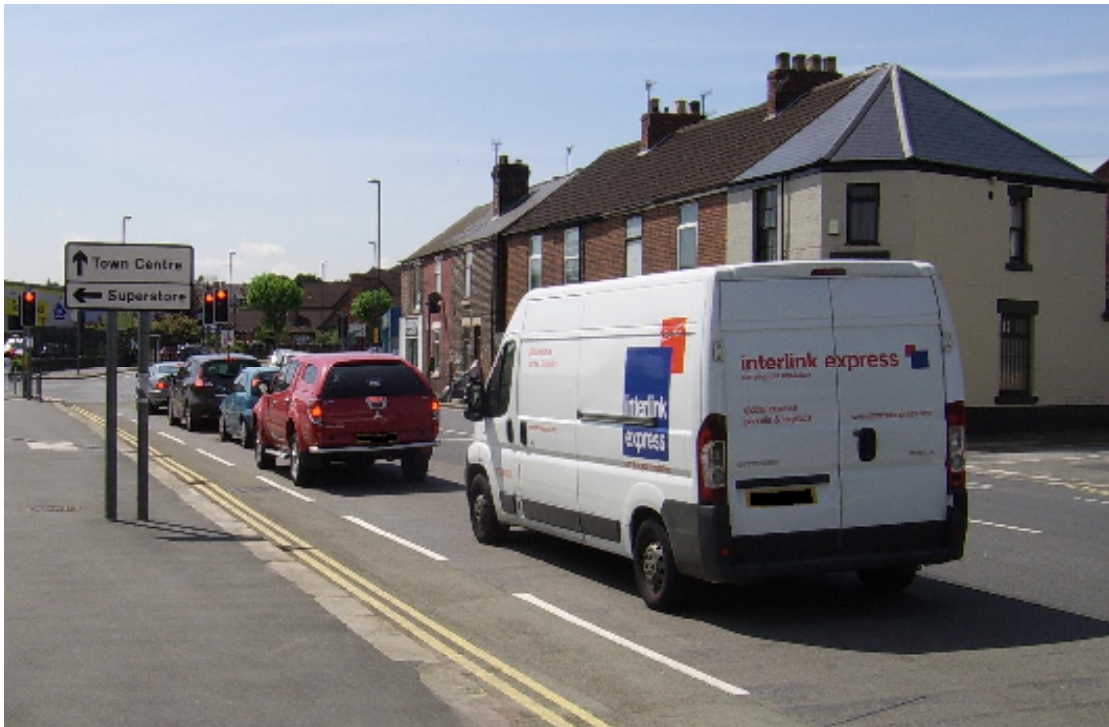
Figure 4.1.6 Queuing Traffic on Sheffield Road

Sheffield Road is a busy road and the traffic controlled junction serves to impede the flow of traffic, directly in front of the row of houses shown in the pictures above.

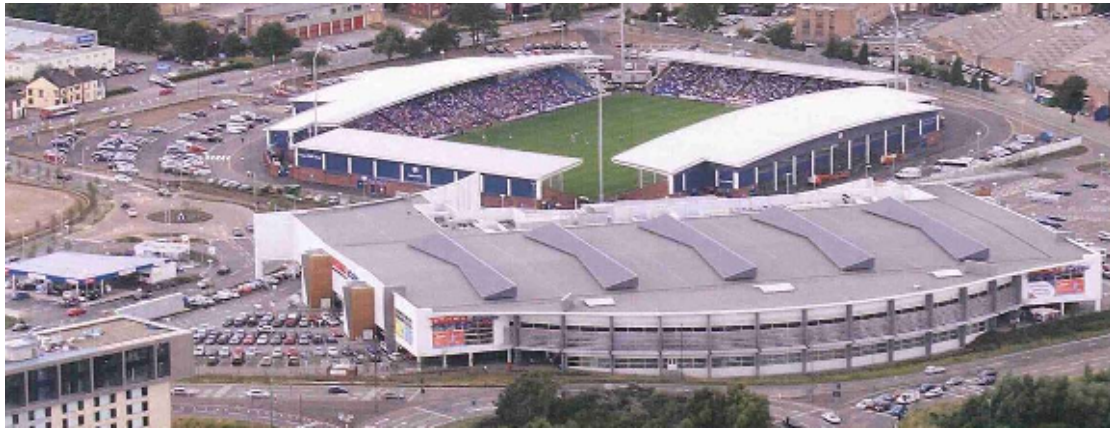
Figure 4.1.7 The New Supermarket and Football Ground

Figure 4.1.7, overleaf, is a cropped view of the development site, with Sheffield Road running across the top of the picture (from upper left to the upper middle of the frame, where it leaves the shot), and part of the affected terrace of housing can be seen in the upper left corner of the picture. The new junction is out of the frame just above centre left. The large building in the foreground is the supermarket, with the Proact stadium behind.

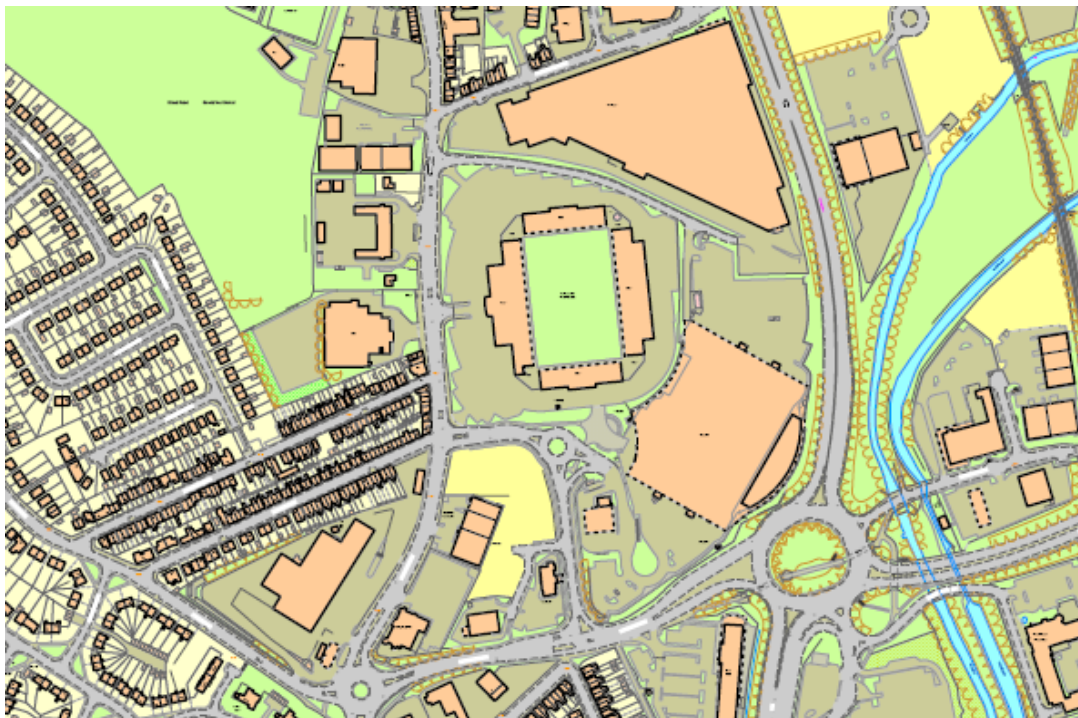
Figure 4.1.8 Revised Road Layout

The following map shows the revised road layout, serving the football stadium, and the supermarket:

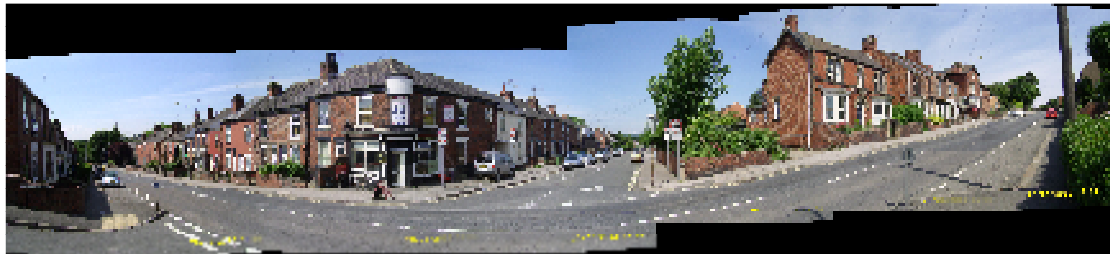
Figure 4.2.1 Whittington Hill

At Whittington Hill, it appears that the increased levels of NO₂ concentrations arise because engines of HGVs and buses tend to be working very hard as they travel up the relatively steep hill and, since there is only one lane of traffic in both directions, all other vehicles are forced to follow at the same speed. The result is that emissions rates are at their highest over this section of the road. The road has an increased number of HGVs than may normally be expected on a road in such a location due to the presence of the industrial estate at Station's Lane, at the far side of a housing estate over the brow of the hill. This problem is exacerbated due to an increase in gradient halfway up the hill. The effect of this is that heavy vehicles lose momentum and are forced to change down a gear at this point, slowing traffic along the length of the road. Some buses turn off the road onto Holland Road, at the T-junction shown in the middle of the picture, below. The panoramic mosaic shows the roadway and the adjacent housing, the change in gradient is approximately at the centre of the picture. Note: the pictures used to assemble the mosaic were taken when vehicles were not in shot to avoid "ghosting" of vehicle images in the final panorama.

Whilst the increase in gradient would be likely to have an adverse effect upon ambient air quality, this is greatly eased by the fact that the adjacent housing is set further back from the roadway as the hill is climbed. Due to the age of the housing built along this stretch of road, this greatly advantageous fact cannot have been planned but is nonetheless fortuitous.

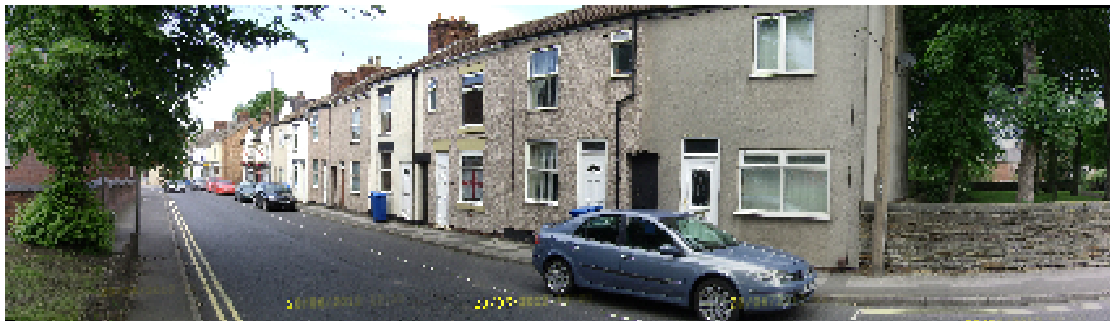
Figure 4.3.2 Affected Façade at Church Street, Brimington

The affected row of terraced houses are located on the north side of the one way system, adjacent to the church.

As can clearly be seen, the houses face directly onto the street. There may also be a minor canyon effect due to the Church Hall on the opposite side of the roadway, as shown more clearly in the picture overleaf, from the opposite side of the road.

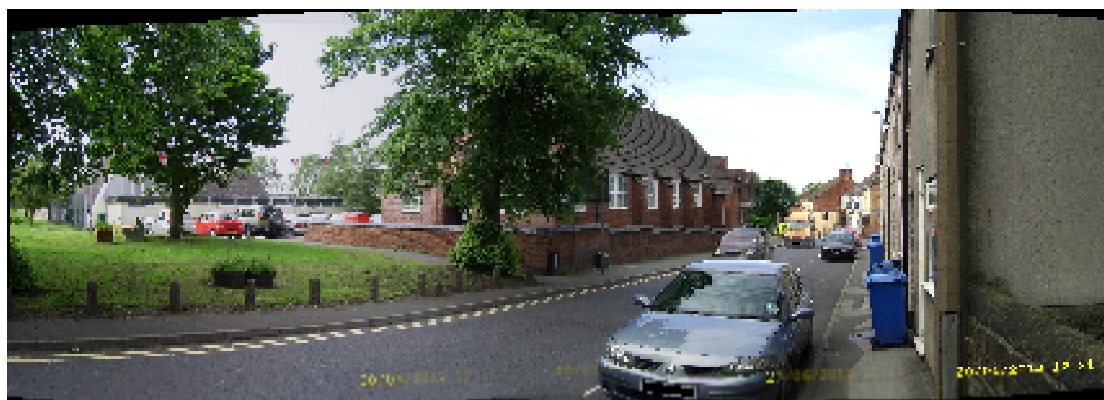
Figure 4.3.3 Carriageway at Church Street, Brimington

On street parking serves to restrict the effective road width, but also acts to move the traffic away from the affected façade.

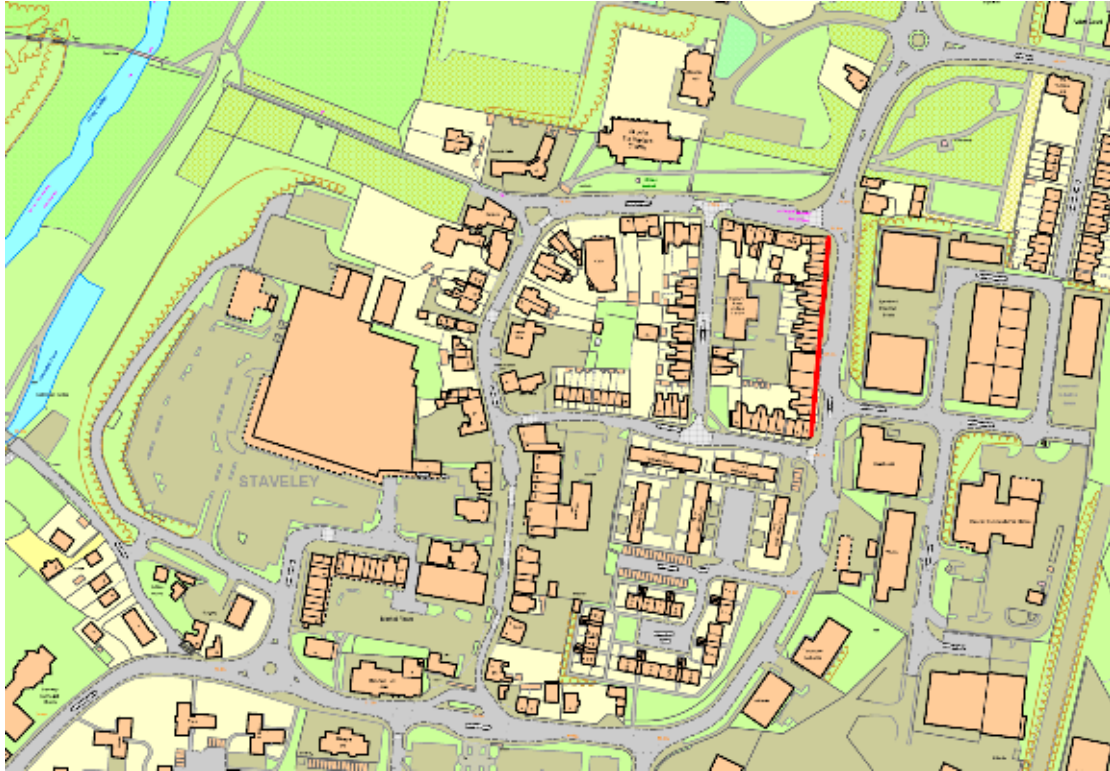
Figure 4.4.1 Road Layout at Duke Street, Staveley

The A619 trunk road linking the north side of Chesterfield to the M1 passes through Staveley, closely by-passing the heart of the village. The figure below shows the road layout, the main road passing from lower left to upper right, passing to the south and east of the old village, and the affected housing façade is highlighted in red.

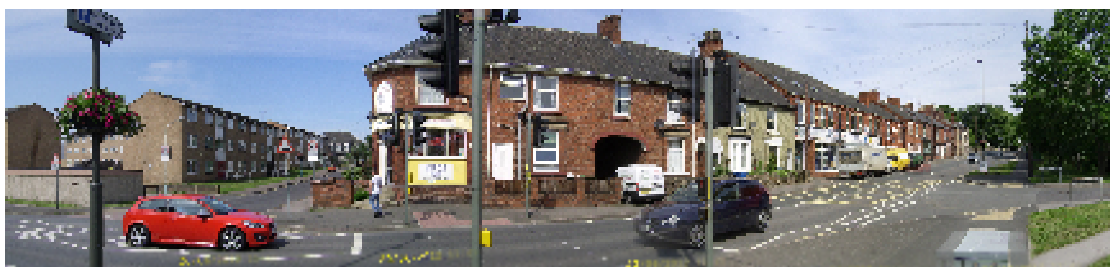
Figure 4.4.2 Affected Façade at Duke Street, Staveley

The pictures, below, show the roadway and the affected row of terraced houses and shops. The road is on a slight incline, with a roundabout at the junction on the brow of the hill (this is at the northern end of the row of houses highlight in the map above, and to the right of the picture below). The road is generally free flowing, with only the single pedestrian controlled crossing to change the flow. However, as the road is the only practical link to the M1 motorway, it is prone to severe congestion backing up from the entry to the motorway if there are traffic problems on that major route.

The picture below shows the affected road of houses from the south end, and also shows the pedestrian crossing.

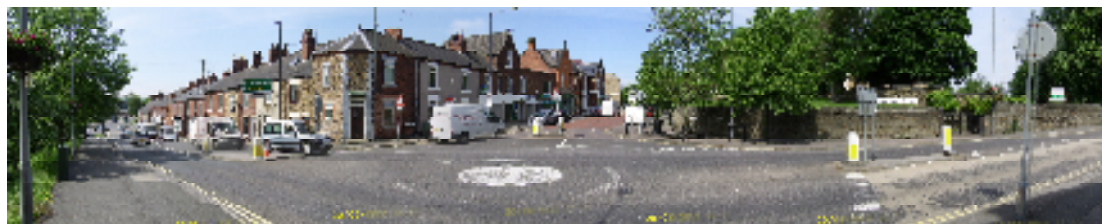
Figure 4.4.3 Northern Section of Façade and Carriageway

The second picture shows the same stretch of road from the north, with the affected row of housing to the left of the picture.

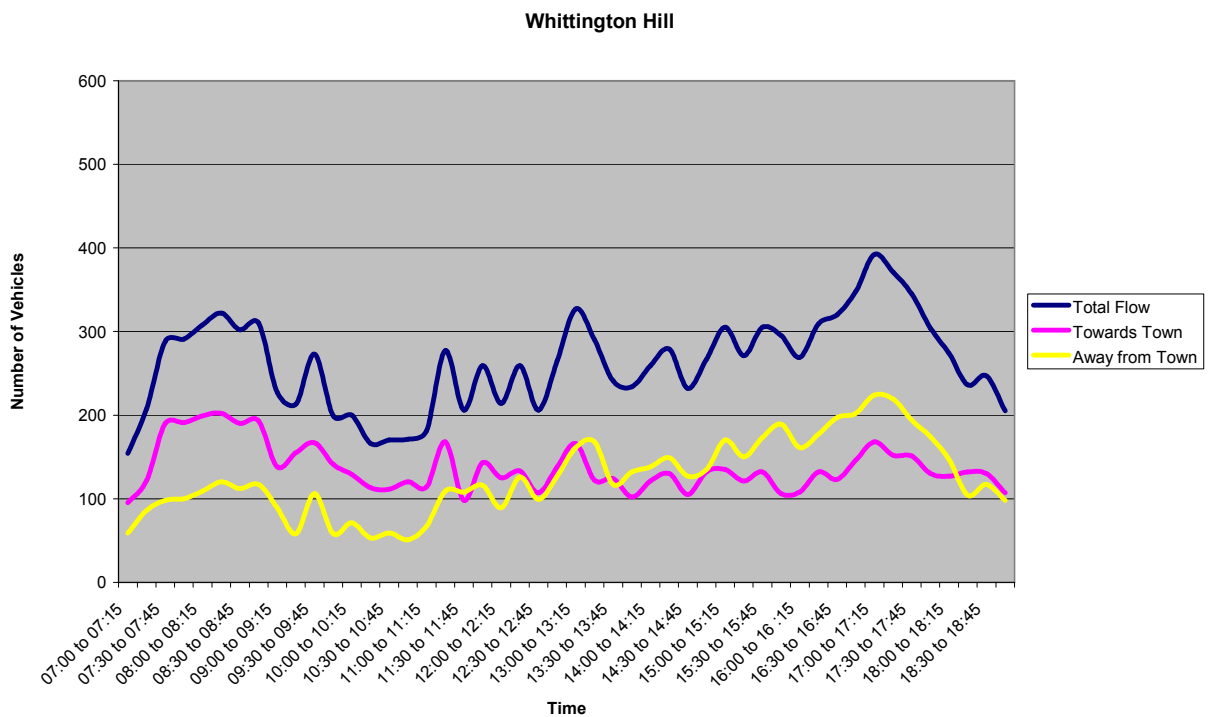
Figure 5.1.1 Traffic Flow on Whittington Hill

Whittington Hill had a total vehicle flow of 12594 with the busiest period between 17:00 and 17:15, with 379 vehicles. Note how the direction of traffic flow reverses from early afternoon, in the morning most flow is into town (downhill) and from the afternoon it changes to out of town (uphill).

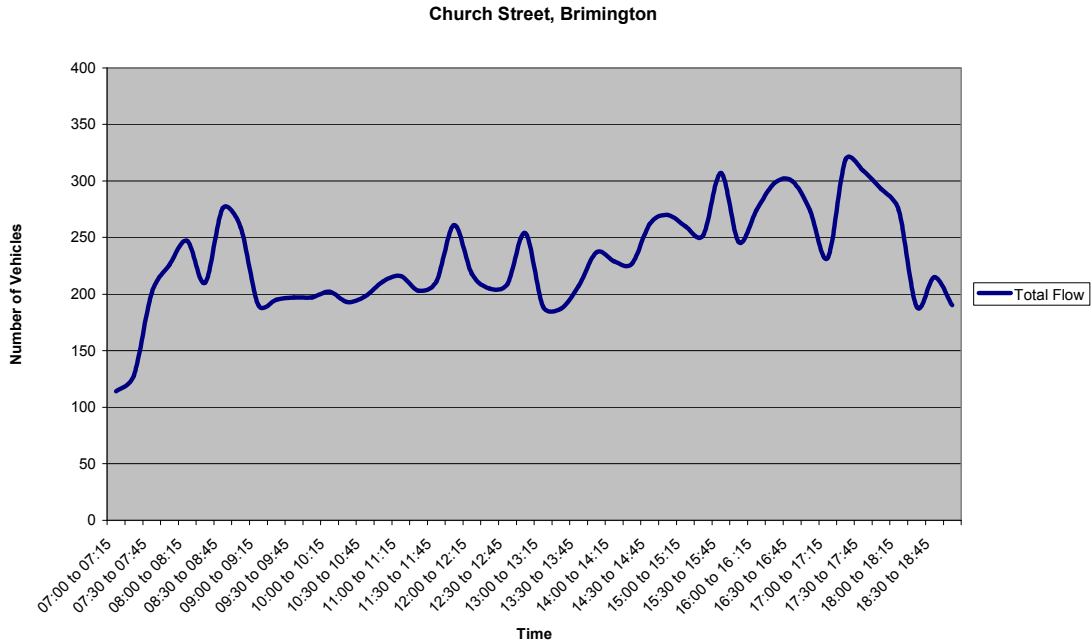
Figure 5.1.3 Traffic Flow on Church Street, Brimington

Church Street at Brimington (on the one-way system) had a peak flow at between 17:15 and 17:30, with 314 vehicles. The total vehicle flow at that site was 11061.

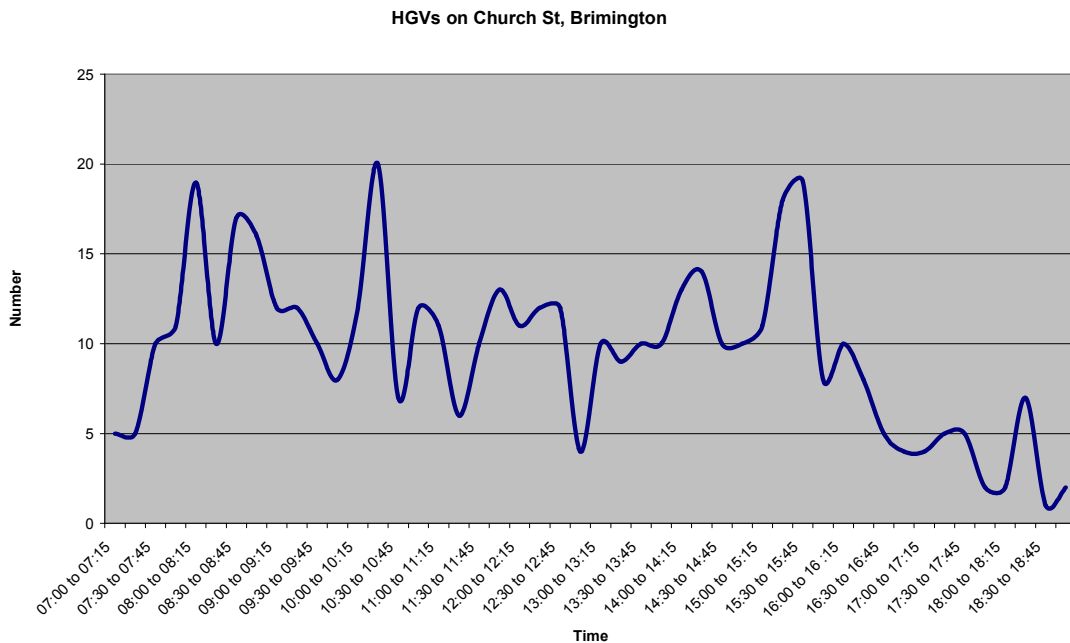
Figure 5.1.4 Variation in HGV flows on Church Street, Brimington

The related number of lorries and buses on the road is shown below:

In both locations it is noted that the number of HGVs appear to decline gradually through the day. This may confirm the anecdotal evidence that many haulage journeys are carried out on the motorway network in the night, and enter the domestic road system during the mornings.

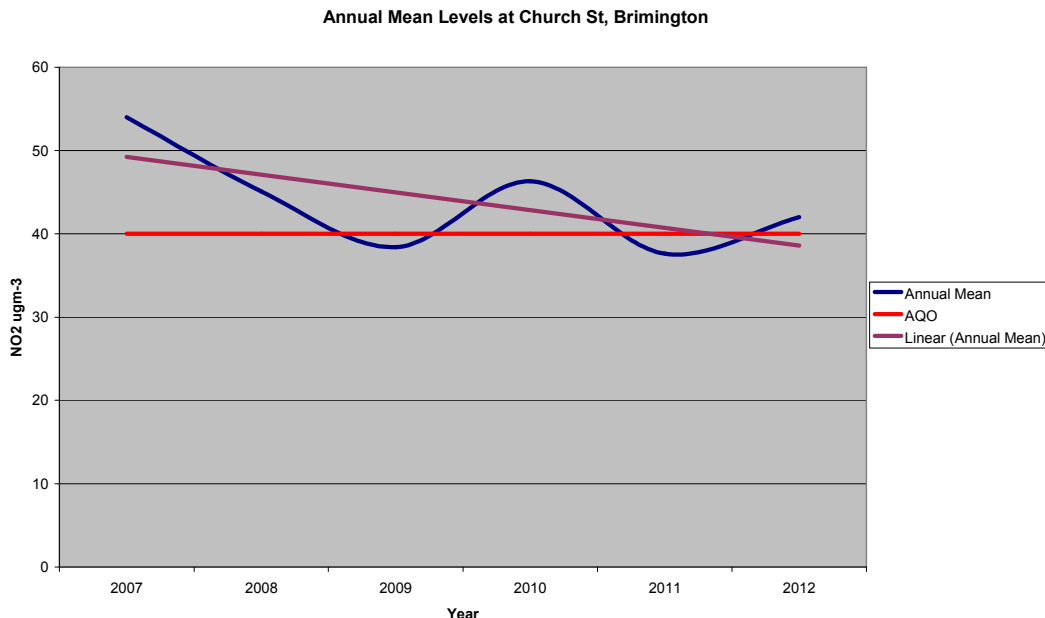
Figure 6.3.1 Trendline of Annual Mean NOx levels at Church St, Brimington

We are concerned about the fluctuating levels at Church Street, Brimington, where the level varies above and below the Objective. Monitoring has been carried out at a single location since 2007, this being the NOx tube at 14 Church Street. Figure 6.3.1, below, shows the changes in annual mean over time, in comparison with the Objective:

A trendline has also been plotted onto the graph, and clearly shows a general downward trend in the level, in this area. Given this fluctuation and the long term trend we are unable to conclude that an ongoing breach of the Air Quality Objective is occurring in this Detailed Assessment area. As such, we believe that it would be precipitous to proceed along the route of formally declaring an AQMA when the fluctuating levels may well continue as before,

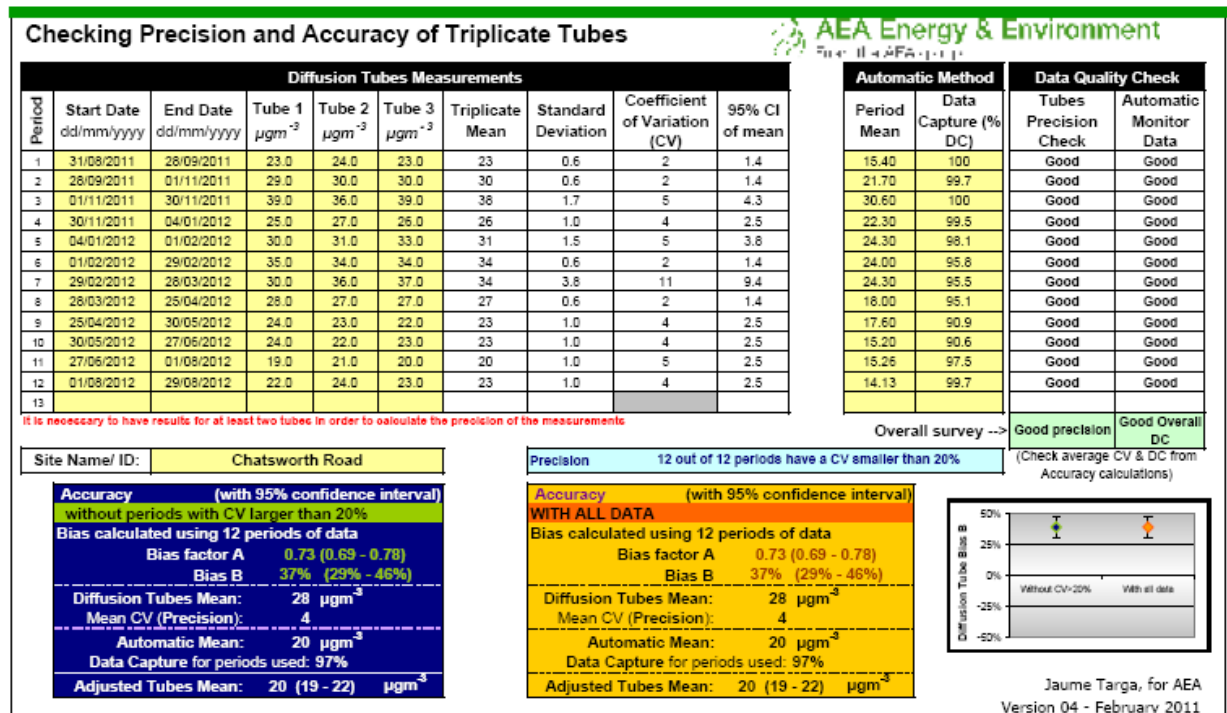
Figure AP1.3 Ricardo-AEA standard Bias factor calculation output

The use of the co-located diffusion tubes on the AURN monitoring station allows a locally derived bias factor to be calculated. The annual factor for the period September 2011 to August 2012 is **0.73**, this is comparable with the factors applied over the previous seven years.

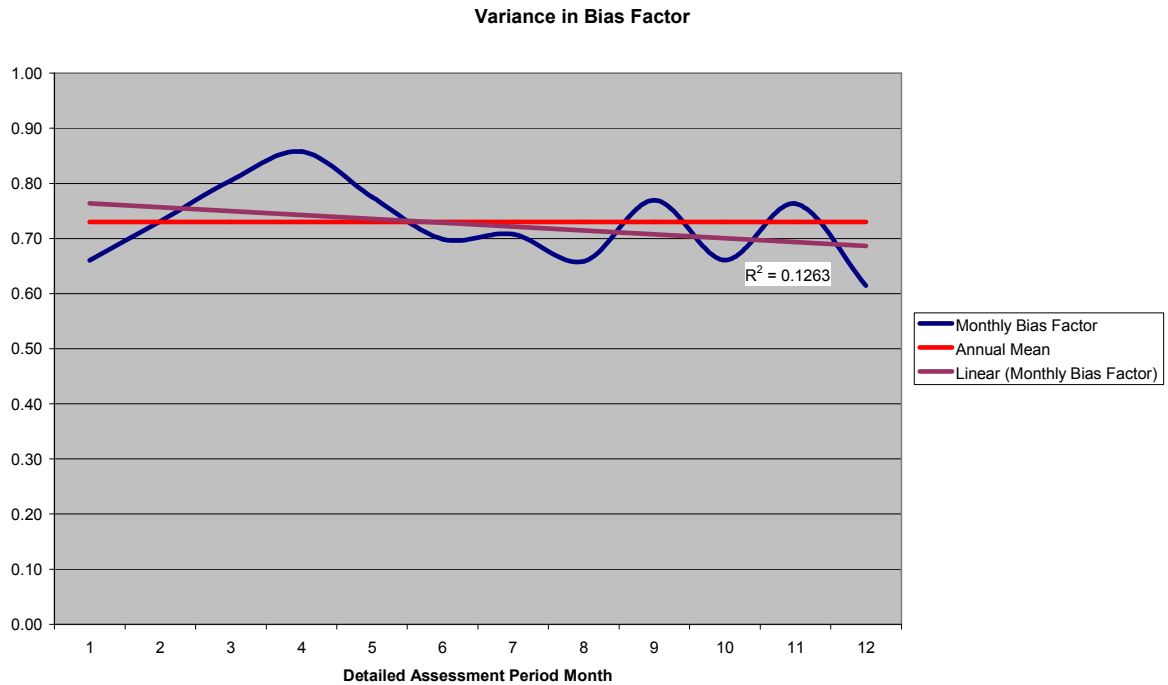
Figure AP1.4 Variation in Bias Factor

The bias factor data has been plotted on a graph allowing the monthly and annual bias factors to be compared. This is achieved by plotting a linear regression line through the monthly data and calculating the R-squared value.

As can clearly be seen, the regression line and the annual mean are closely related. The R-squared value of the monthly bias factor data is low, indicating that the data is of low variability throughout the year.

We are confident that the locally calculated annual bias factor is statistically viable.

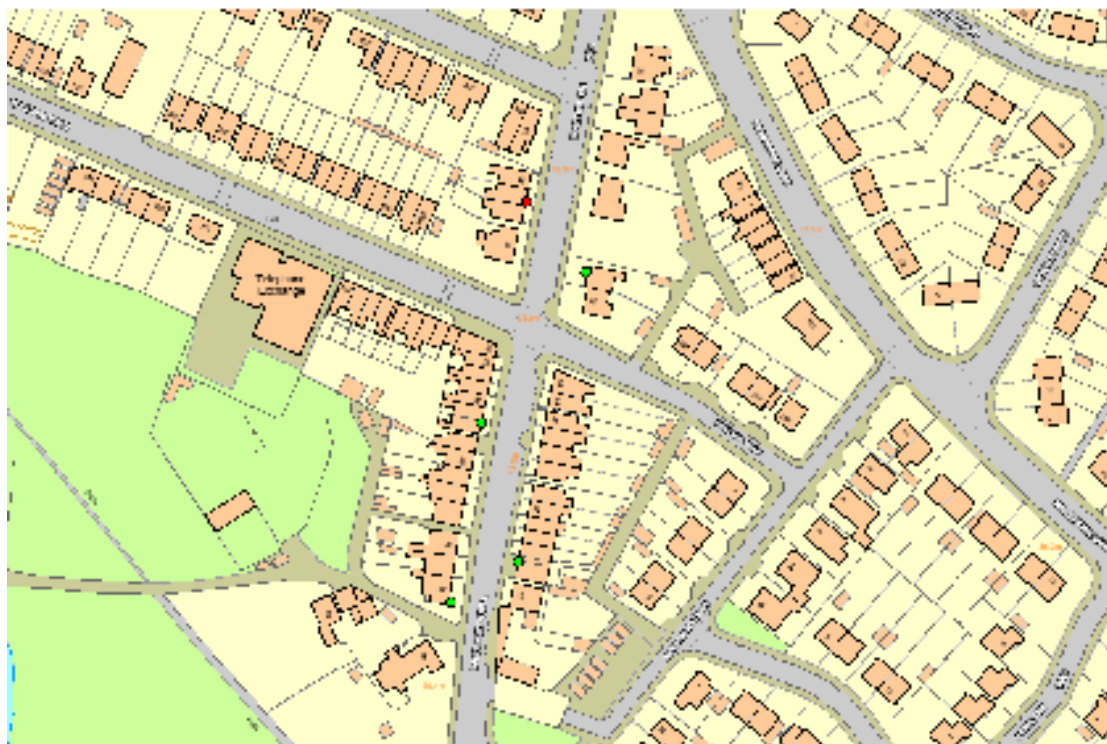
Figure AP3.3 Whittington Hill Sites

The red dots show the locations of the tubes which have not been altered. The green dots are the revised locations allowing the ongoing Detailed Assessments to be undertaken.

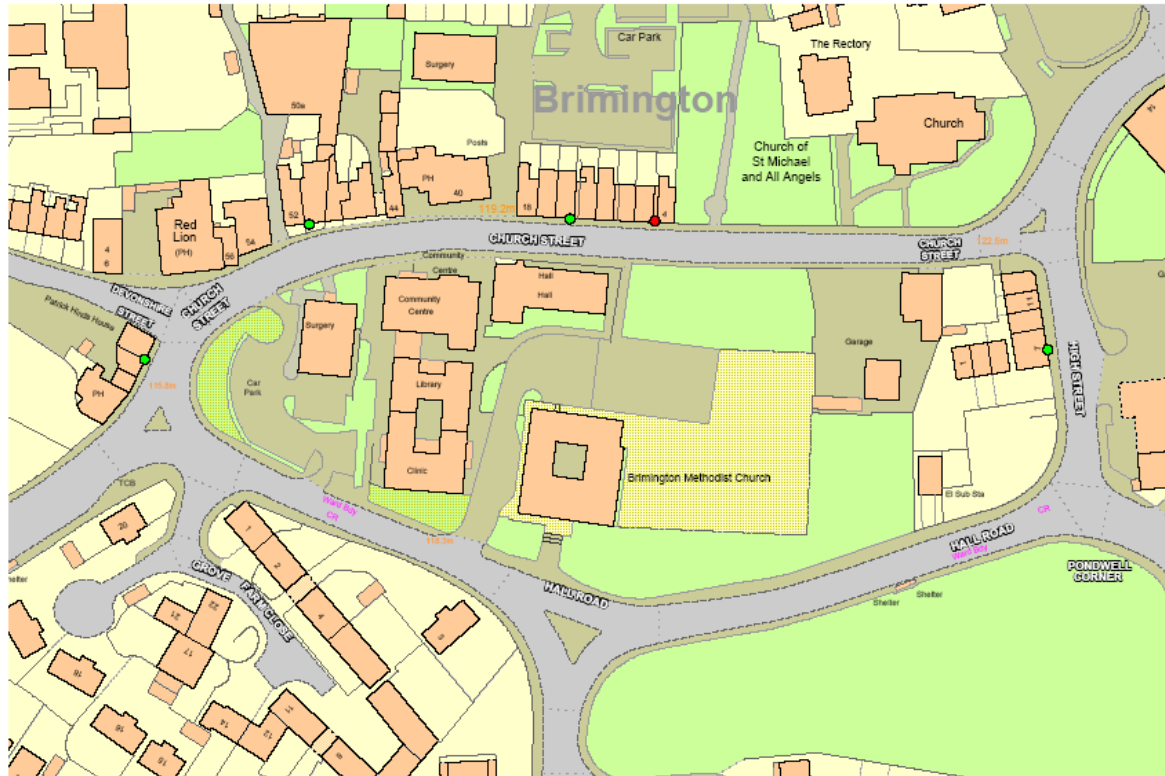
Figure AP3.4 Church Street, Brimington Sites

The red dots show the locations of the tubes which have not been altered. The green dots are the revised locations allowing the ongoing Detailed Assessments to be undertaken.
