2014 Air Quality Progress Report for Chesterfield Borough Council

In fulfillment of Part IV of the
Environment Act 1995
Local Air Quality Management

August 2014

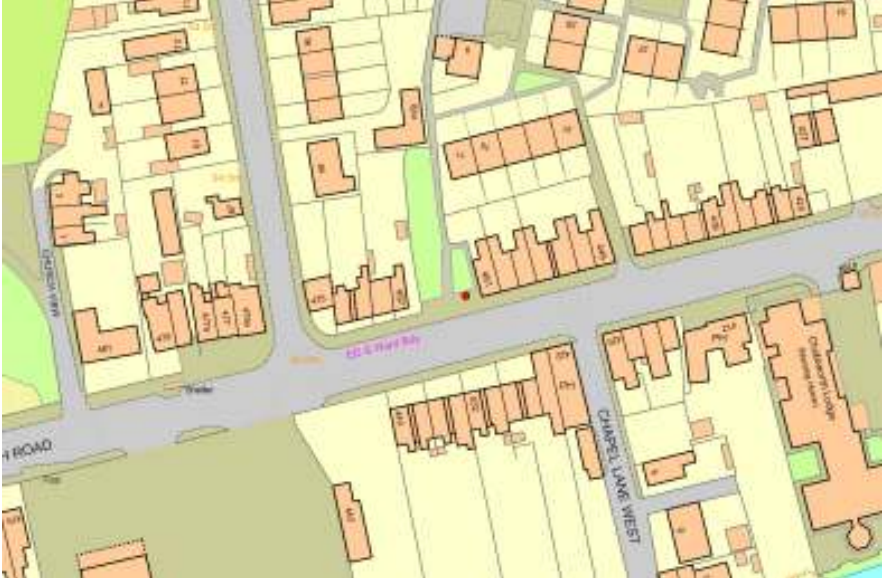
Figure 2.1 Location of Chatsworth Road Automatic Monitoring Site

Note: For data handling and data download purposes, this site is referred to as Chesterfield Roadside, by both Bureau Veritas and DEFRA

This site, formerly classified as a Roadside site, has been reclassified as an Urban Traffic site. This site is indicative of public exposure for dwellings in urban locations.

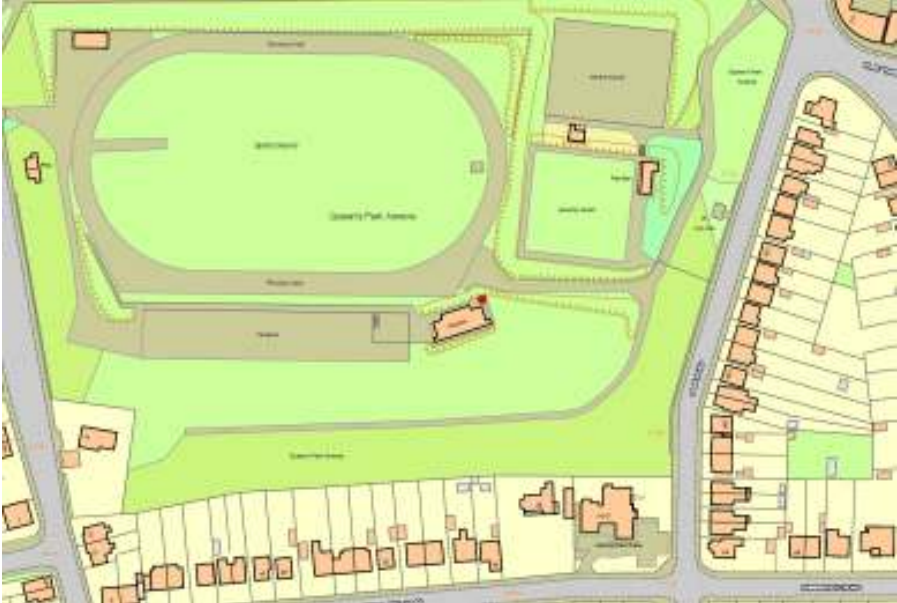
Figure 2.2: Location of Queens Park Annex Automatic Monitoring Site

Note: For data handling and data download purposes, this site is referred to as Chesterfield, by both Bureau Veritas and DEFRA.

This site is classified as an Urban Background site, and was indicative of the diffusion tubes in locations set away from main roads. However, with the re-organisation of the diffusion tubes across the Borough to concentrate on roadside monitoring this site now operates, solely to provide data to DEFRA for input to the Automatic Urban/Rural Network (AURN)

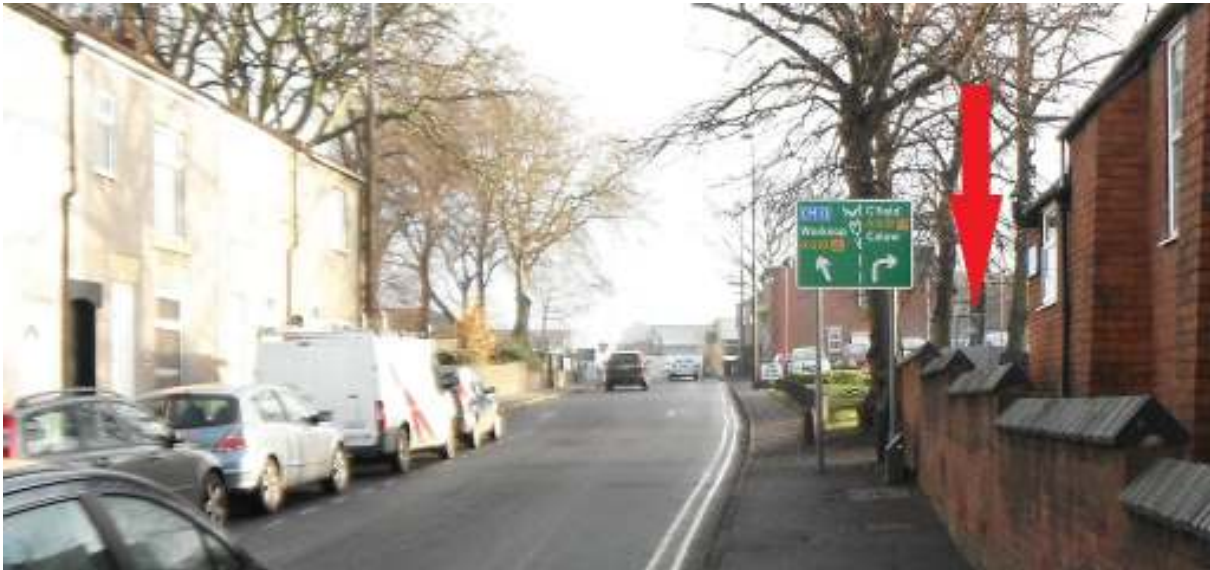
Figure 2.4: Location of Sampling Head in Relation of the Affected row of Terraced Housing on the Opposite side of Church St

The sample head (arrowed) is placed between the road sign and the window of the building façade, and projects above the adjacent wall. One of the diffusion tubes on the terrace façade is directly opposite, but is obscured by the van near the centre of the picture. Note how, due to the row of parked vehicles, the useable carriageway is displaced away from the terrace façade. The practical result of this is that the sample head is located an equivalent distance from the traffic as the diffusion tubes on the housing façade.

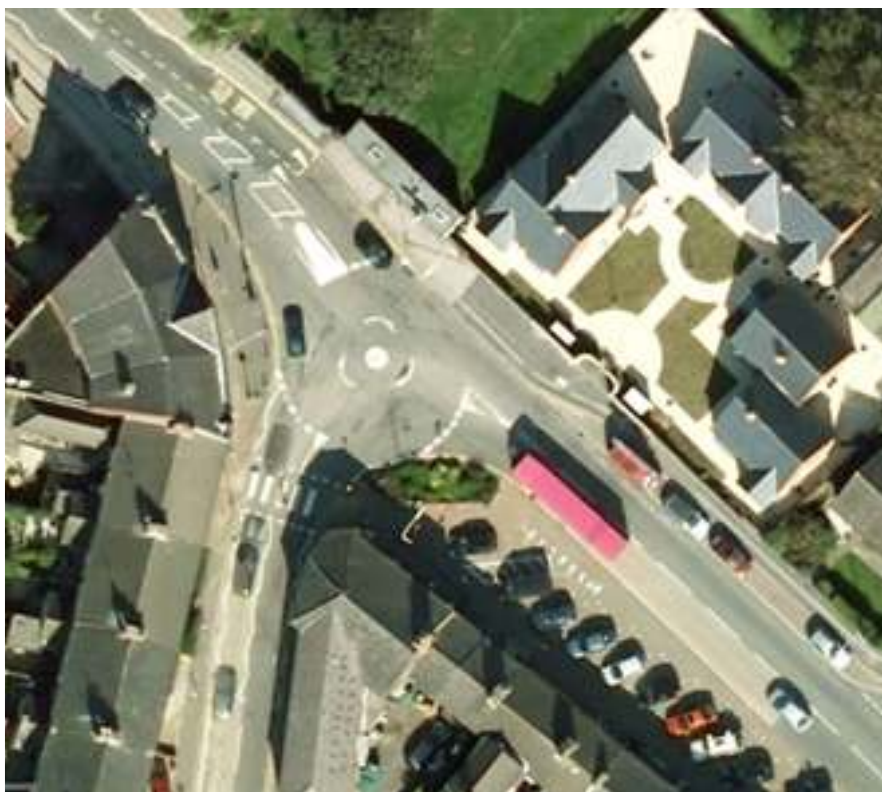
Figure 2.5: Original Road Layout

The monitoring location at Hollis Lane has been reinstated, reflecting the increased traffic flow in this area. In addition 5 new diffusion tubes locations were brought into use in and around Mansfield Road, Hasland. Anecdotally, the traffic congestion on this road has increased greatly, due to recent changes made to a junction on this road. This involved the removal of a pre-existing roundabout (shown in Figure 2.5, below).

The green space at the top of both pictures is Eastwood Park. This has been the subject of investment to bring it back into general use. Concern had been raised that the previously uncontrolled junction may have given rise to an increased risk of accidents to crossing pedestrians, prompting the alterations which were carried out by the County Council (in their role as the local highways authority). The new monitoring locations are spaced along the main road and on the junction road which makes up the leg of the “T” junction, with an additional tube on a further adjacent road junction, due to the proximity of houses at that location, and the locations are shown in Figure 2.7, overleaf.

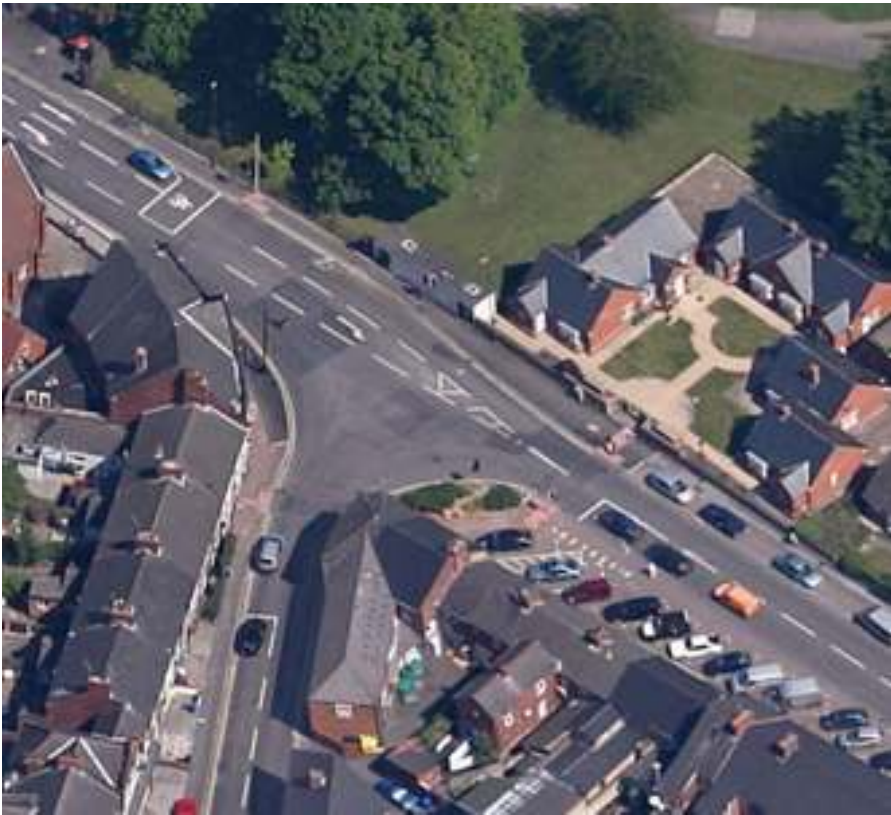
Figure 2.6: Revised Road Layout

This has been replaced by a traffic light controlled junction (shown in Figure 2.6, overleaf).

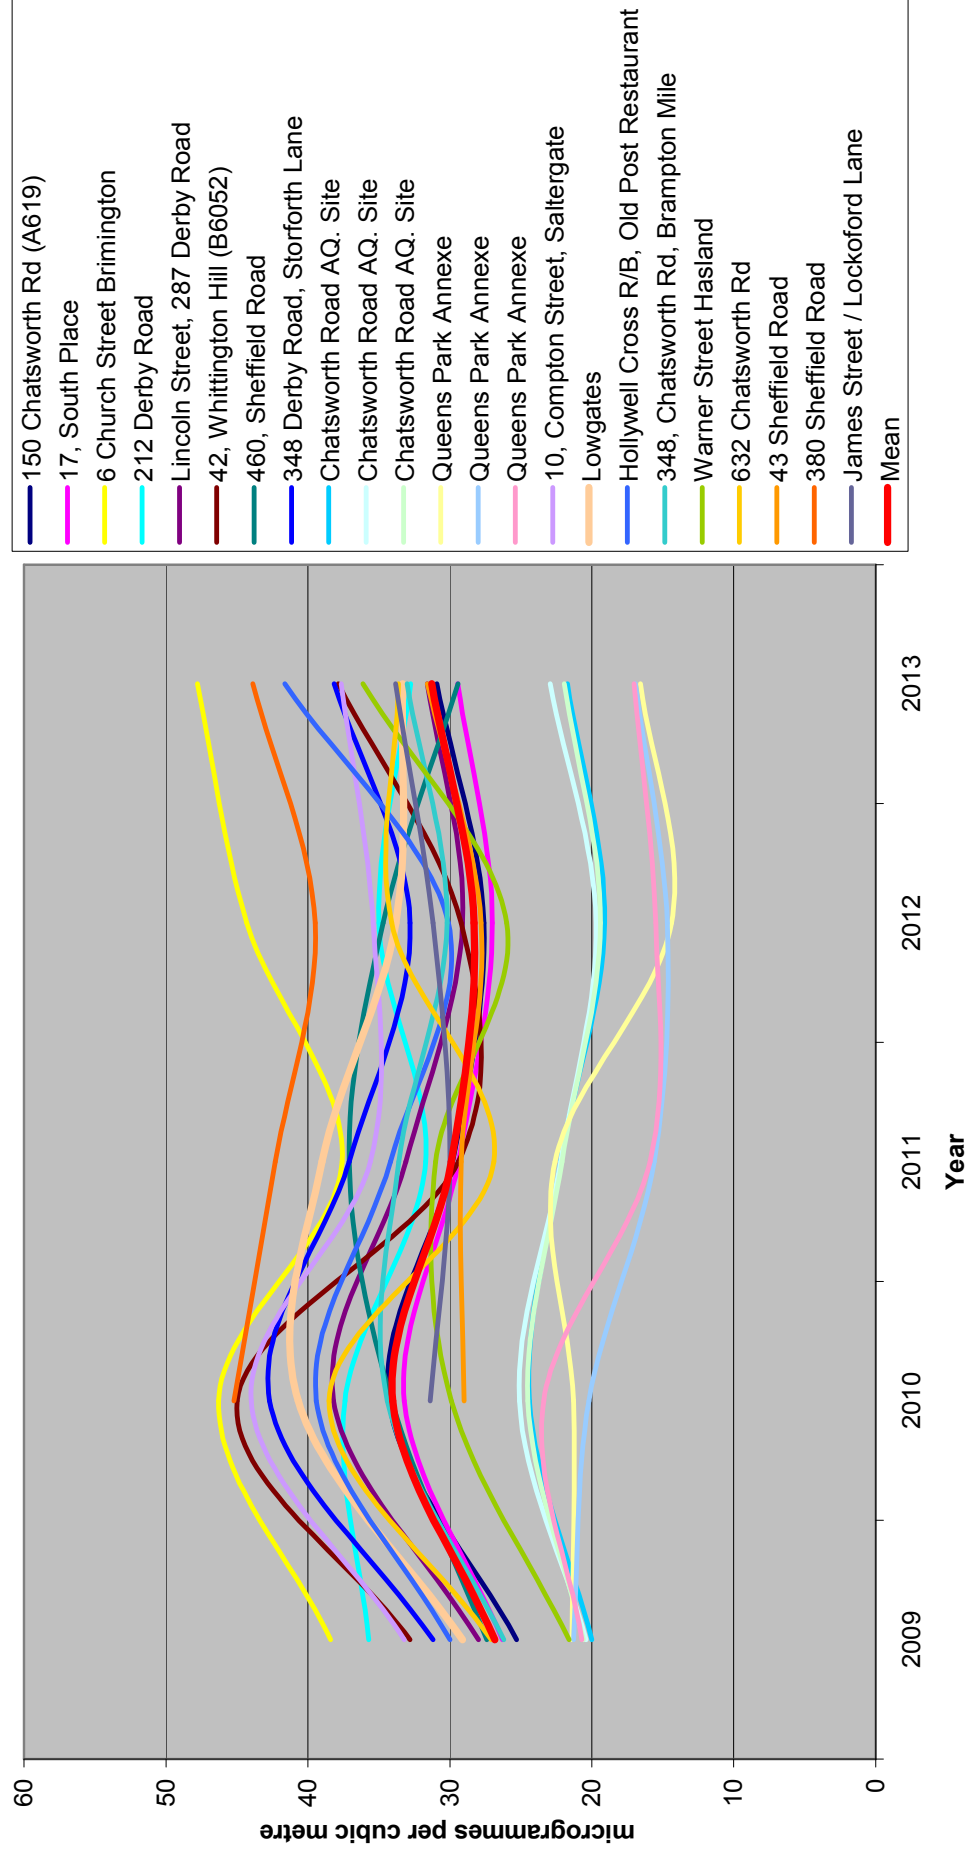
Figure 2.8: Trends in Annual Mean Nitrogen Dioxide Concentrations Measured at Diffusion Tube Monitoring Sites

As can be clearly seen, the general trend of improving air quality from a peak in 2010 has reversed.

Of the long term diffusion tube locations (which are solely those plotted in the graph) three sites now breach the annual AQO. These are:
 6 Church Street, Brimington,
 380 Sheffield Road, Whittington Moor,
 and Holywell Cross Roundabout, in the town centre.

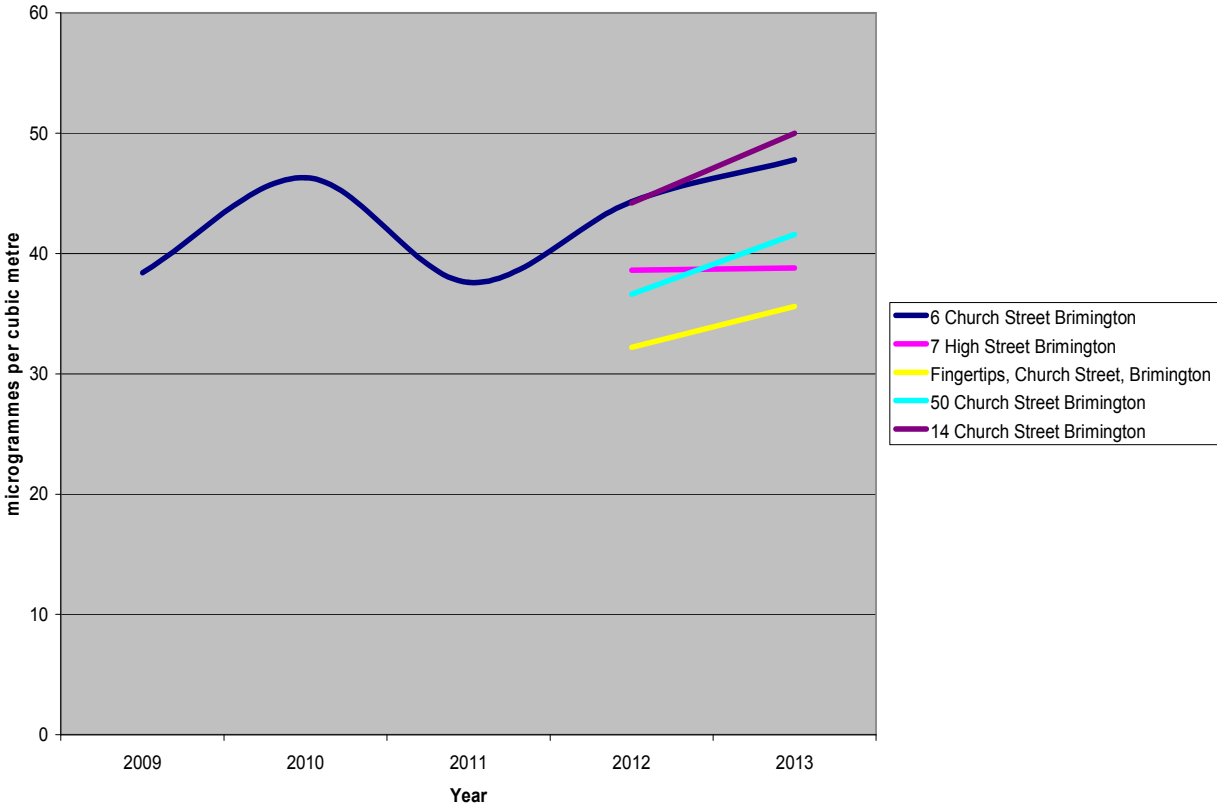
Figure 2.9: NO₂ Trends in the Brimington Assessment Area

The increasing NO₂ levels are all on the route leading through Brimington towards the northbound M1. The traffic flows around the one-way system in the heart of Brimington is shown overleaf:

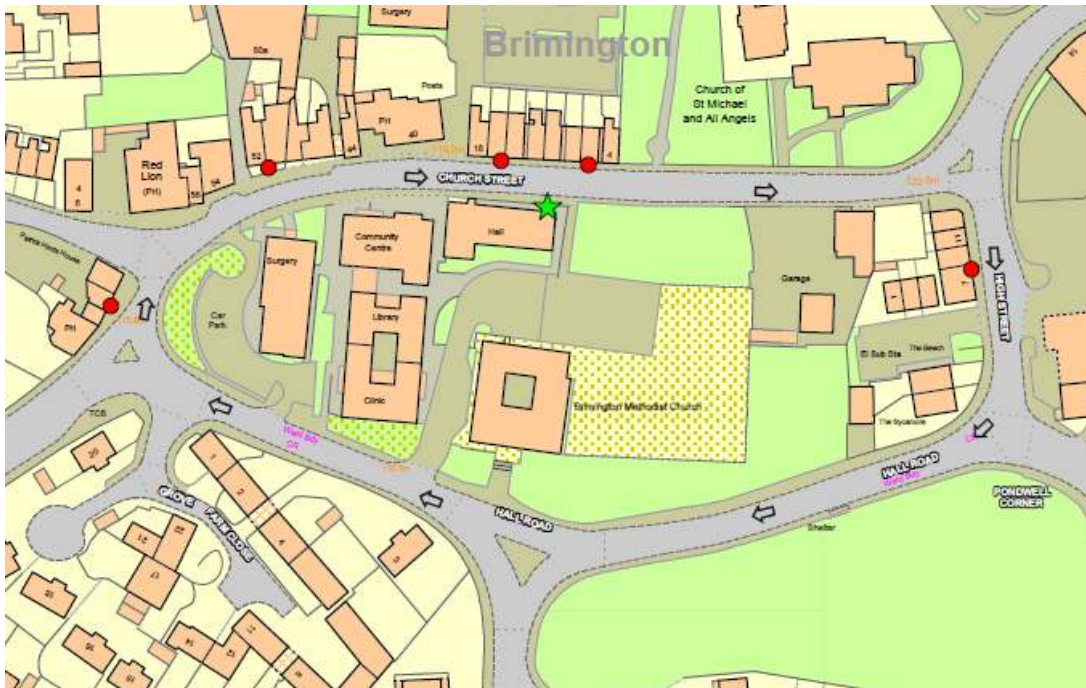
Figure 2.10: Traffic Flow at Brimington

Note: The arrows show the traffic direction, the red dots show the locations of the diffusion tubes, and the green star denotes the location of the automatic NOx monitor

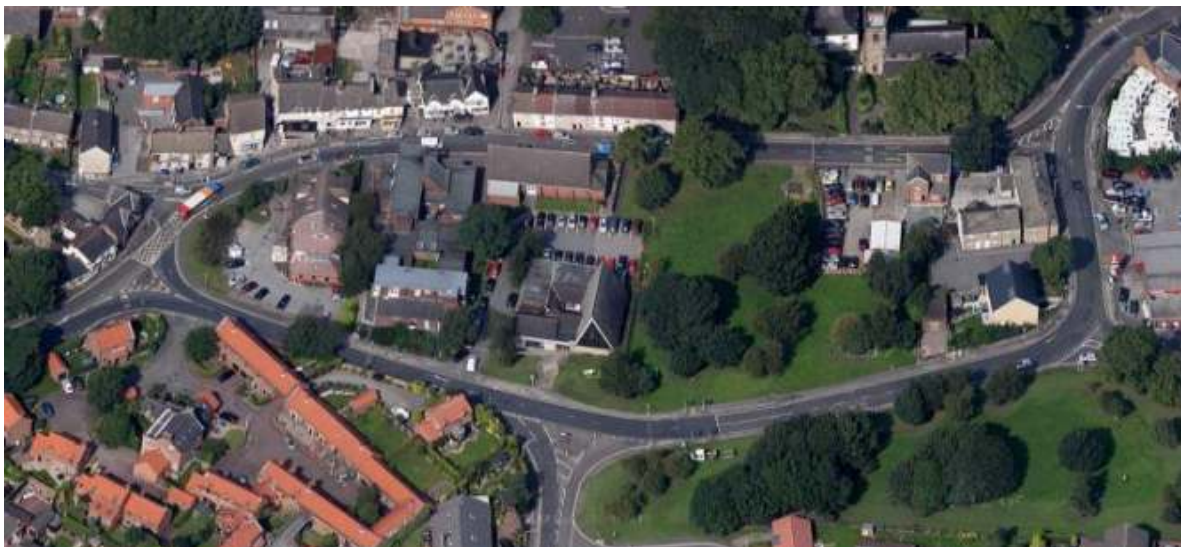
Figure 2.11: Oblique view of Church St, Brimington, and the immediate vicinity

Figure 2.11, below, shows an oblique view of the area, showing the same area as the plan, above, and clearly shows the contrast in the area surrounding the carriageways, with the open spaces to the south contrasting sharply with the enclosed nature of the original road to the north.

The route to the M1 is at the top right in both images.

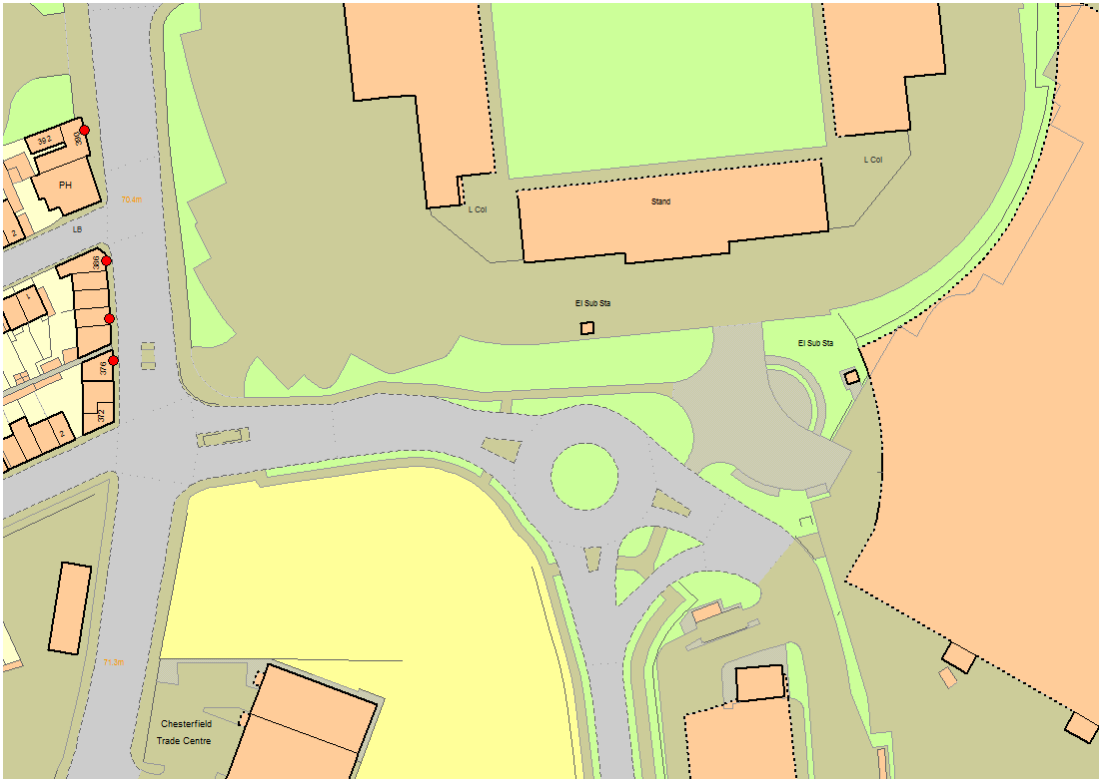
Figure 2.12: Affected Façade and the adjacent road layout

Figures 2.12 and 2.13 (below), which follow shows the affected face to the left (with the locations of diffusion tubes shown in red, below), with the road providing access to the supermarket in the centre. The crossroad junction adjacent to the façade is traffic light controlled.

The two central diffusion tubes (as shown in figure 2.12) have demonstrated a breach of the AQO, whereas both the northernmost and southernmost diffusion tubes are within the AQO.

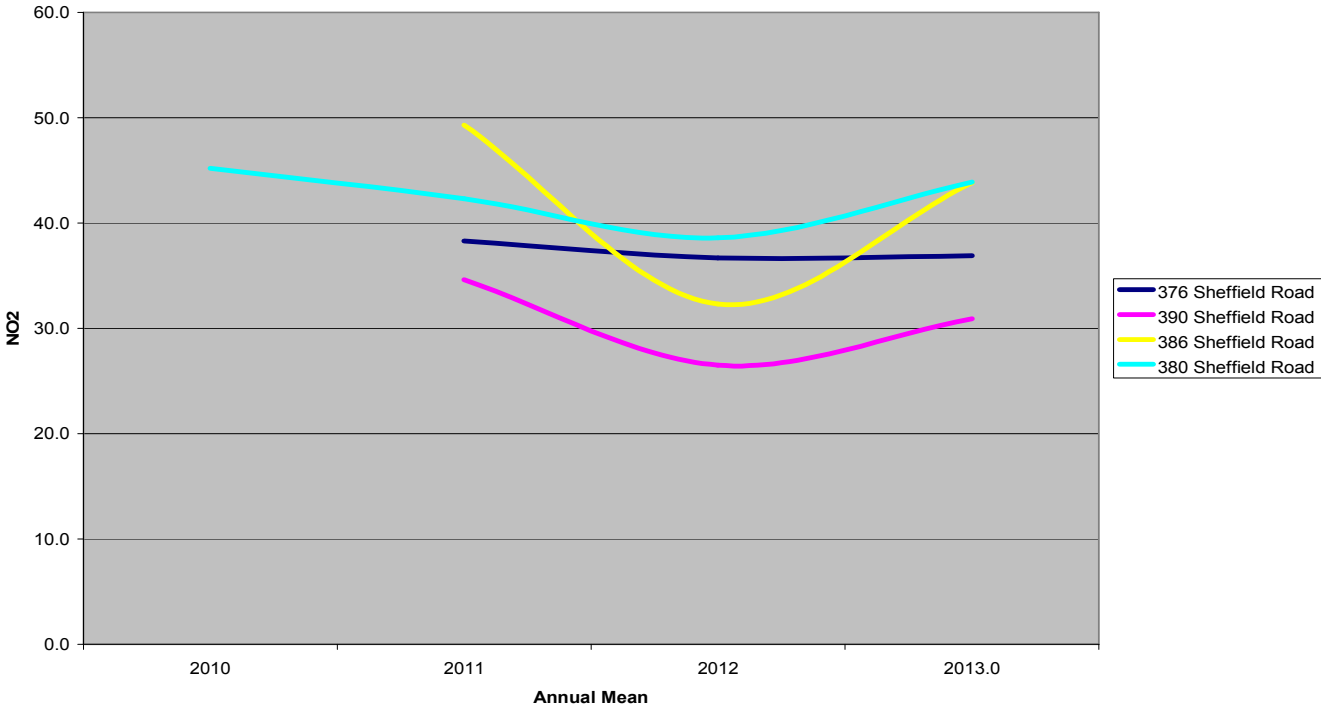
Figure 2.14: NO₂ Trends in the Sheffield Rd Area

The results which have been obtained are of concern in that a breach of the AQO has been demonstrated. However, of further concern is the disparity between the results obtained over such a short section of housing façade. Given that the traffic flow along this very short section of road should be very similar along its length, and acceleration across the junction should mostly affect the southernmost located diffusion tube, the reason for the disparity is currently unexplained. Figure 2.15 shows the affected façade (in the centre of the picture) with the traffic light controlled junction directly to the left.

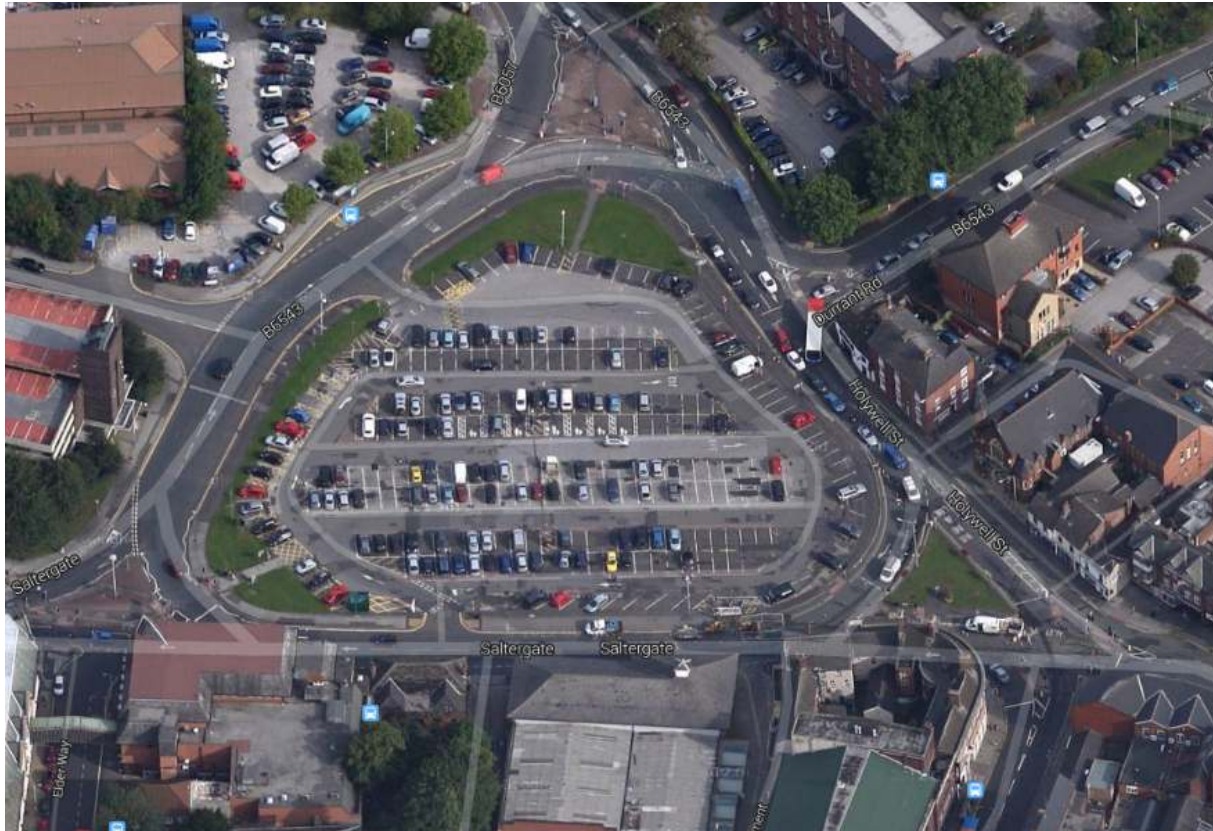
Figure 2.16: Holywell Cross Roundabout and car park

The diffusion tube is located on the façade to the centre left of the picture, directly adjacent to the queuing traffic.

The third site, at Holywell Cross Roundabout is included in the monitoring exercise as it is a location where all of the main commuting routes converge to the north side of the town centre. There are no dwellings in this area, only short term exposure can be expected in this vicinity. Given that the annual mean is $41.6\mu\text{g}/\text{m}^3$, and therefore well below the trigger level requiring an assessment as to whether there is the potential for an exceedence of the NO_2 hourly mean AQS objective (ie greater than $60\mu\text{g}/\text{m}^3$), we are confident that there is no need for further action at this stage. Monitoring will continue at this location.

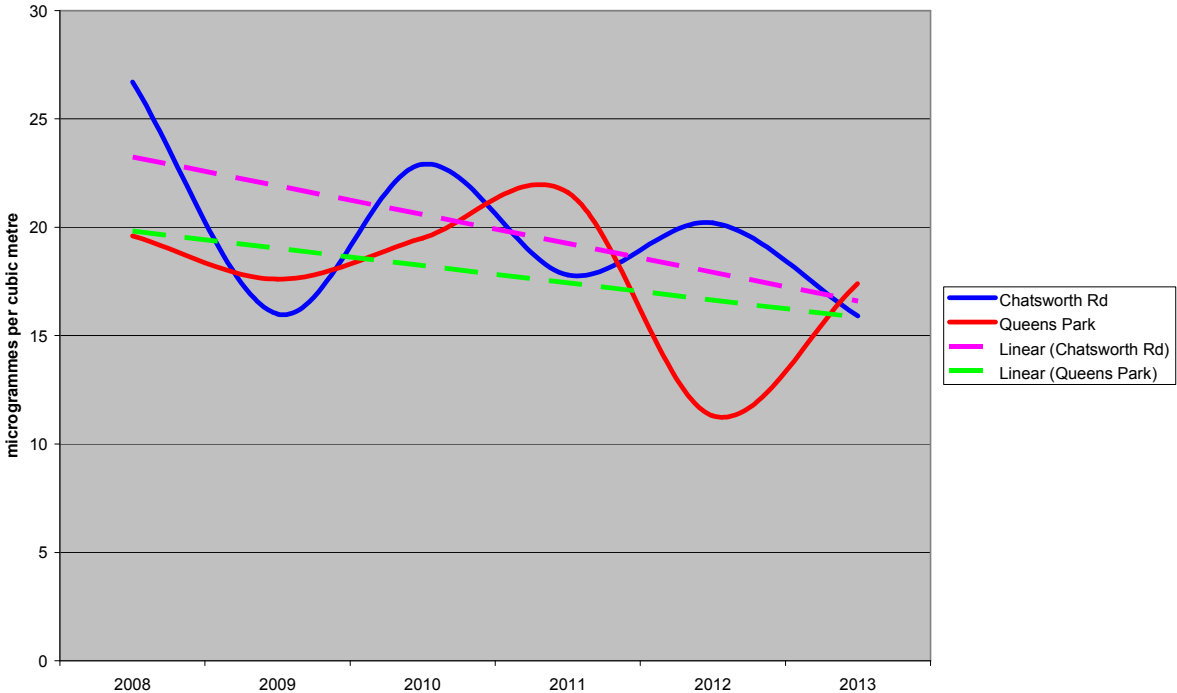
Figure 2.17: Trends in Annual Mean PM₁₀ Concentrations

The above figure shows the annual levels and overall trends for PM₁₀ results for the current monitoring locations. As can clearly be seen, the overall trend for PM₁₀ monitoring results at both sites is a steady reduction. During the preparation of this report, the World Health Organisation issued data regarding PM₁₀ pollution (http://www.who.int/phe/health_topics/outdoorair/databases/cities/en/), and Chesterfield was included on a list of regions in the UK which exceed their threshold (20µg/m³), which has not been adopted across the EU. This was based on 2011 data. As can be seen from the chart, above, the background levels were above the WHO threshold in that year but the levels, while fluctuating, are displaying a general downward trend.

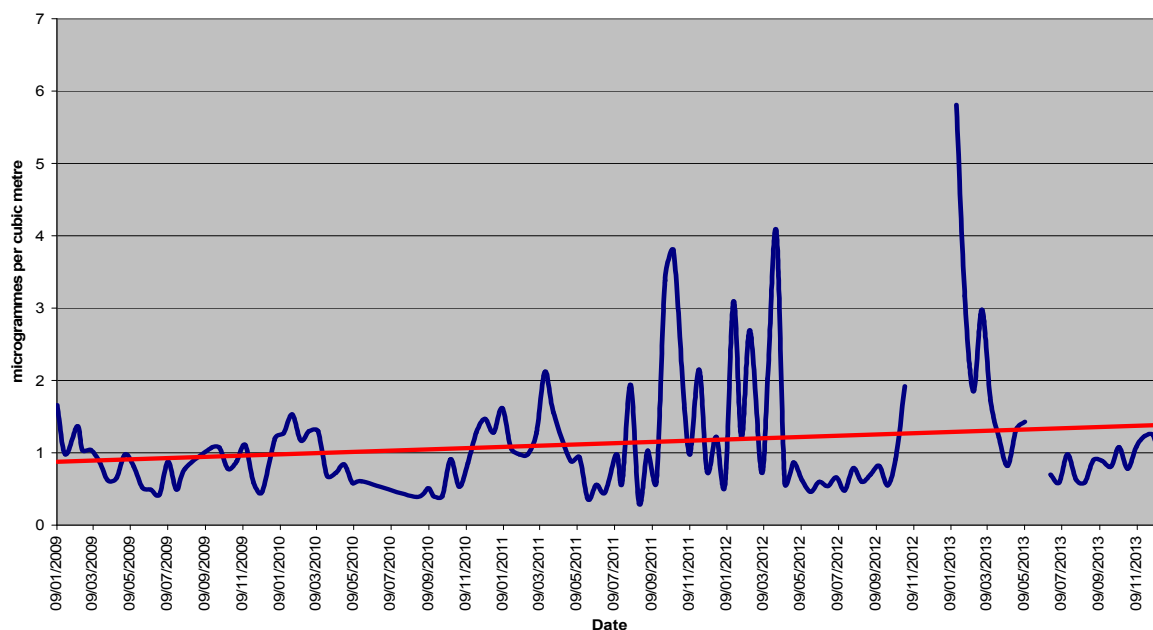
Figure 2.18: Trends in Benzene Levels, from 2009 to 2013

Benzene is sampled at the Chesterfield Roadside site, by the use of sampling tubes containing a proprietary absorbent (Carbopack X). The tubes are exposed for 14 days. The monitoring results (shown below) are well below the AQO, and have consistently been so over the years of monitoring at this site.
