33 The Crescent, Brimington, S43 1AZ

Elemental Structural Report

CHESTERFIELD
BOROUGH COUNCIL

Contract Title	33 The Crescent, Brimington, Chesterfield
Report Title	Elemental Structural Report on Cracking
Revision	Rev.C
Status	Revised
Control Date	05 th October 2018

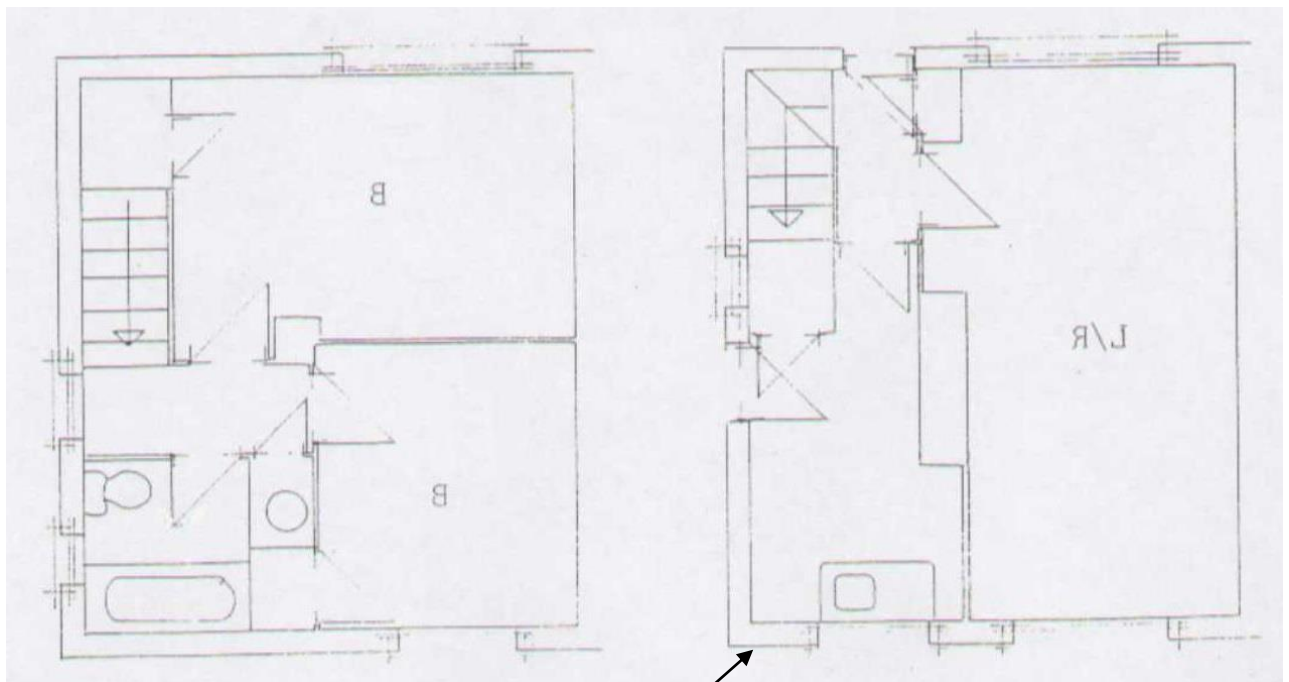
TRIAL PIT LOCATION

- 1.5 Subsequent to the results of the drain inspection by Yorkshire Water, a trial pit was arranged on the rear northeast corner of the property. This was undertaken on the 5th February 2020, but was only taken to a depth of 225mm. The trial hole was increased in depth to 675mm on the 11th February where it terminated due to difficulty in hand digging. The trial pit was extended to a depth of 1100mm by a hand auger on the 12th February during inspection. Results of this investigation have been incorporated in this revised report including recommendations for remedial works.

- 2.9 A trial pit was excavated to the rear northeast corner of the property and the log presented in Appendix C. This indicates that the corner of the house has been constructed on clay fill material over a weak friable mudstone. There were tree roots in the trial pit and a 75mm thick layer of red shale that appears to be imported to level the site to for the flat slab reinforced concrete foundation.

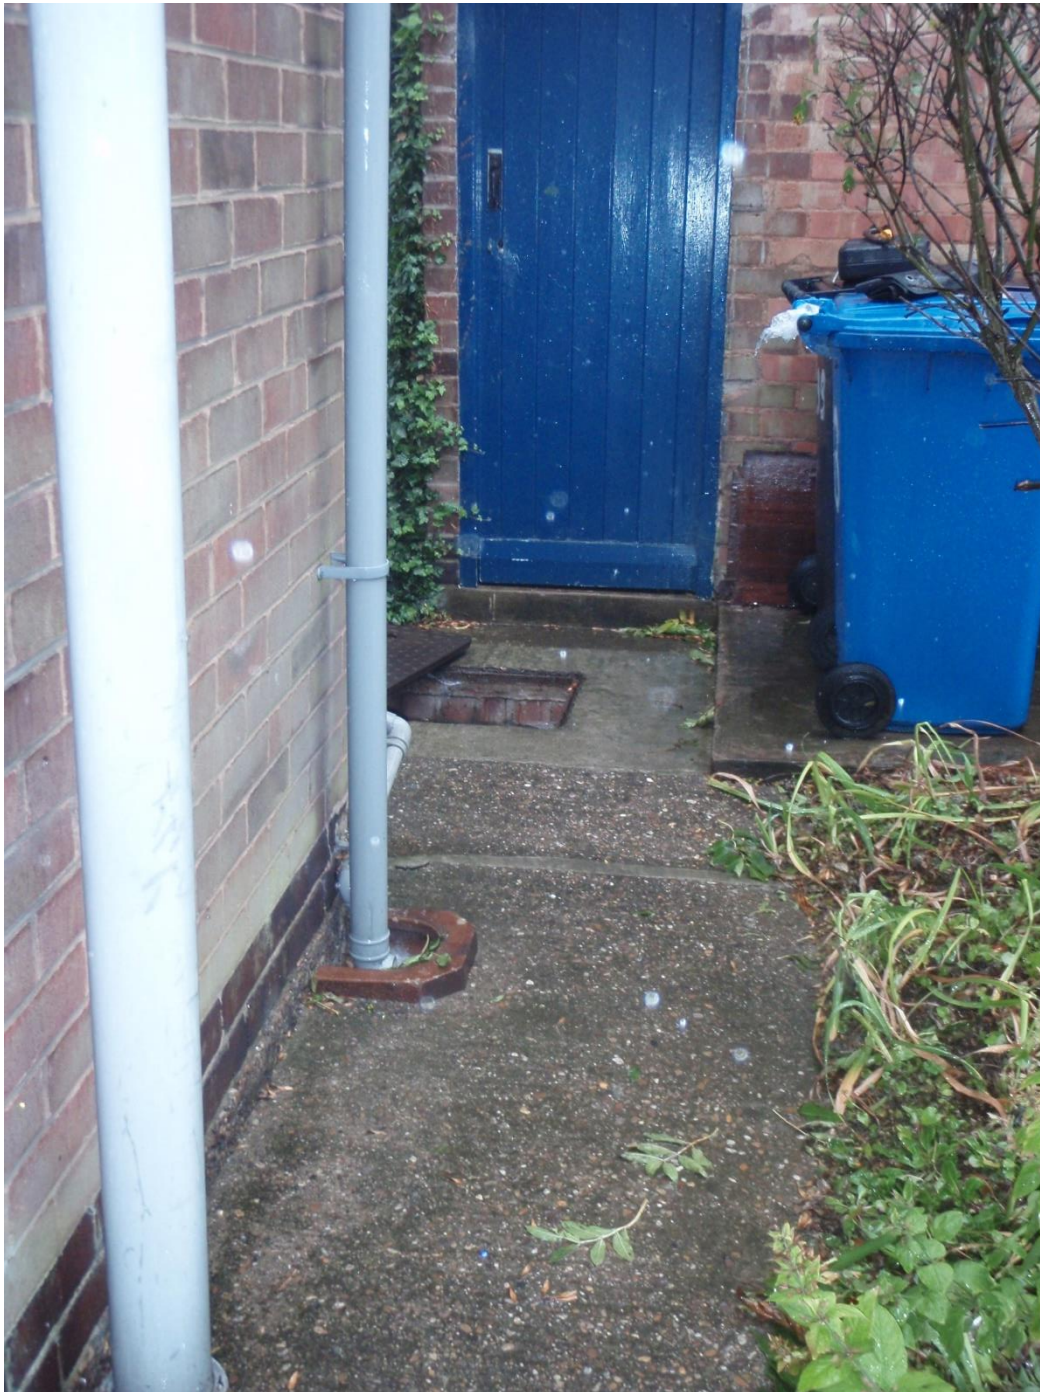
- 2.7 The drainage system was inspected as there are a number of drains in the vicinity of the movement on the property. The report of the CCTV survey of the drains is provided in appendix A. This indicated that there are a number of defects that were found.

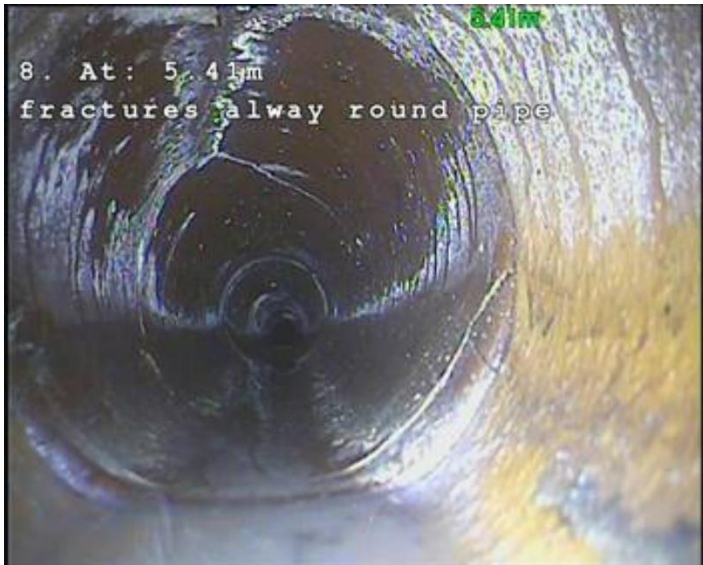
- o. 5.41m Circumferential fractures

RECOMMENDATION – Several fractures and displaced joints – C. Lowe to pass to YW for their information and action

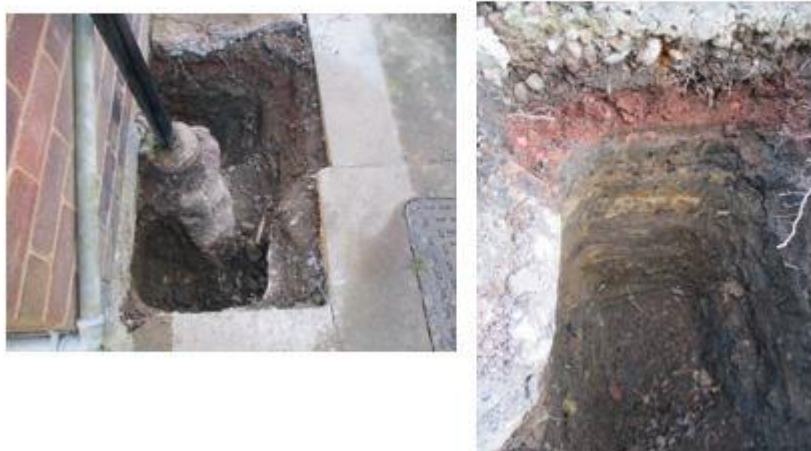
Depth (m)	Soil description and sample depths	0.00 ⇒ 0.07	Concrete Path	0.07 ⇒ 0.15	Red Shale Fill with small tree roots	0.15 ⇒ 0.85	Mottled Grey/Orange Clay Fill with fragments of Black Shale and 20mm diameter tree roots	0.85 ⇒ 1.10	Soft Weathered Friable Mudstone
